WEEKLY EROSION CONTROL INSPECTION

PROJECT:	Avalon Bay Stratford, CT	DATE:	October 24 & 25, 2013
CONTRACTOR:	AMEC	PROJECT NO.:	86 16038
PREPARED BY:	Ken Kohlbrenner, PE	REPORT NO.:	11
SIGNATURE:		PERMIT NO.:	IWWA #2001-9(M)

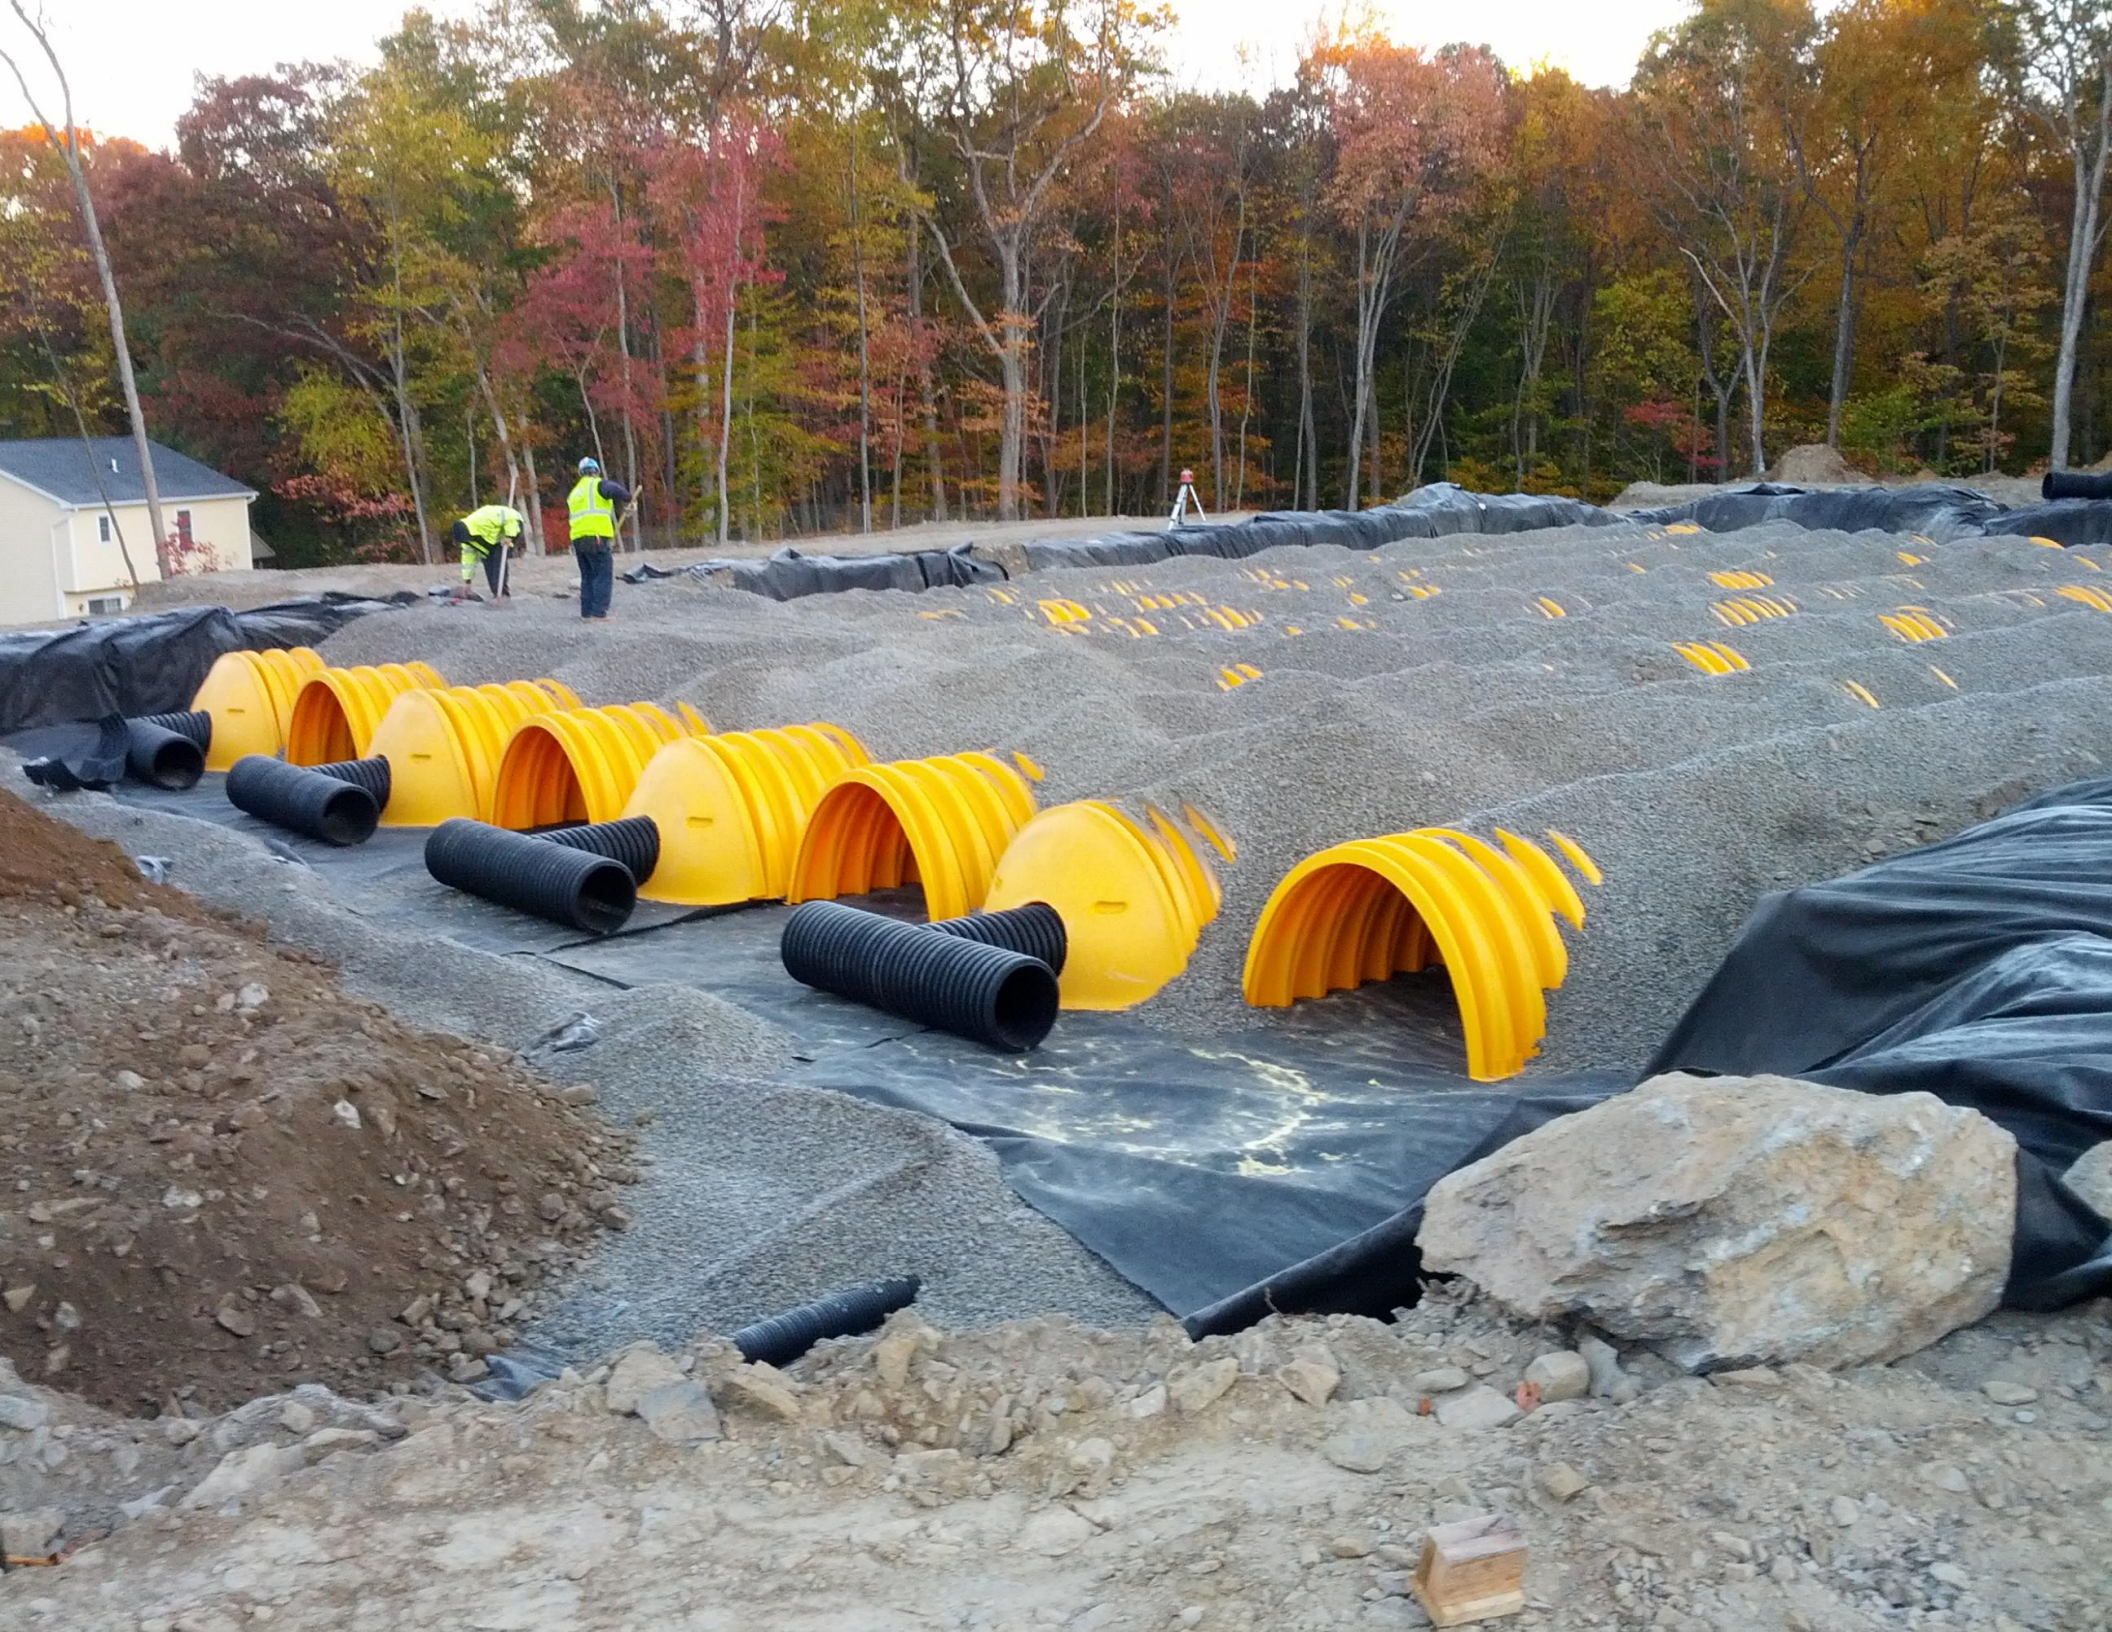
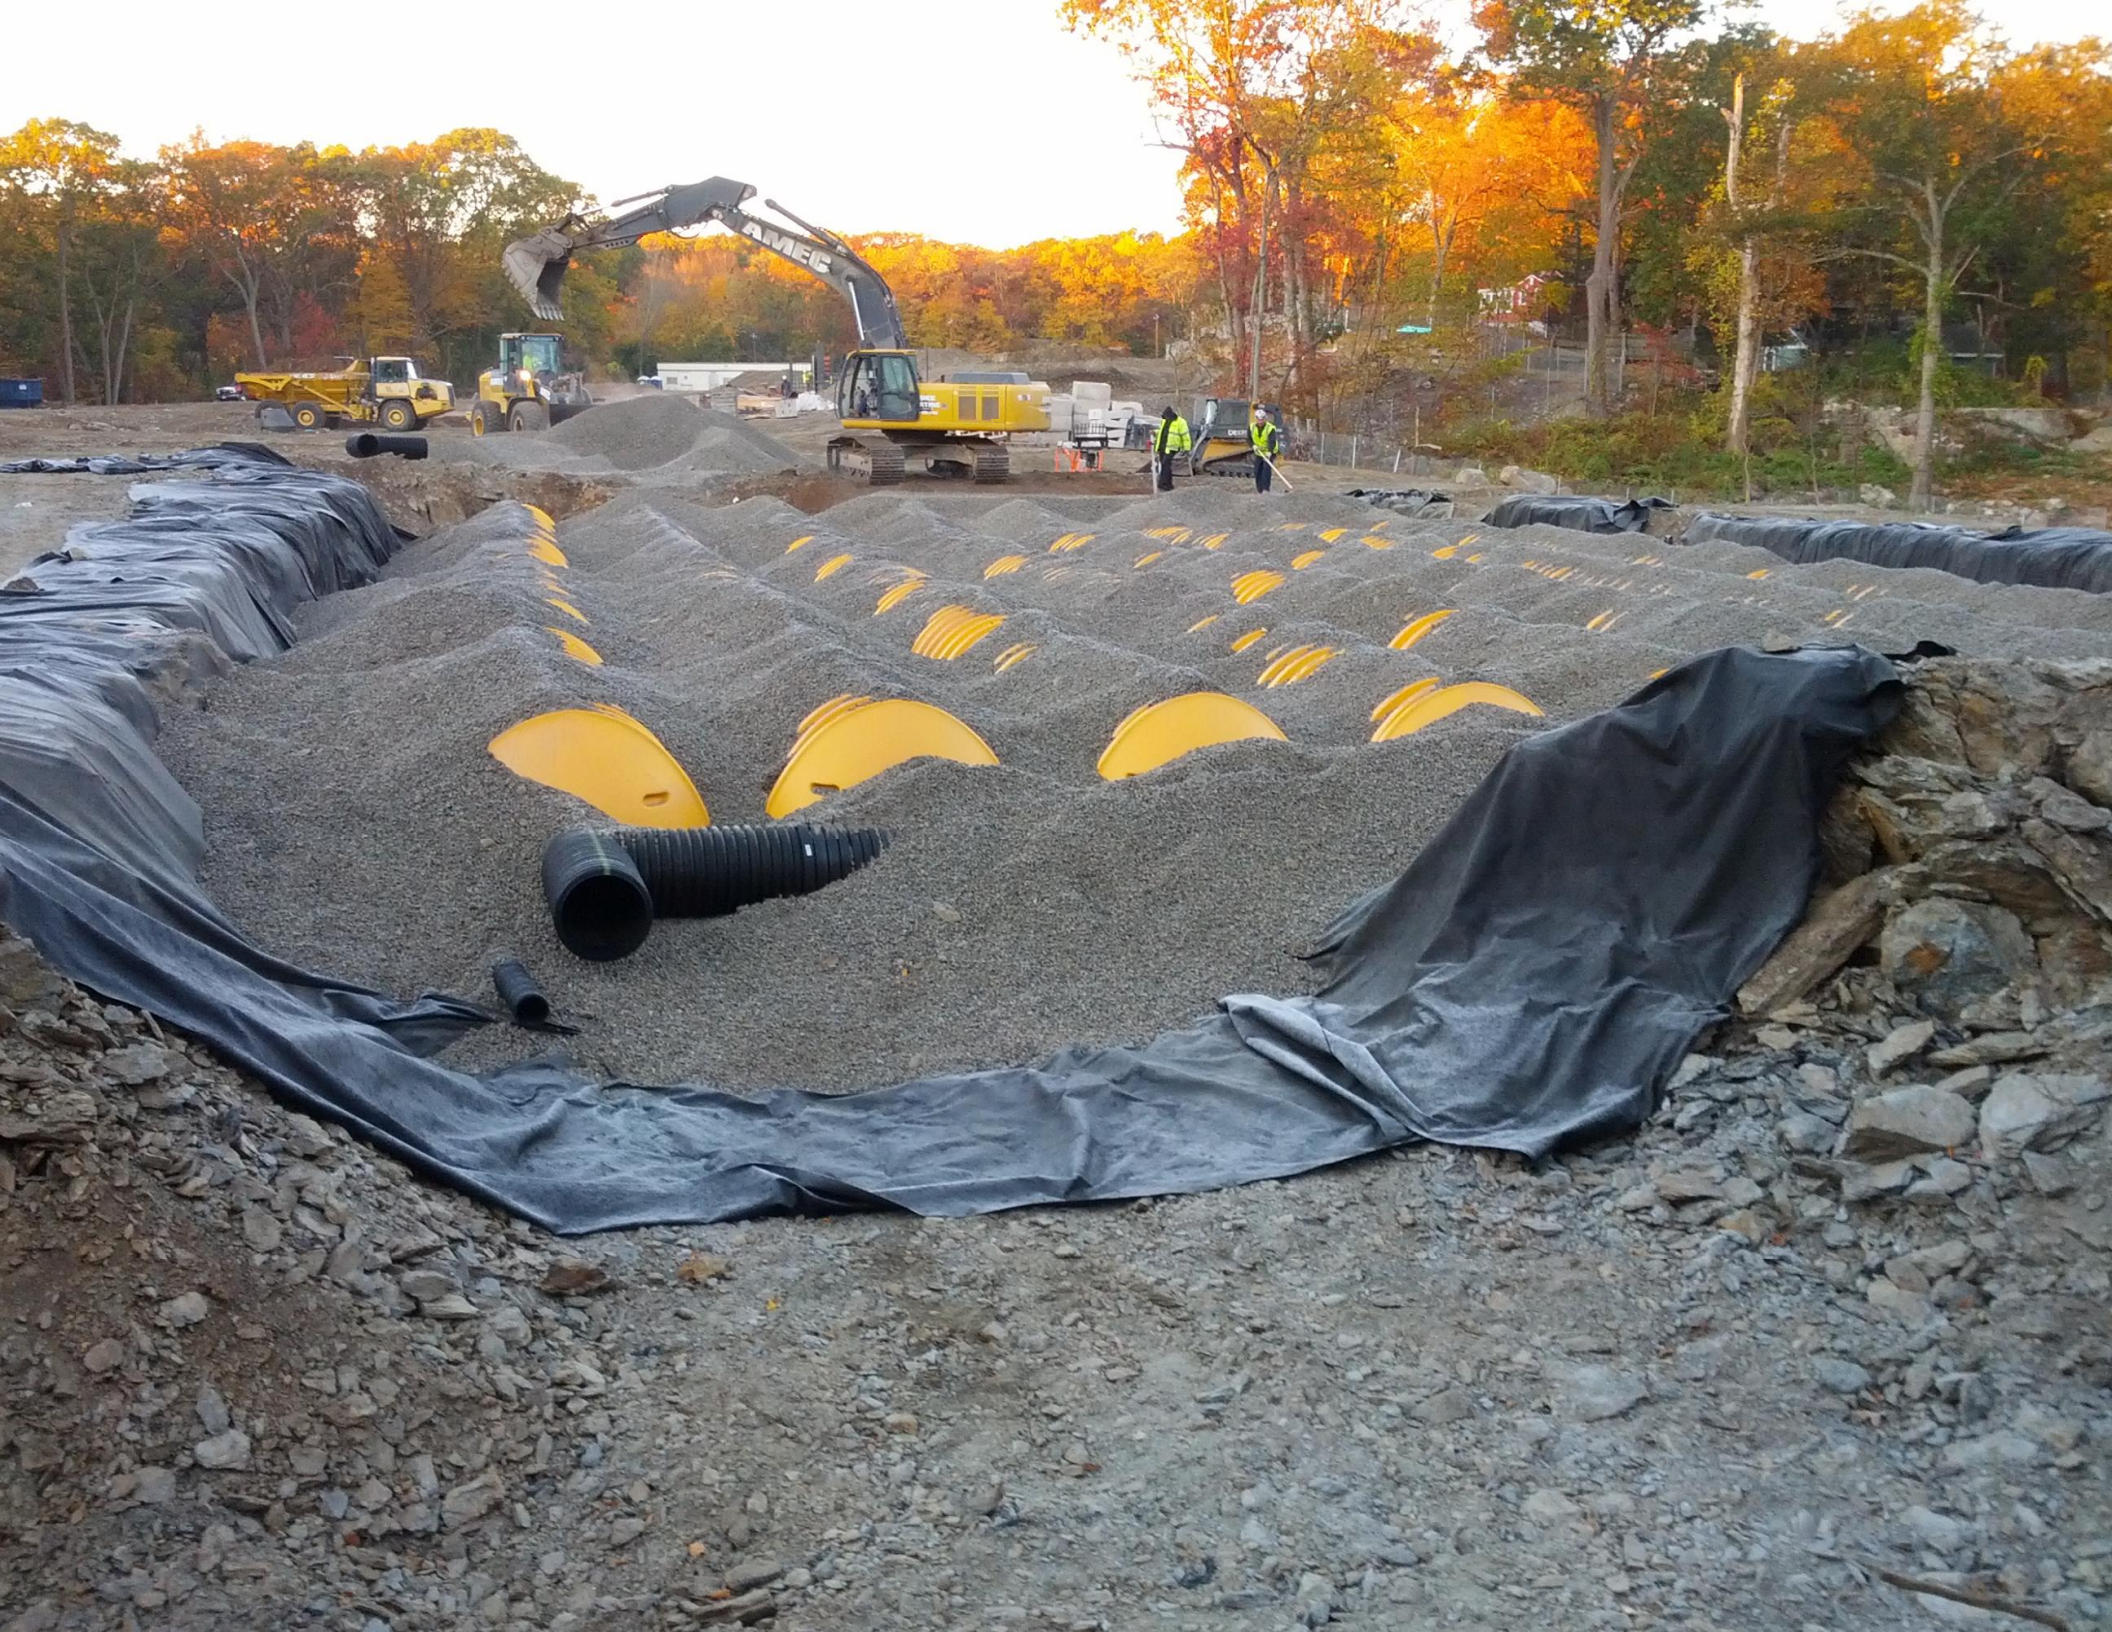
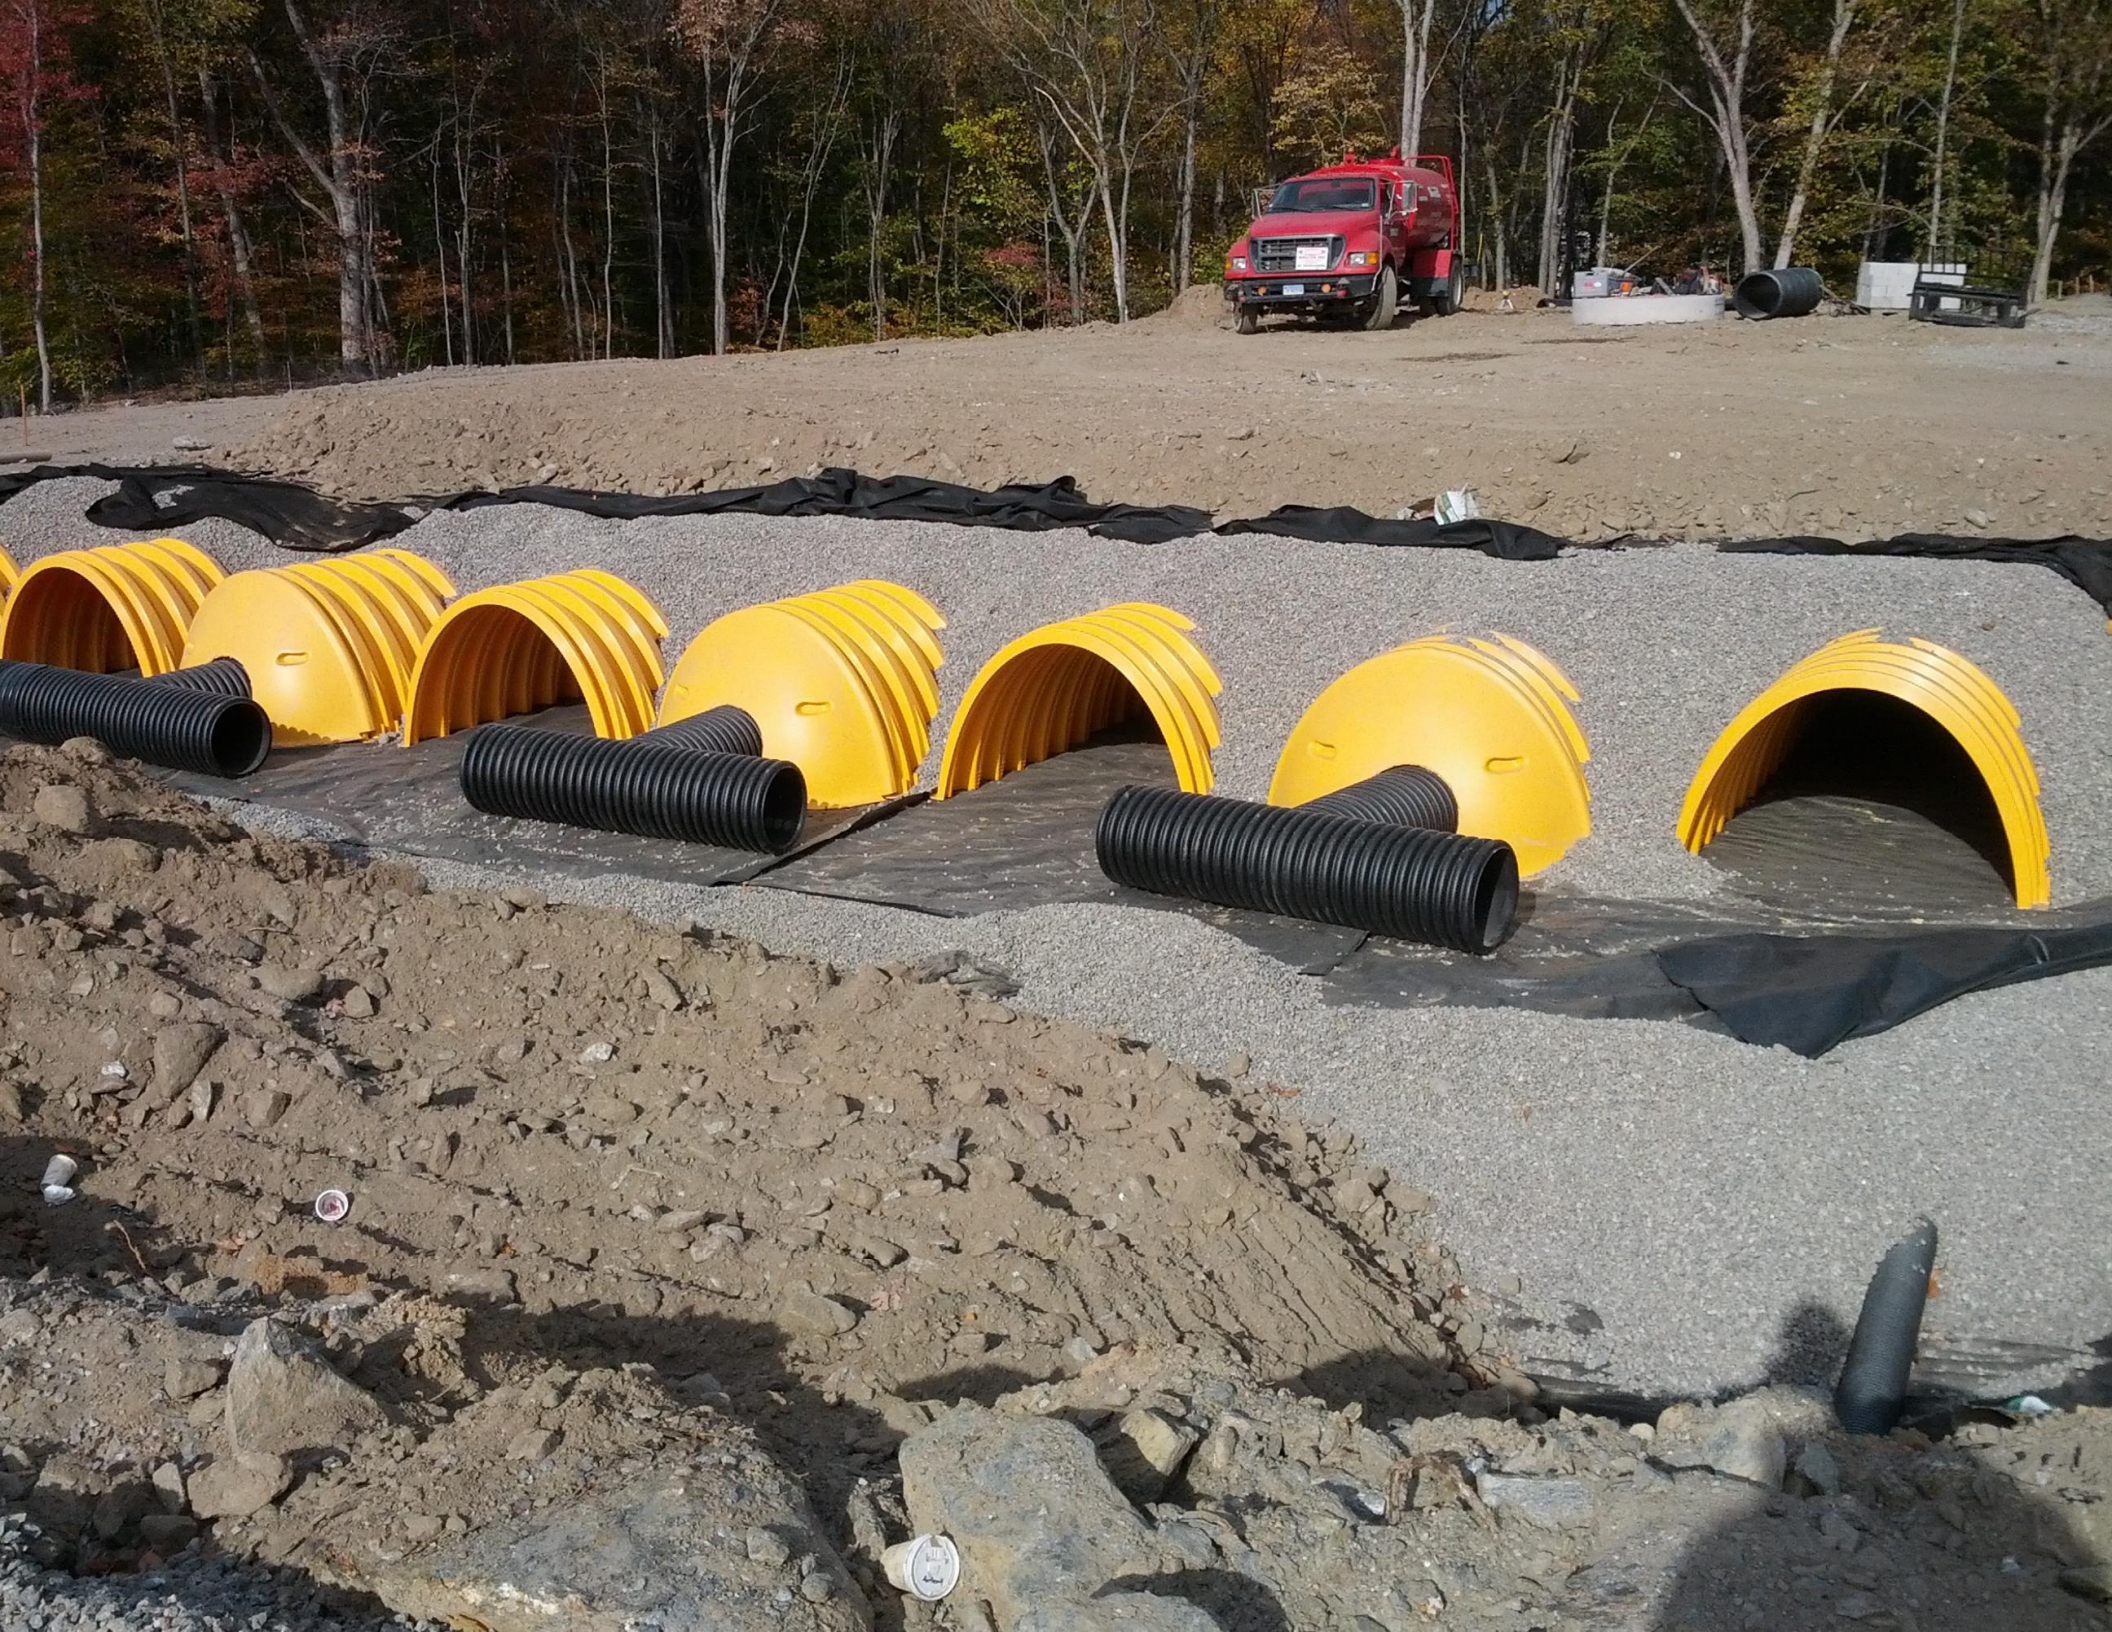
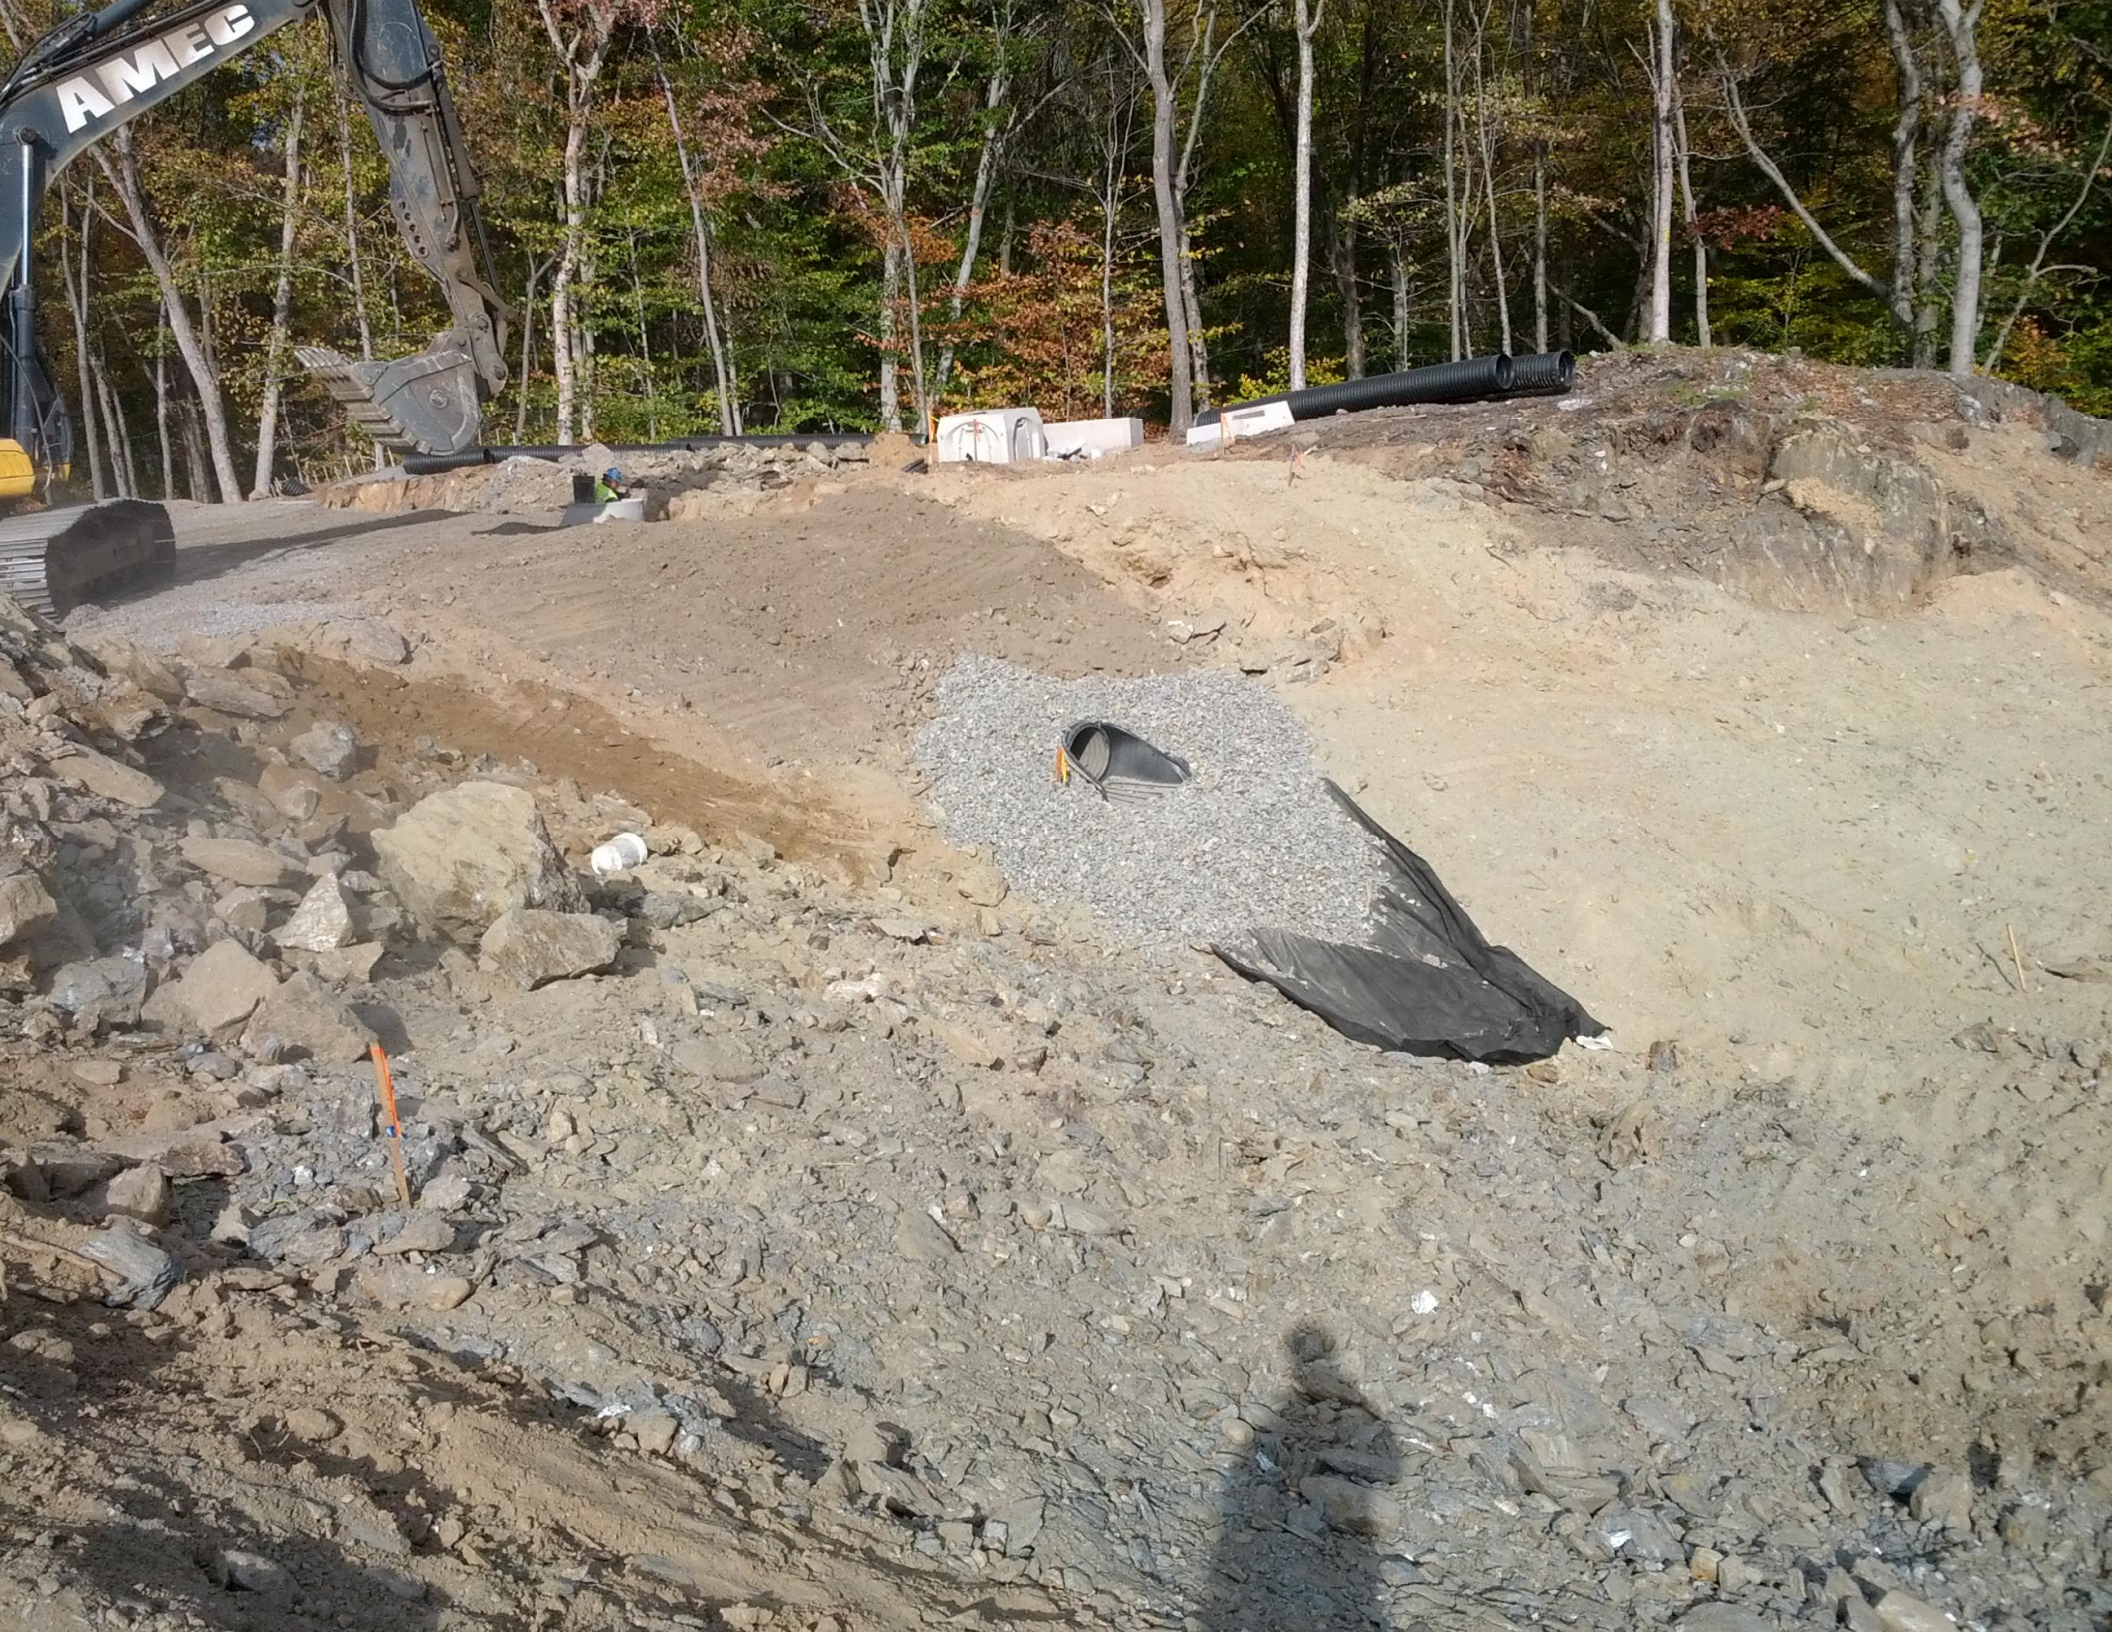
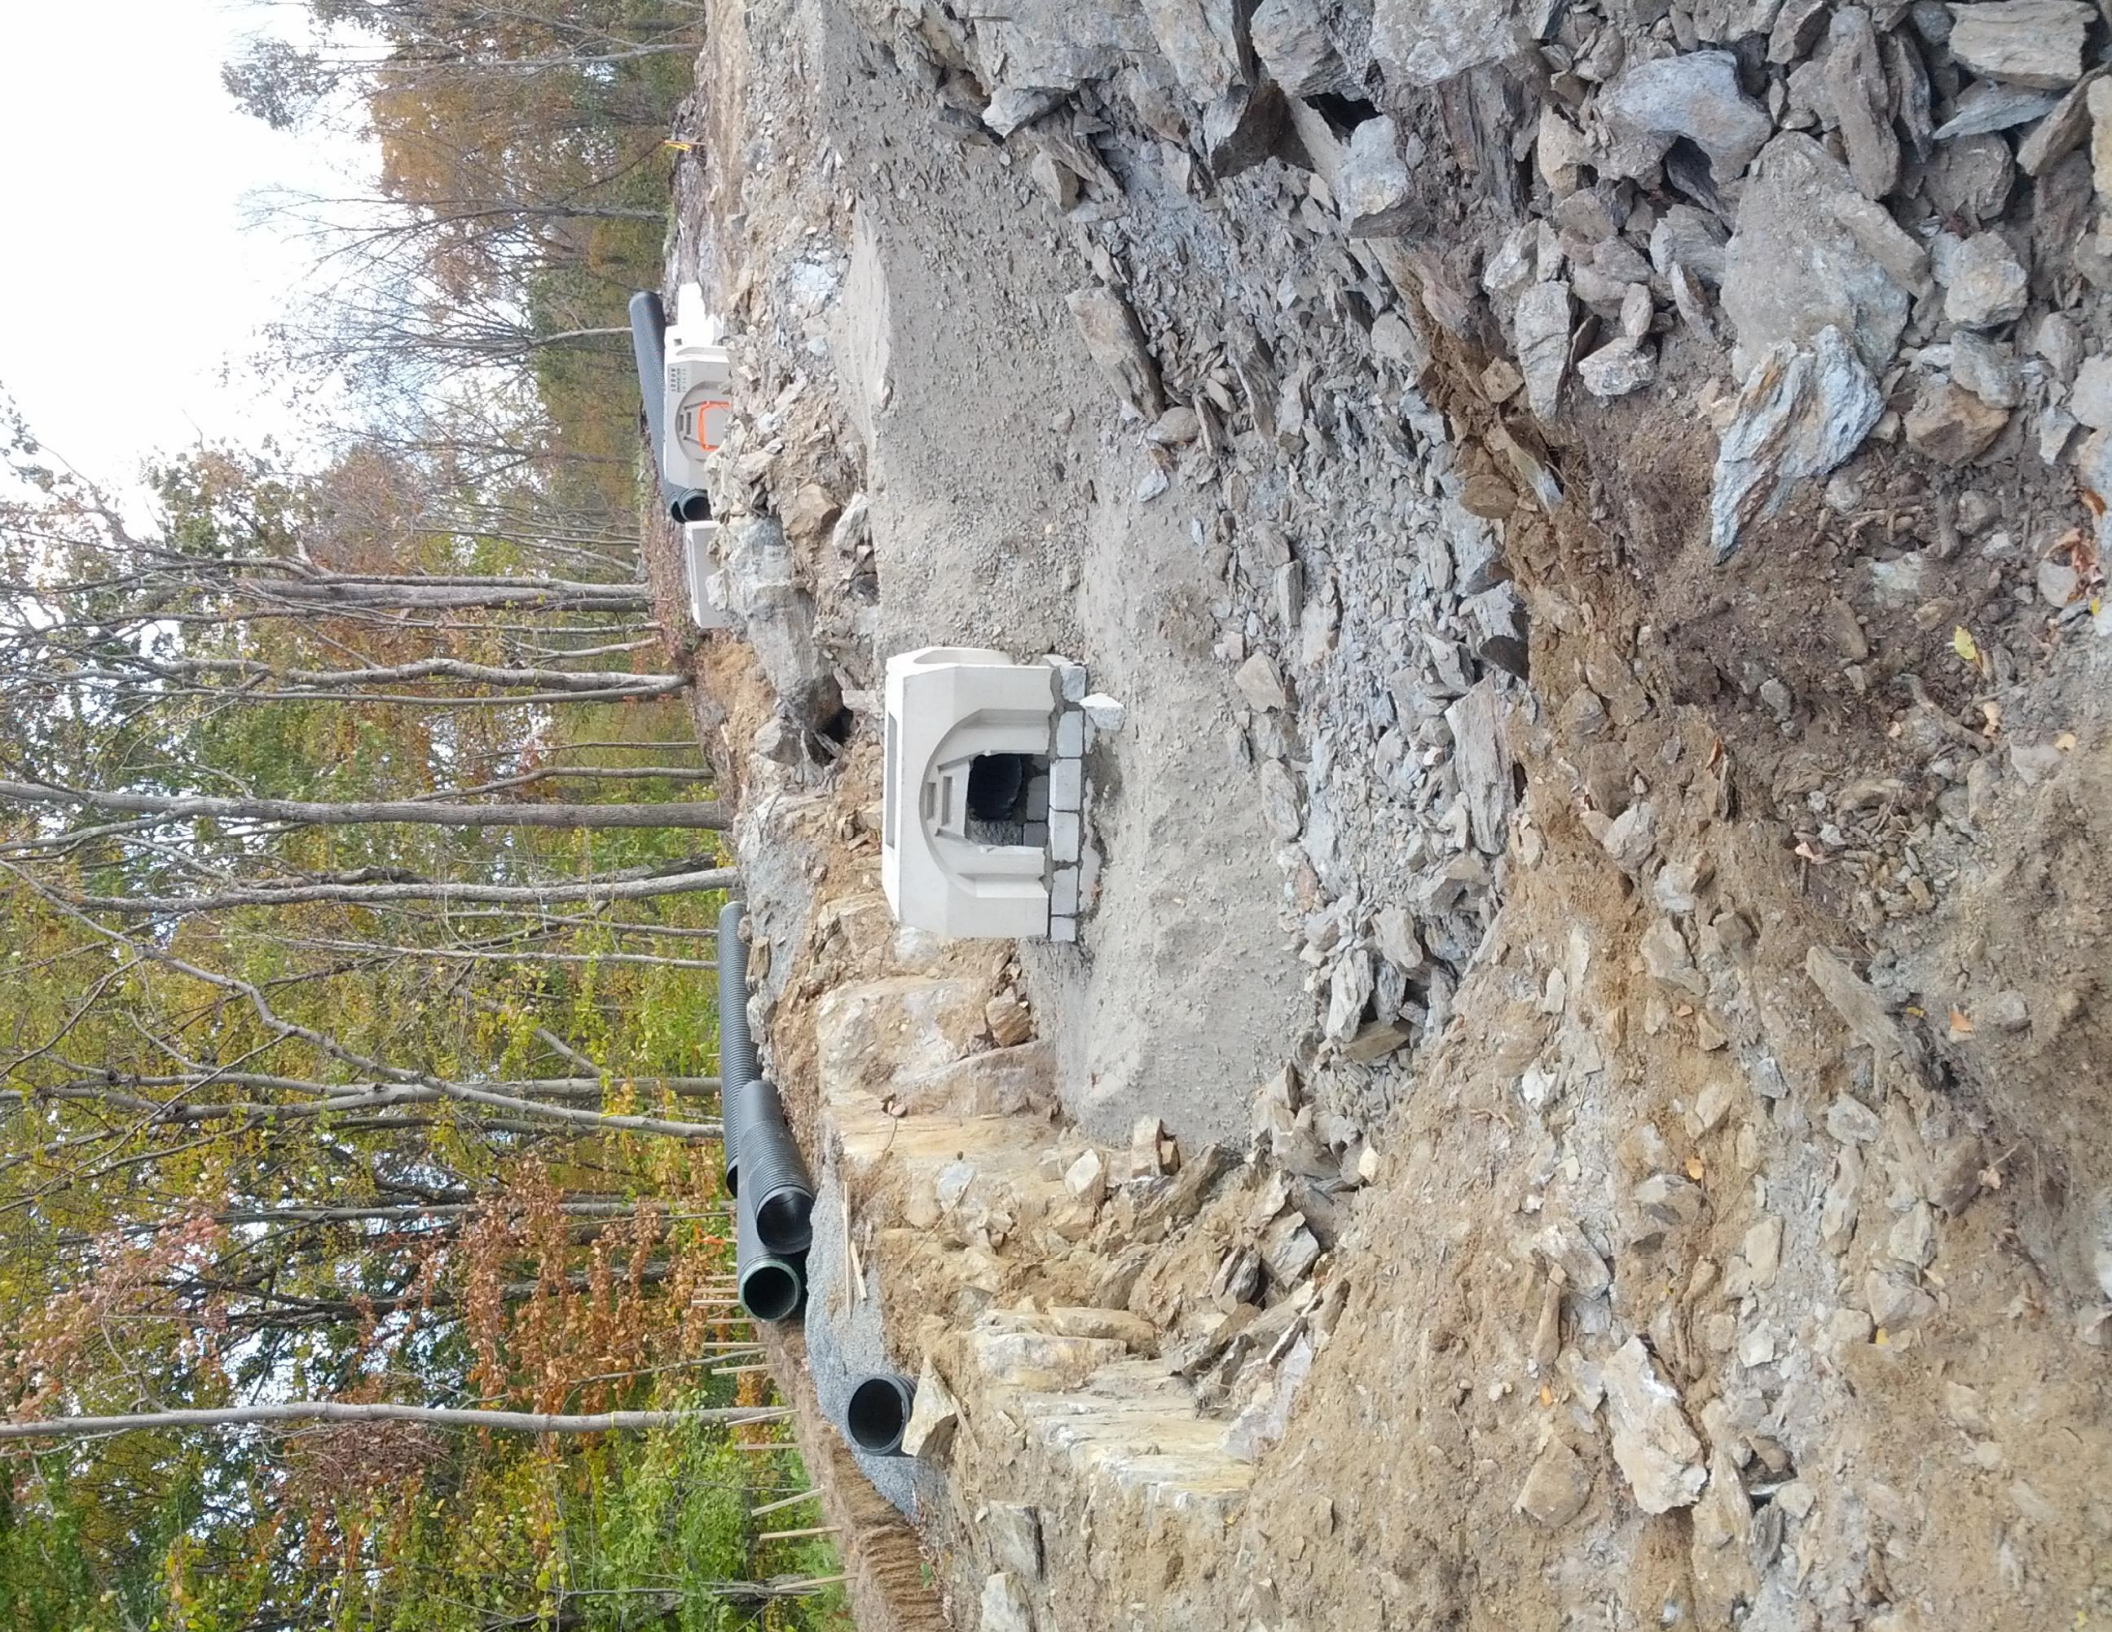
Infiltration area 110 is installed (waiting for 4 endcaps prior to finishing backfill). STMH 6 (infiltration outlet control structure), STMH 6A, and flared end section into detention basin are set (no frames installed). Catch basin 3 (discharges to STMH 6A) is also set.

Photos of infiltration area 110, flared end section, Catch Basin 3, STMH 6A, and STMH 6.
