WEEKLY EROSION CONTROL INSPECTION

PROJECT:	Avalon Bay Stratford, CT	DATE:	November 15, 2013
CONTRACTOR:	AMEC	PROJECT NO.:	86 16038
PREPARED BY:	Ken Kohlbrenner, PE	REPORT NO.:	14
SIGNATURE:	Ty the	PERMIT NO.:	IWWA #2001-9(M)

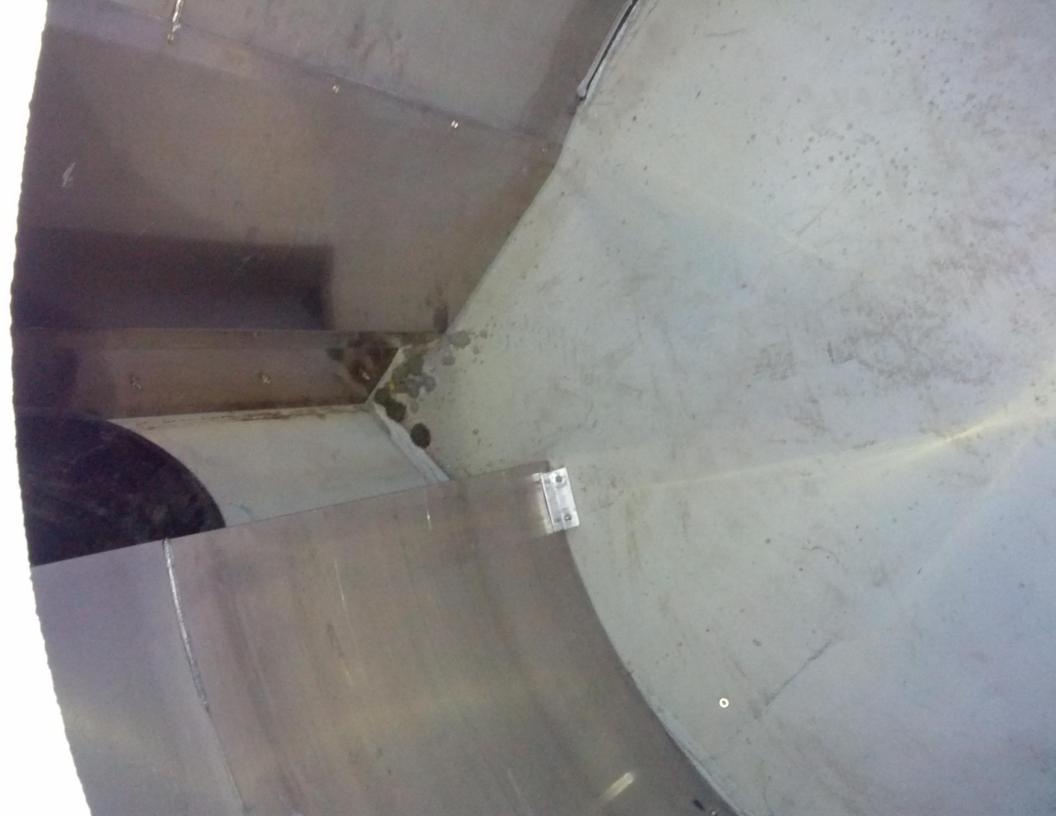
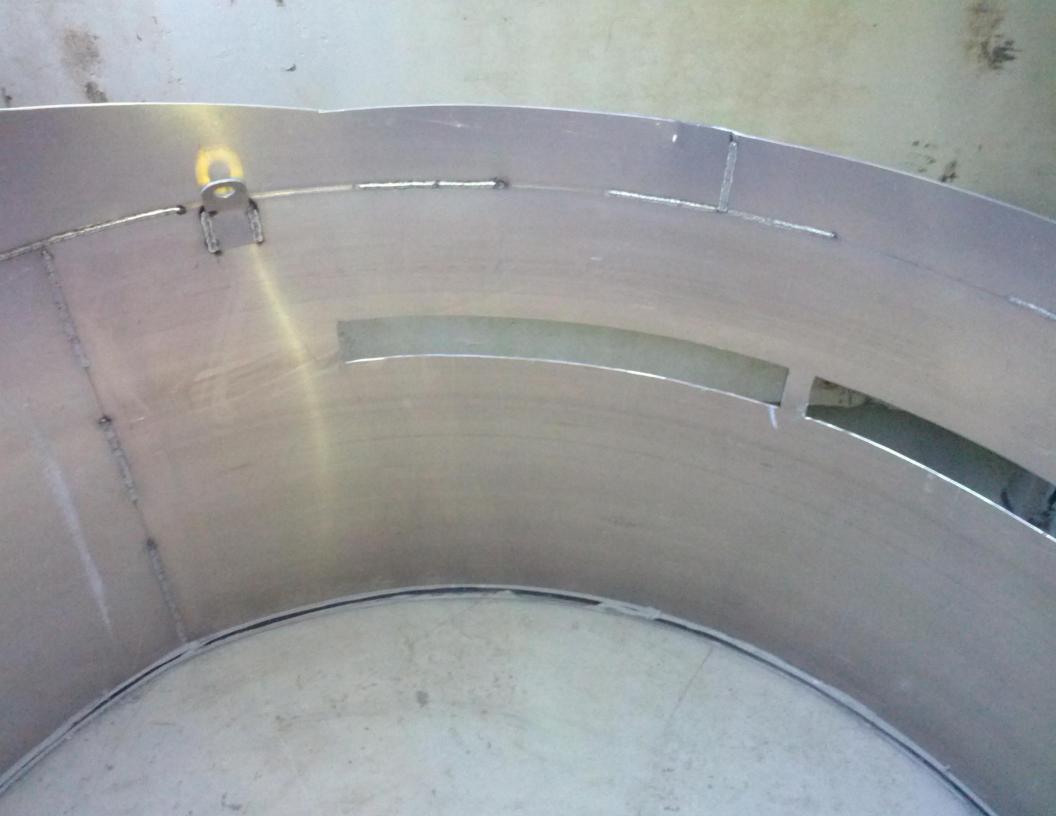
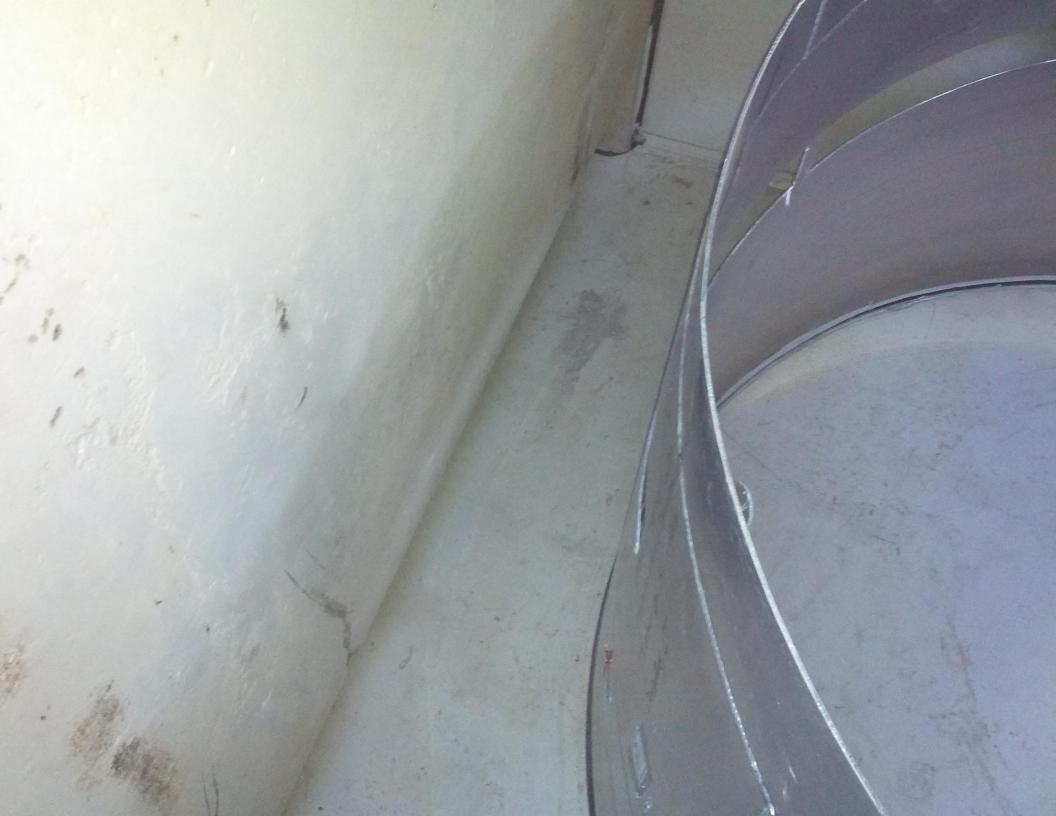
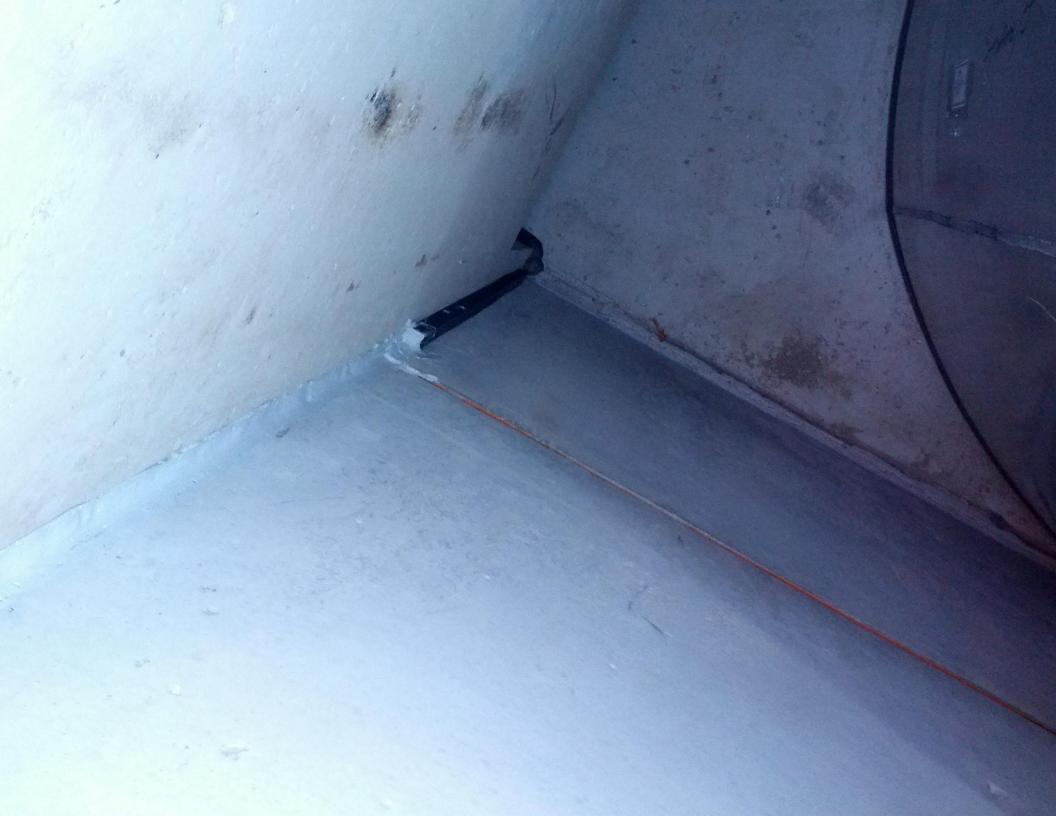
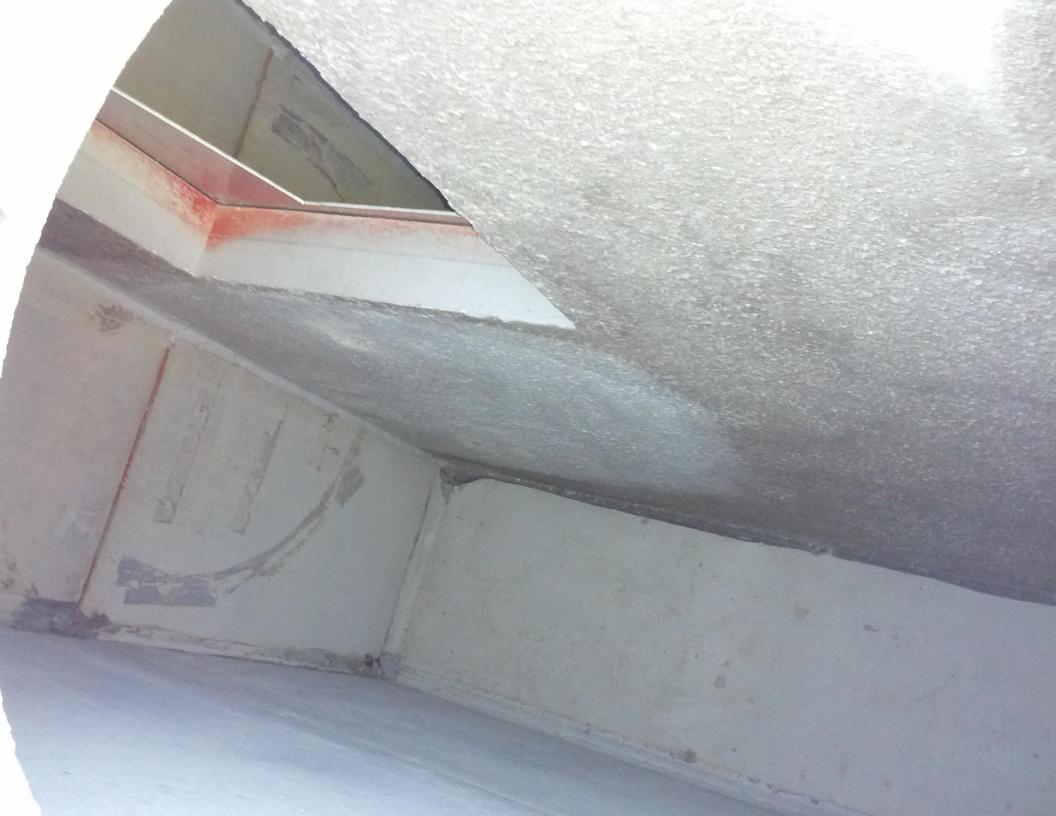
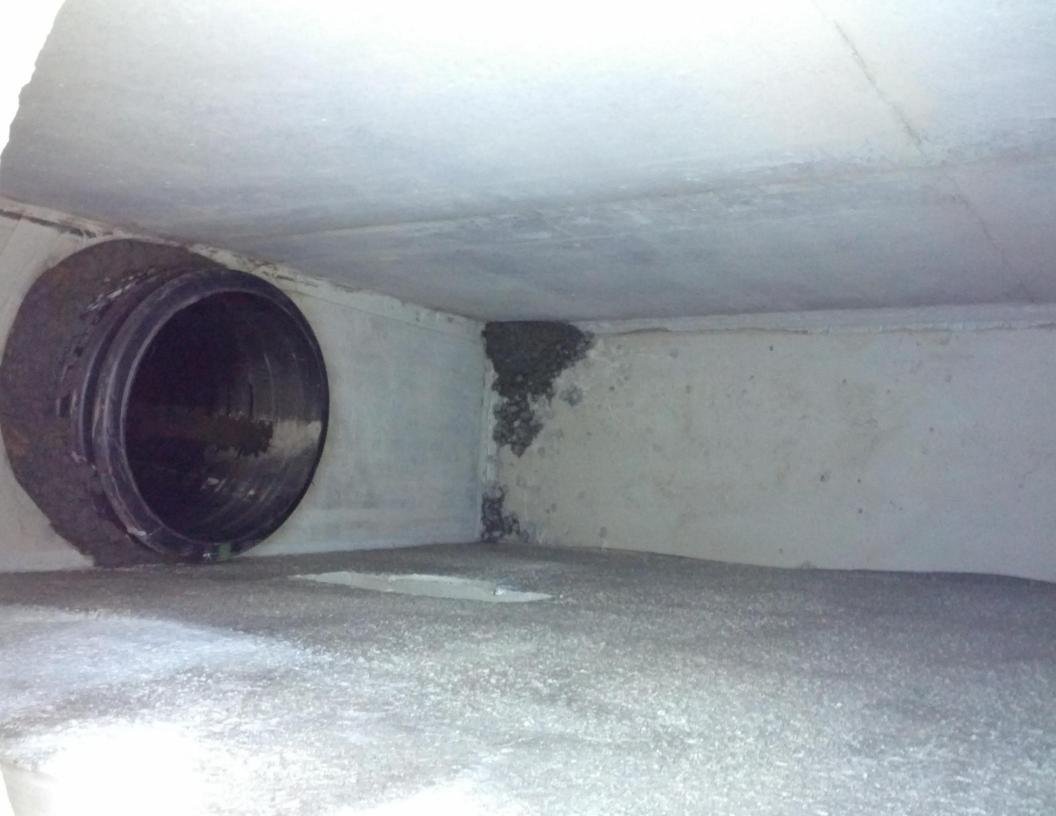
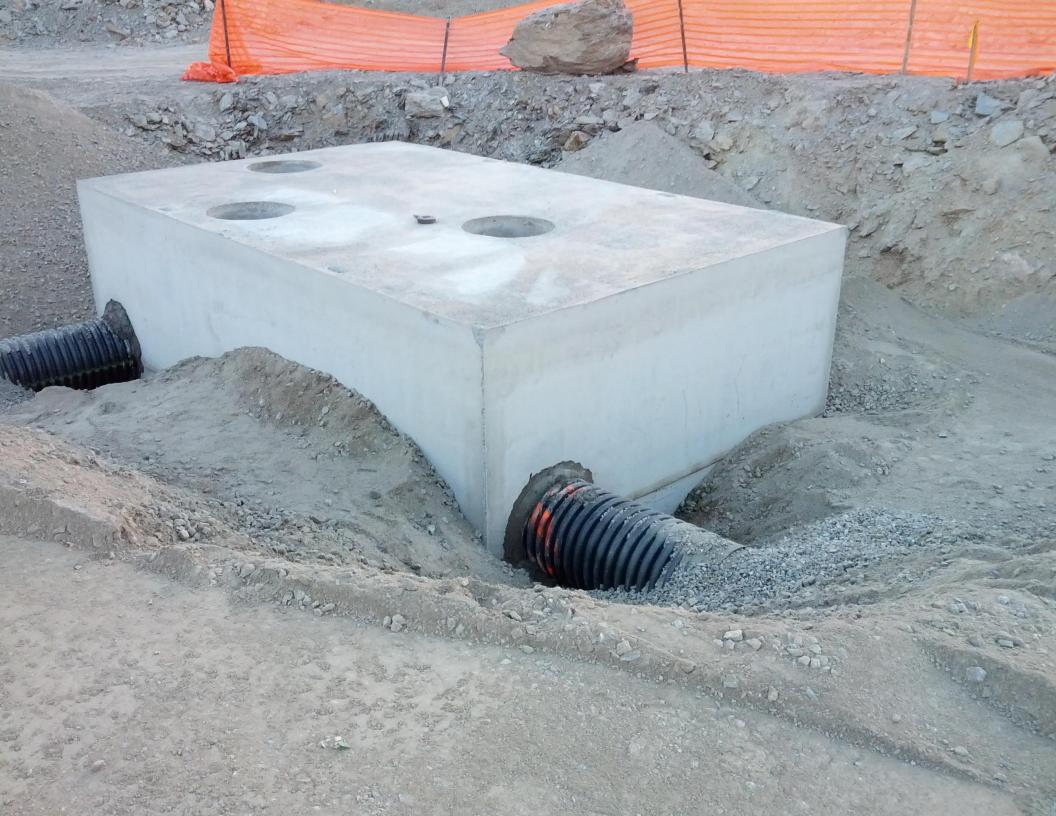
Vortechs Model 9000 Sediment Separation unit set and fully piped and backfilled.

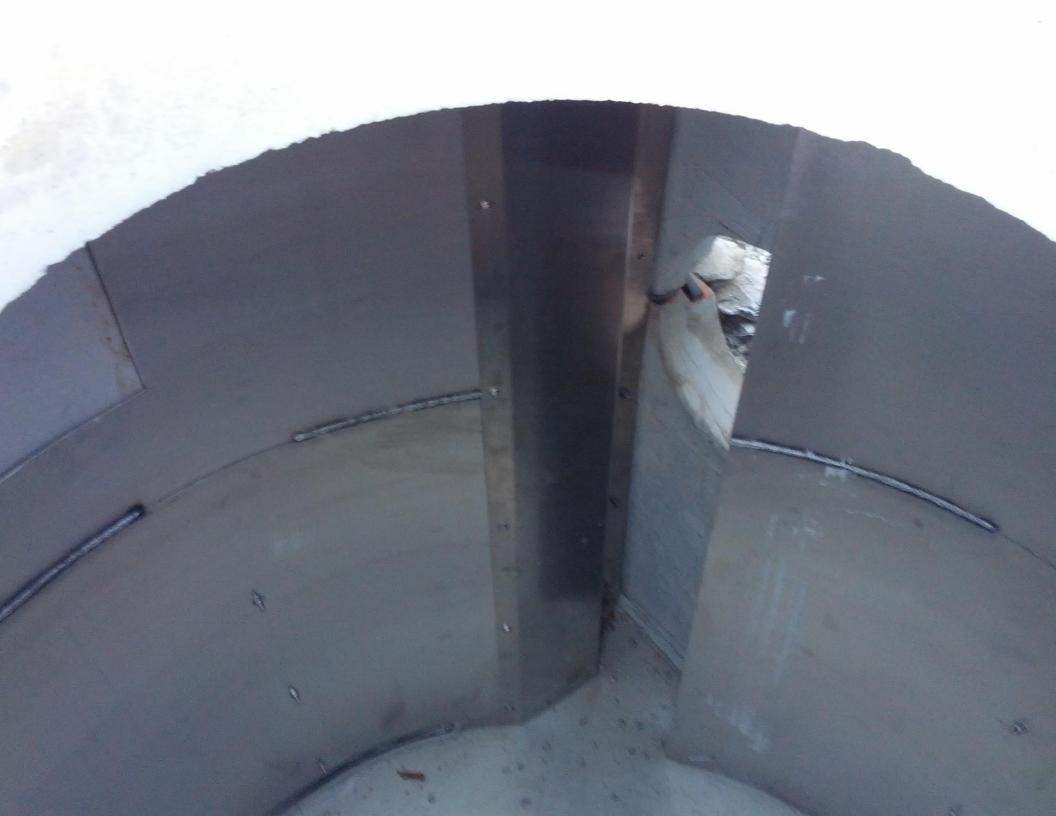
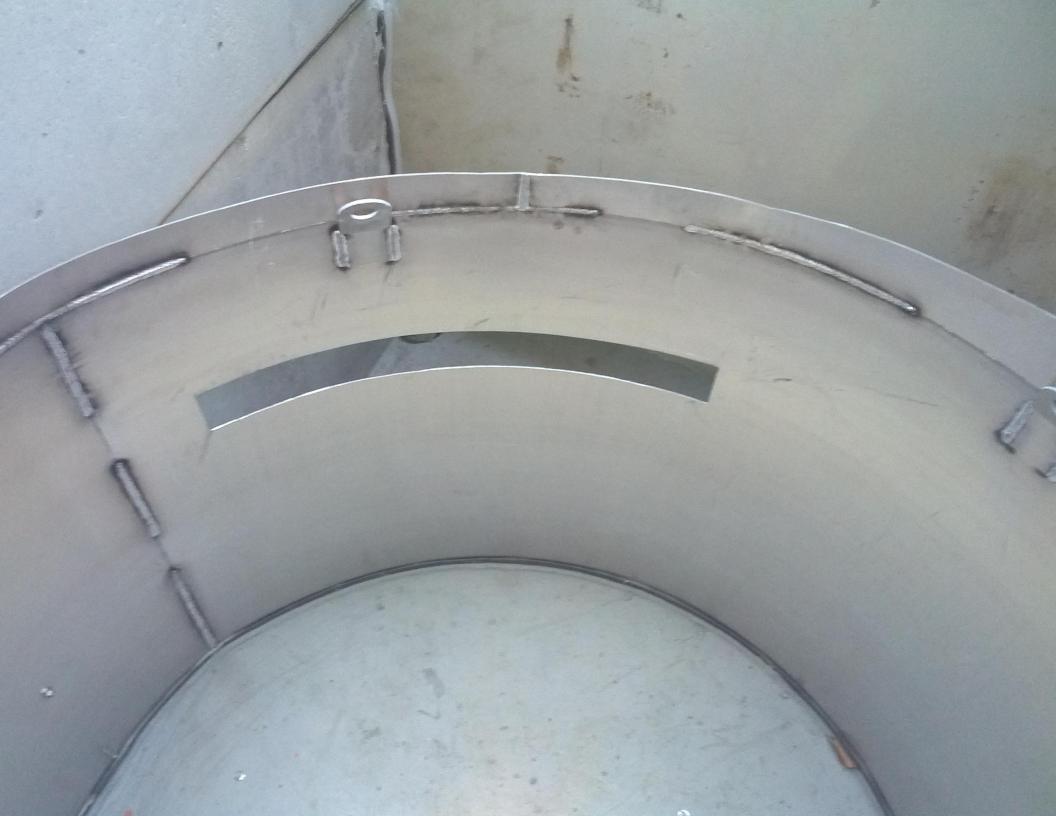
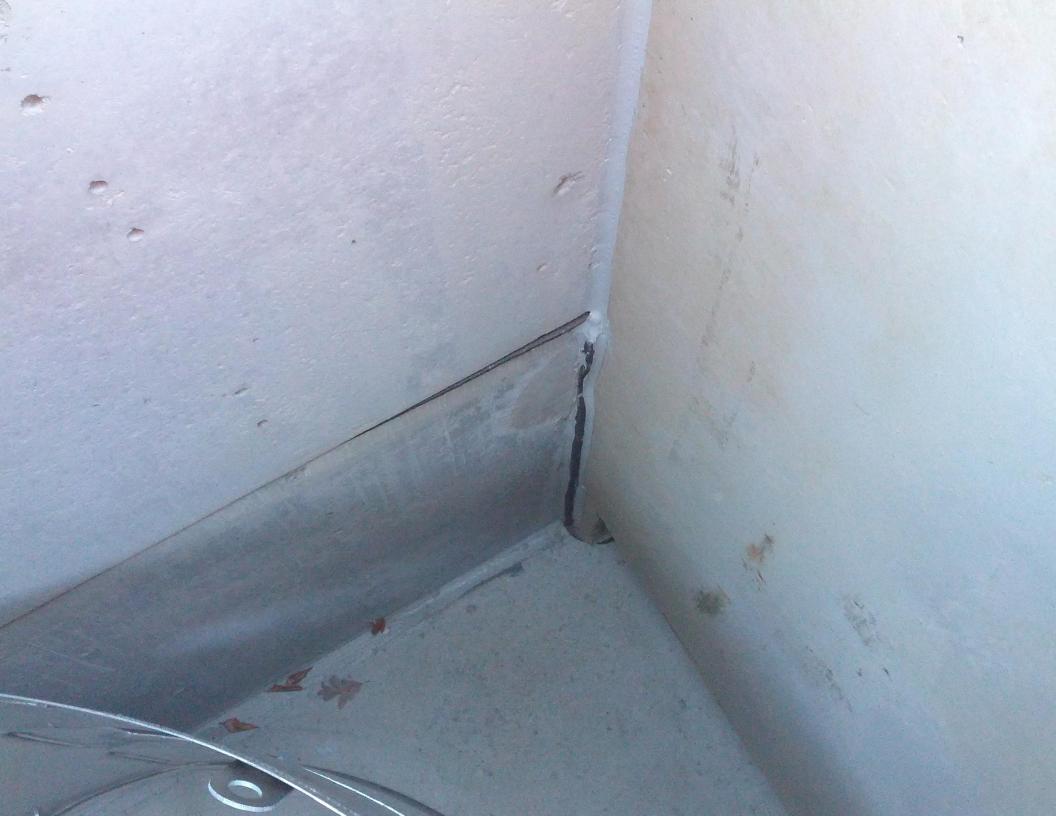
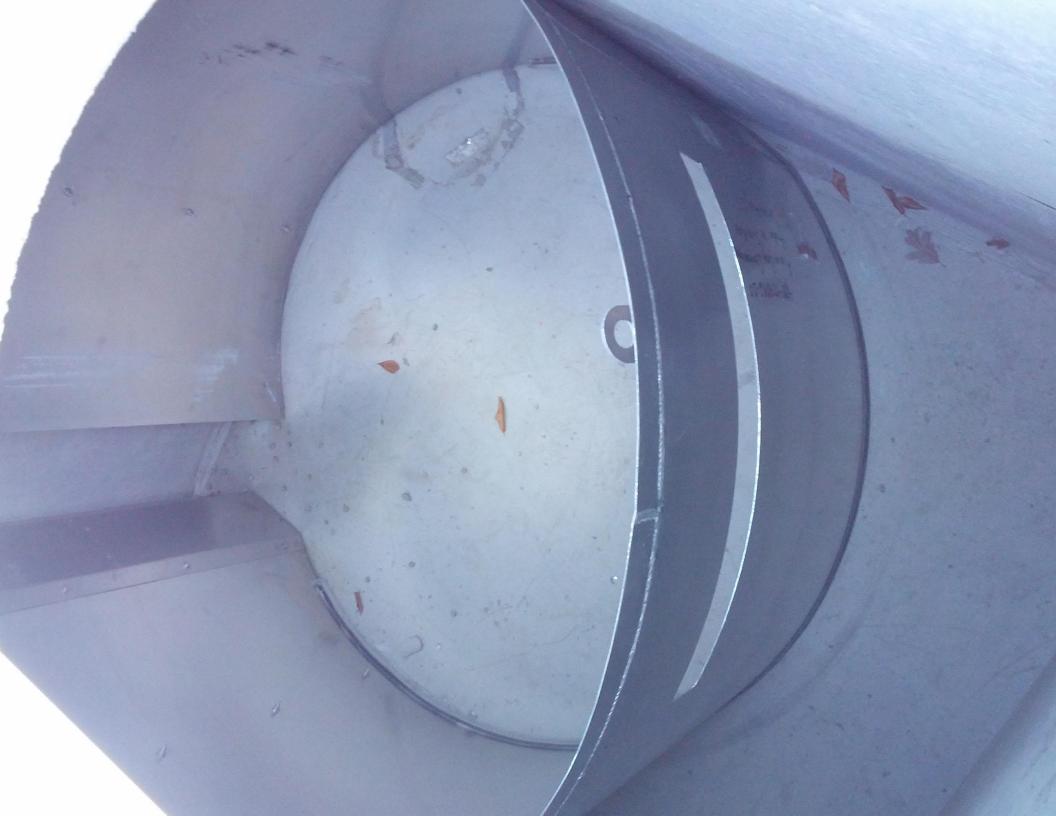
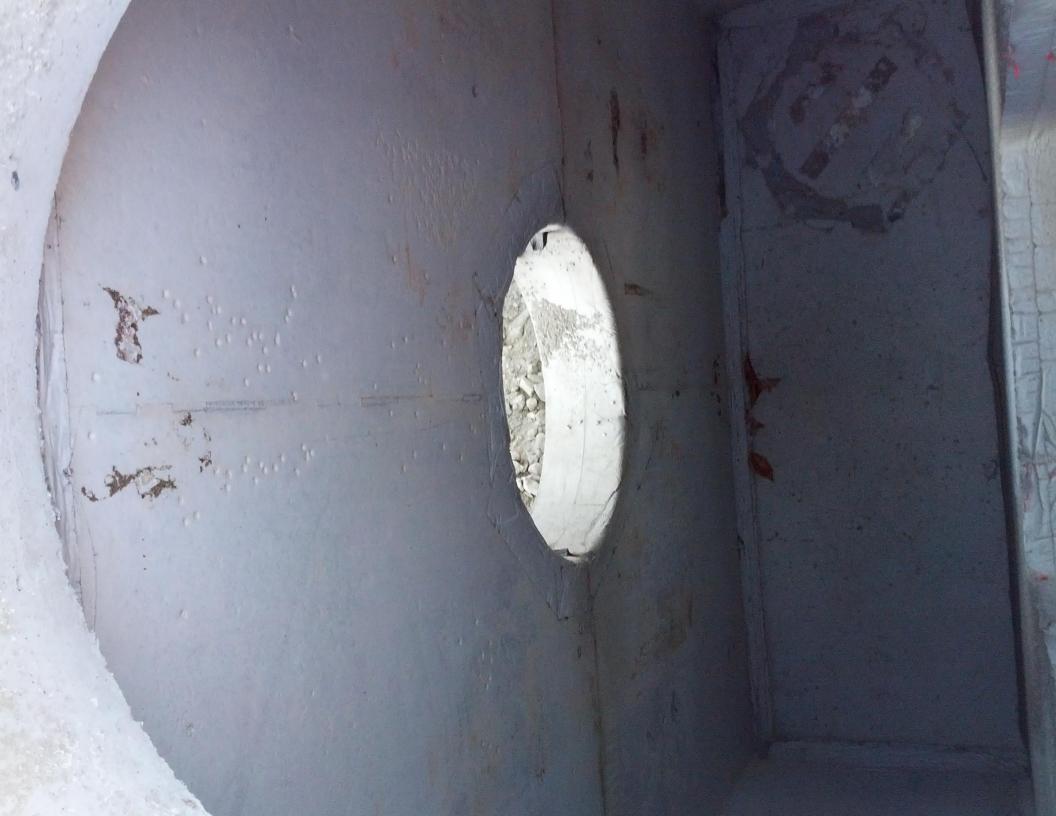
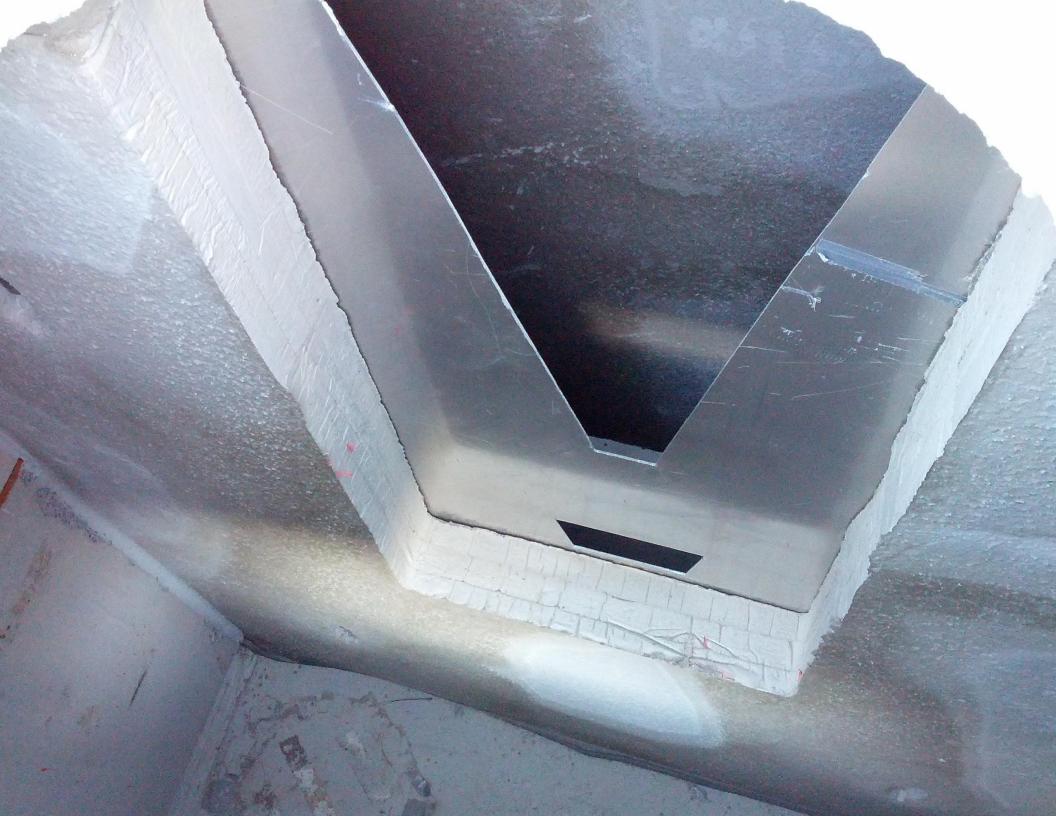
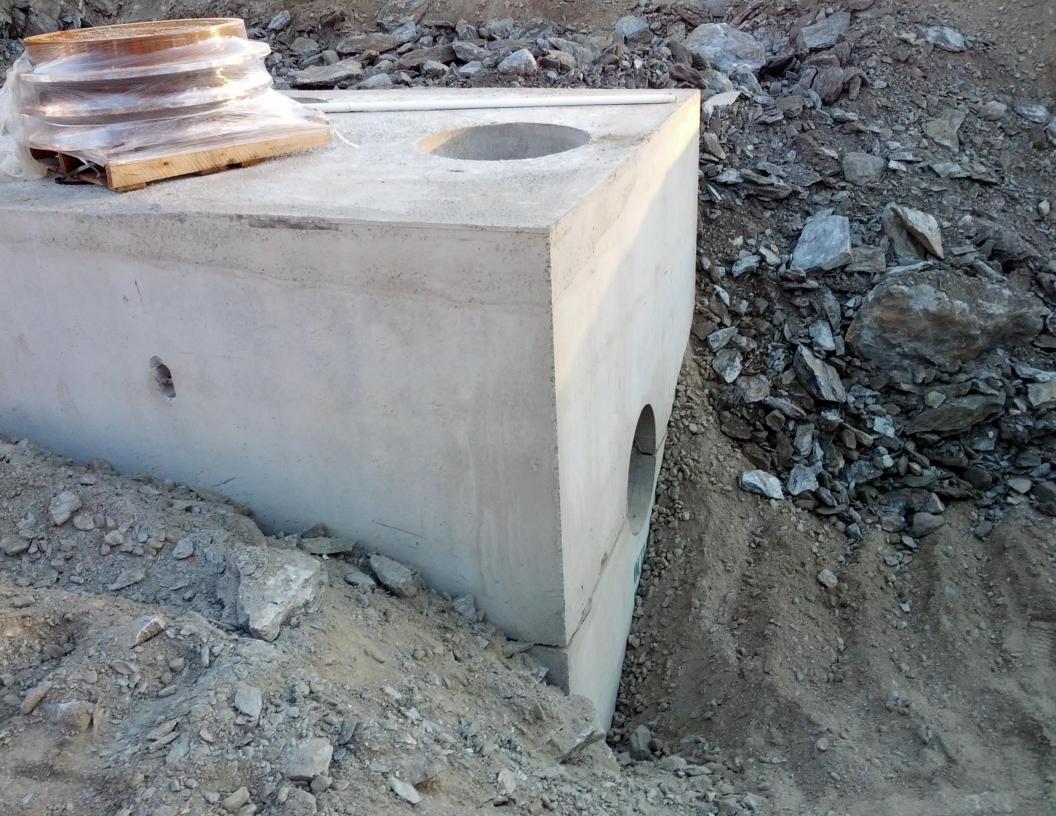
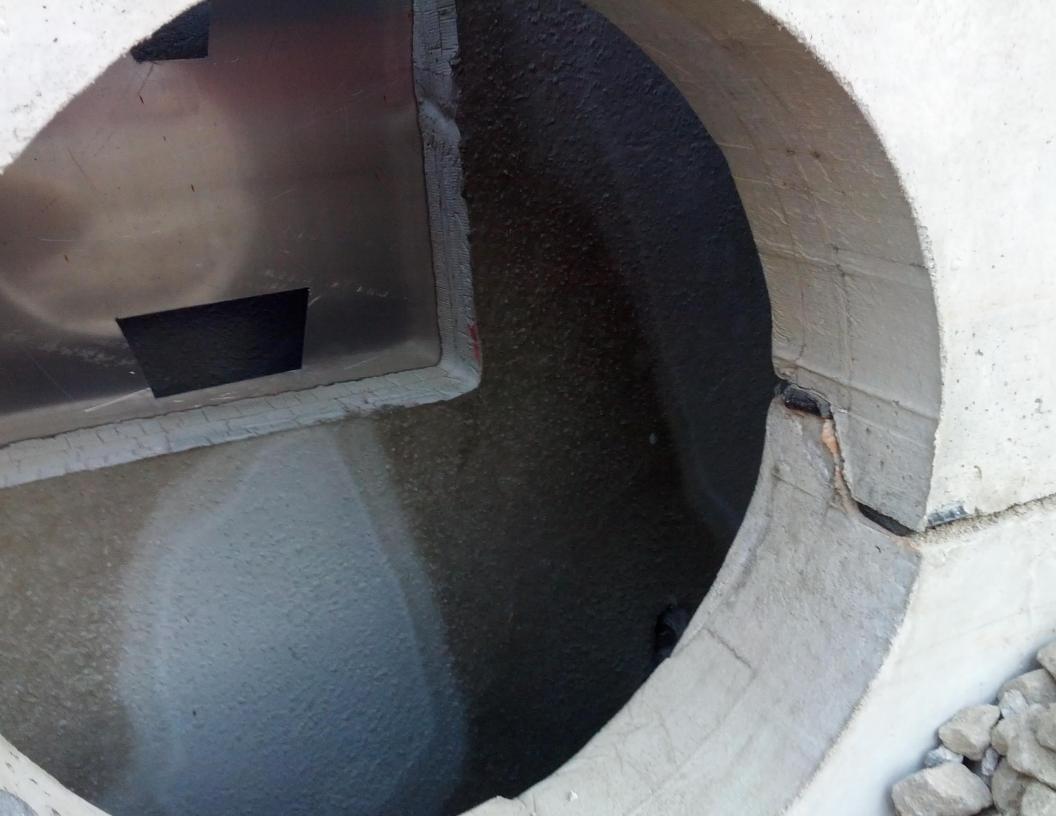
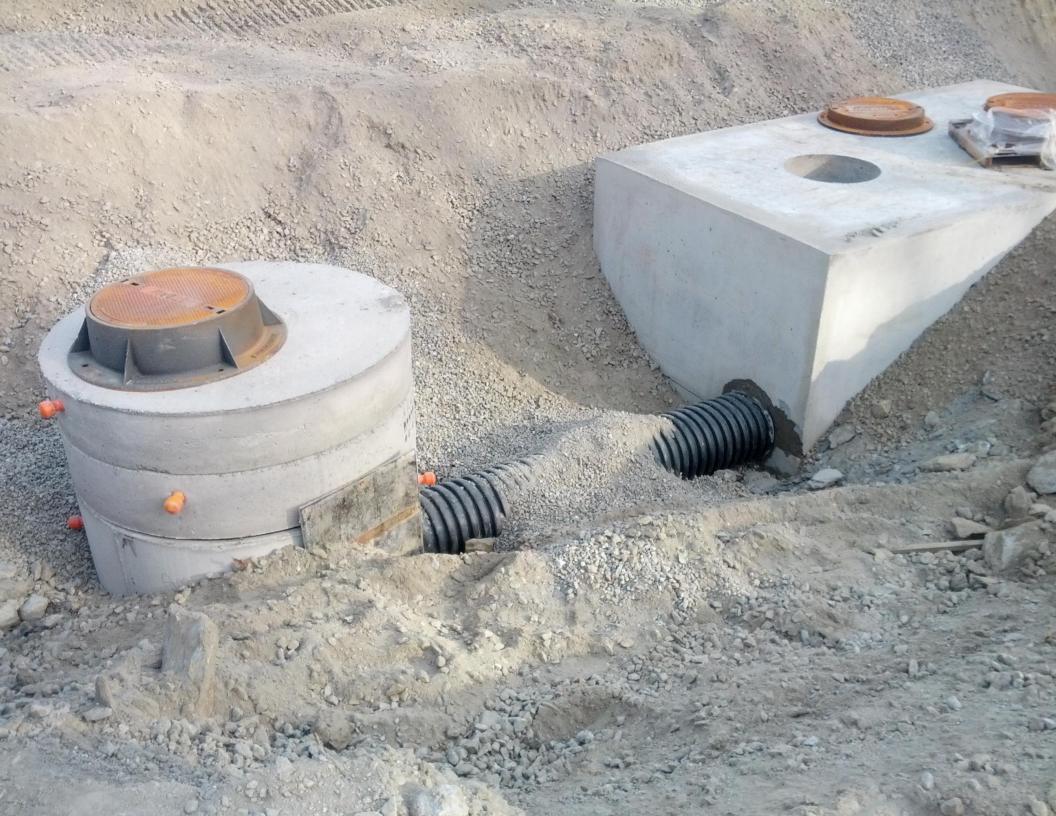
Vortechs Model 4000 Sediment Separation unit set and piped from STMH 39. RCP from STMH 38 not fully installed to Vortechs. Vortechs partially backfilled.
