# WEEKLY EROSION CONTROL INSPECTION

PROJECT:	Avalon Bay Stratford, CT	DATE:	December 13, 2013
CONTRACTOR:	AMEC	PROJECT NO.:	86 16038
PREPARED BY:	Ken Kohlbrenner, PE	REPORT NO.:	19
SIGNATURE:		PERMIT NO.:	IWWA #2001-9(M)

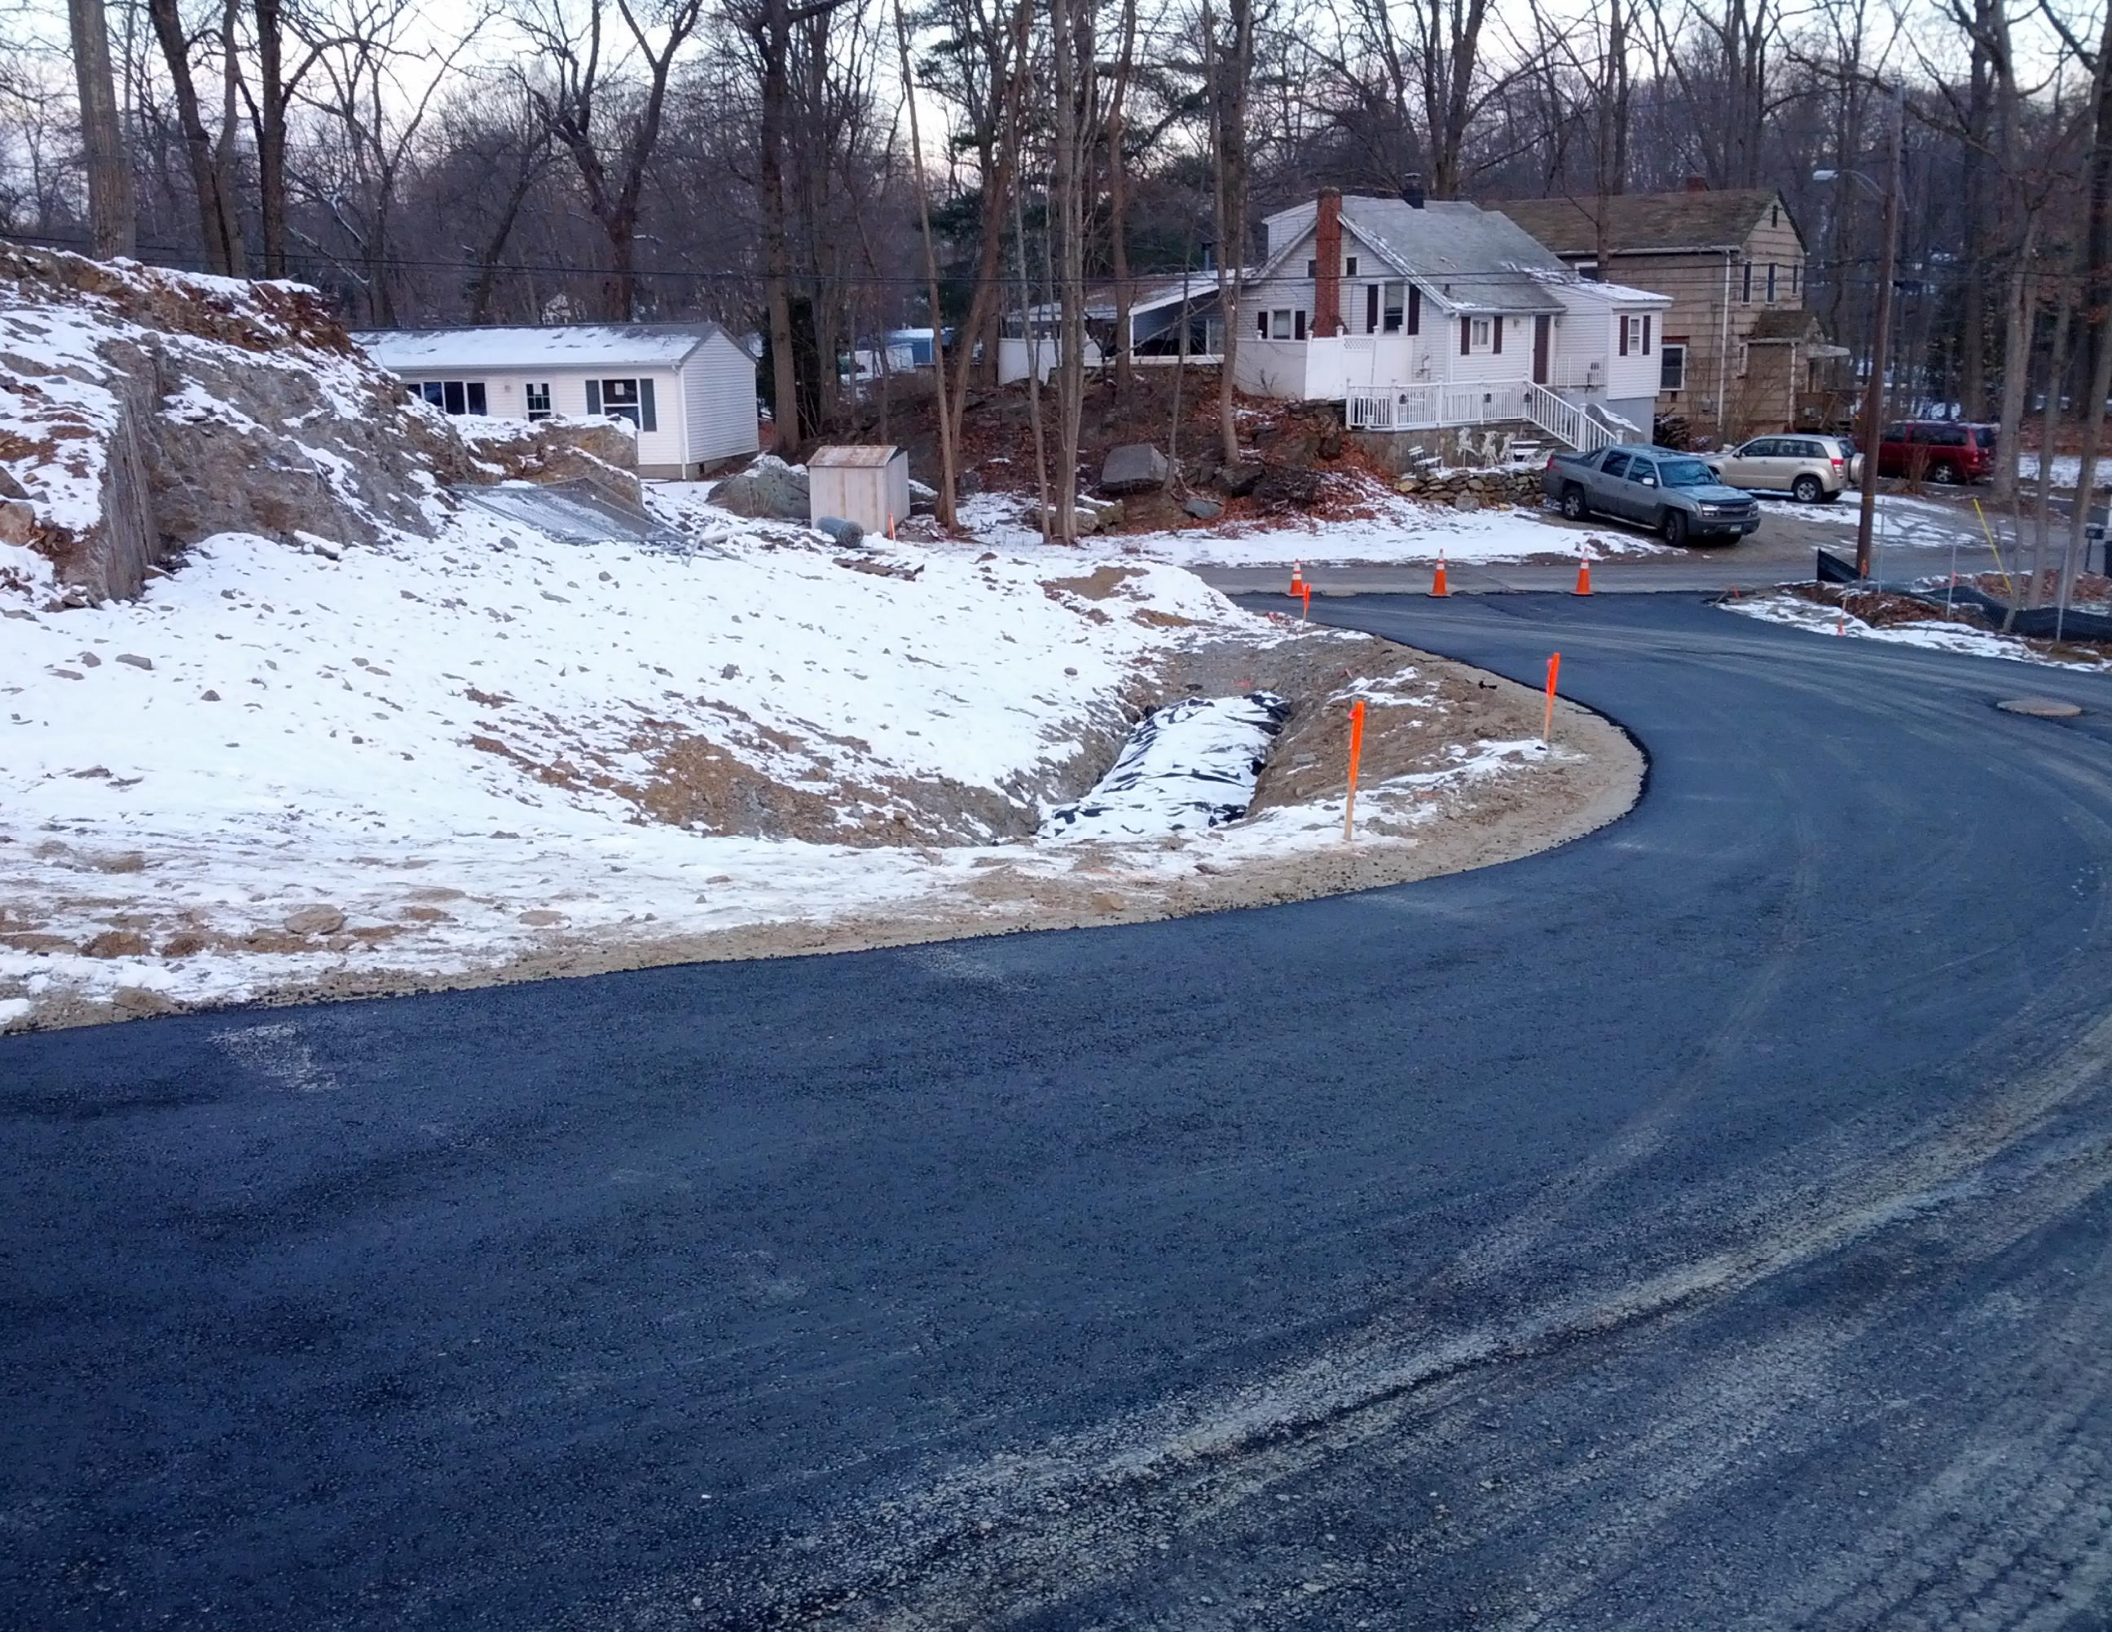
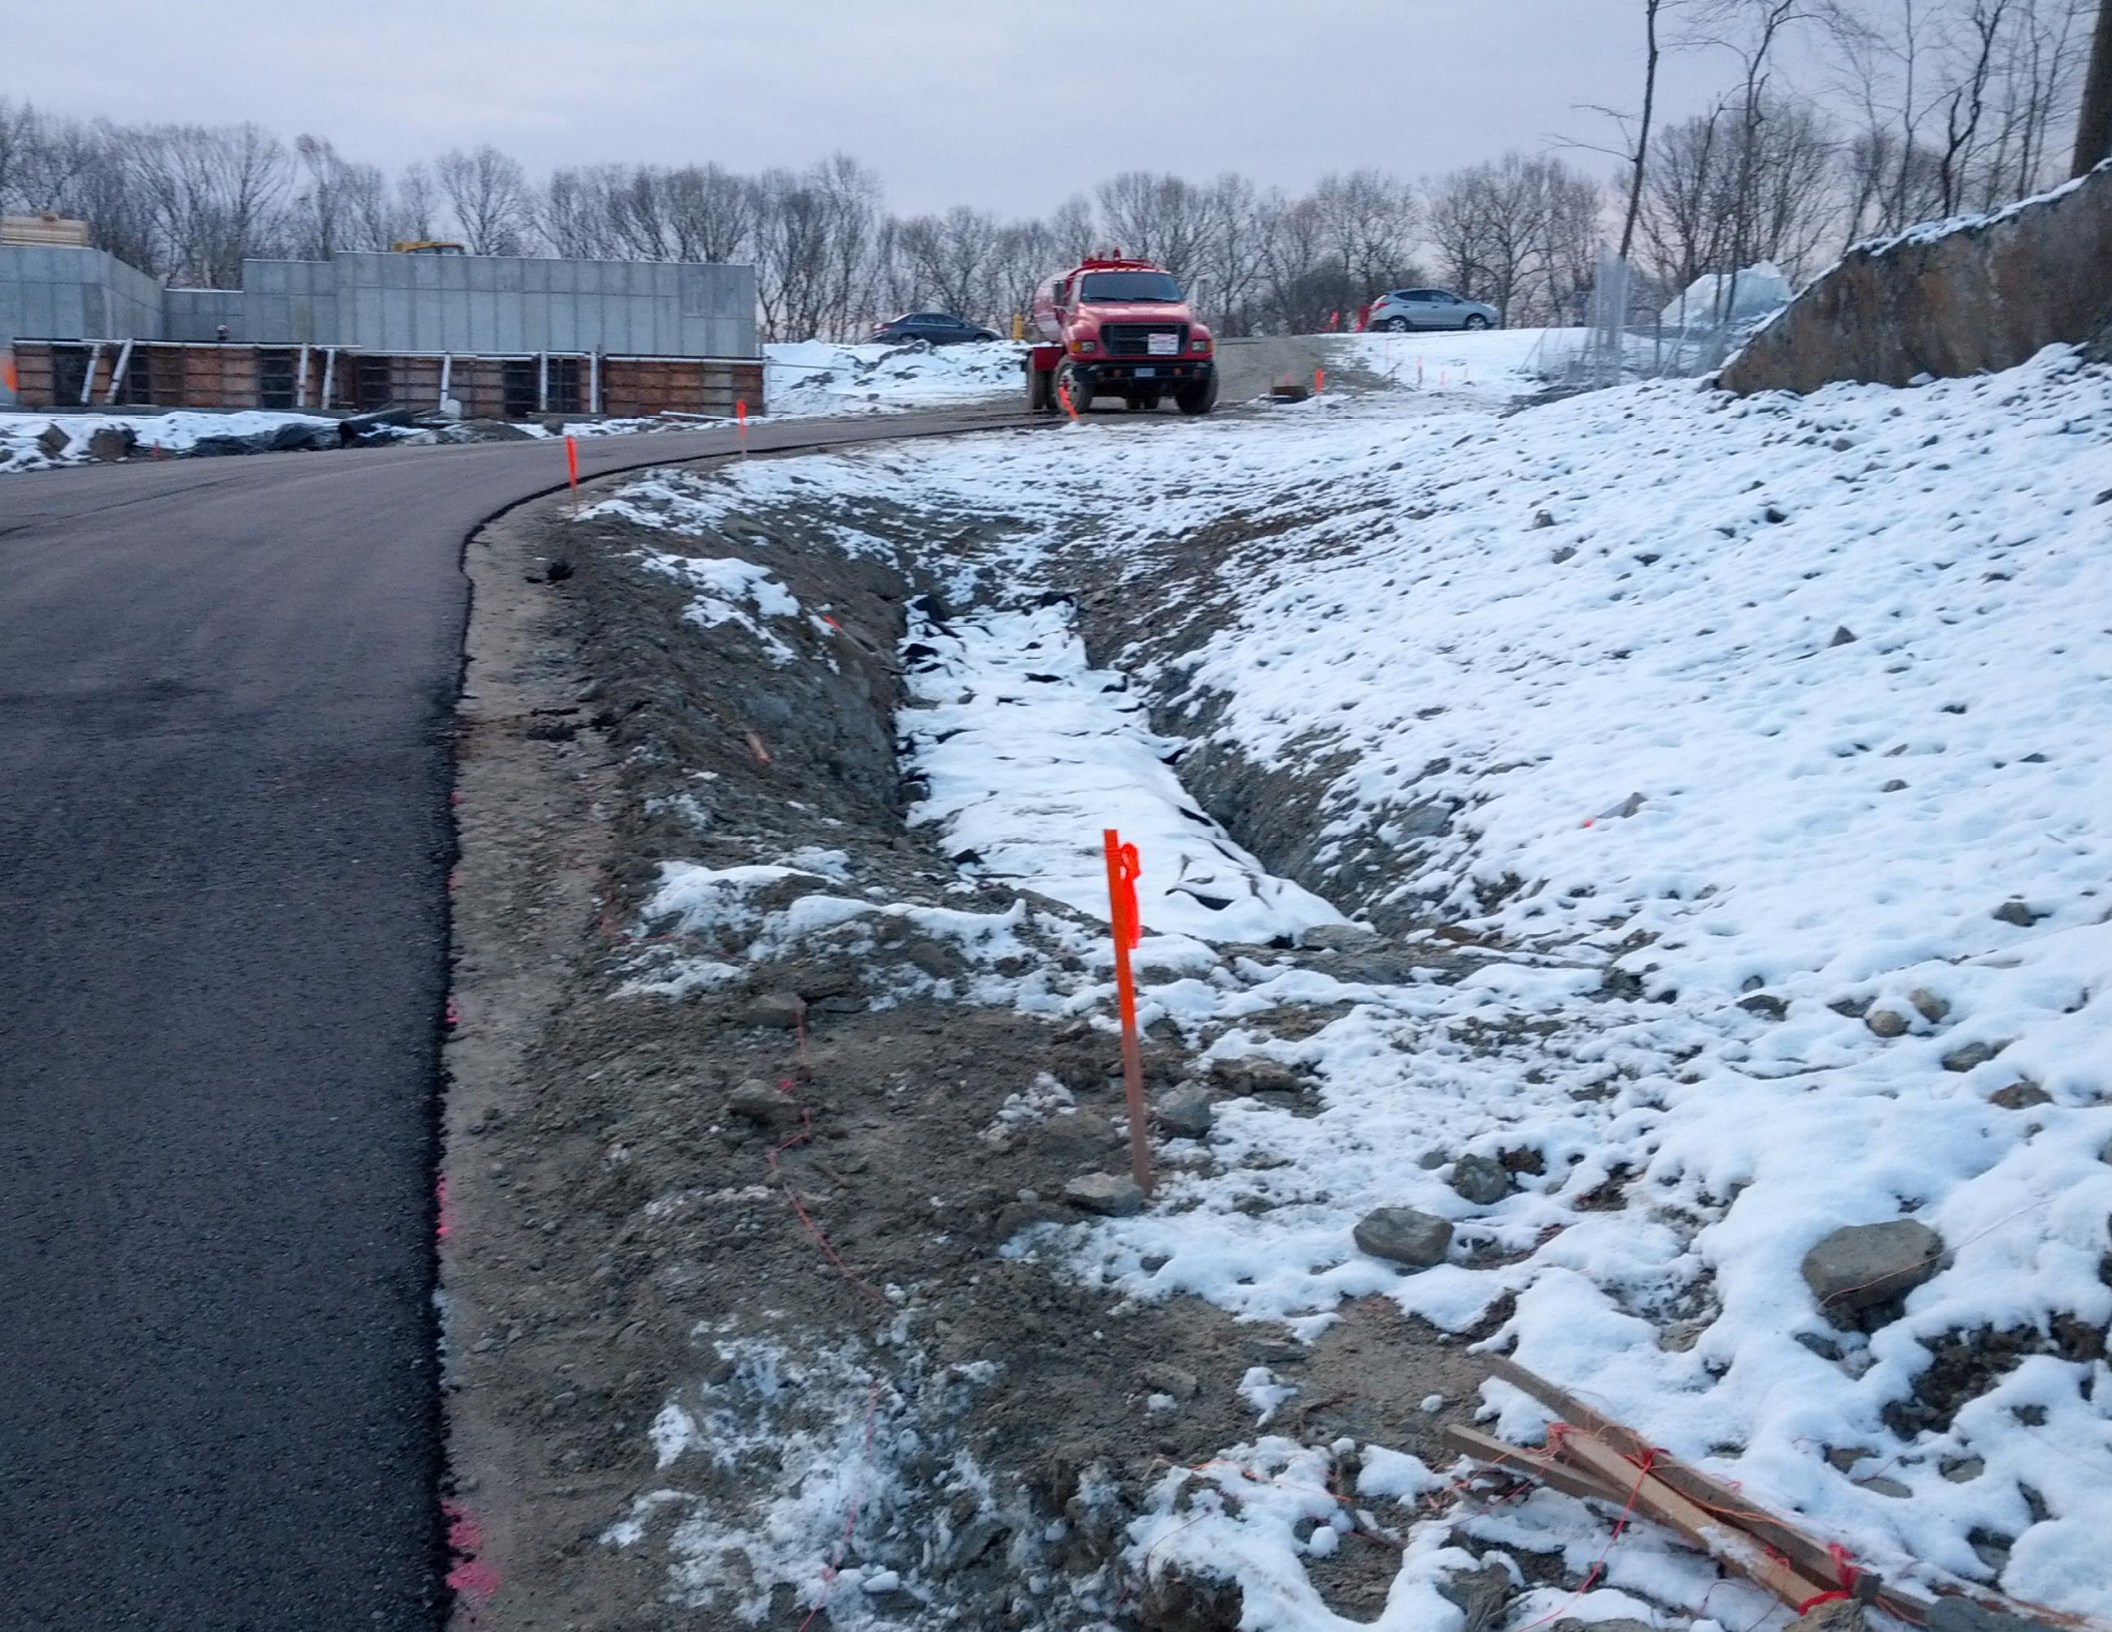
Comment: Minor erosion channels in detention basin

Photos of rough graded rain garden/detention basin near Circle Drive.
