WEEKLY EROSION CONTROL INSPECTION

PROJECT:	Avalon Bay Stratford, CT	DATE:	March 31, 2014
CONTRACTOR:	AMEC	PROJECT NO.:	86 16038
PREPARED BY:	Ken Kohlbrenner, PE	REPORT NO.:	27
SIGNATURE:		PERMIT NO.:	IWWA #2001-9(M)

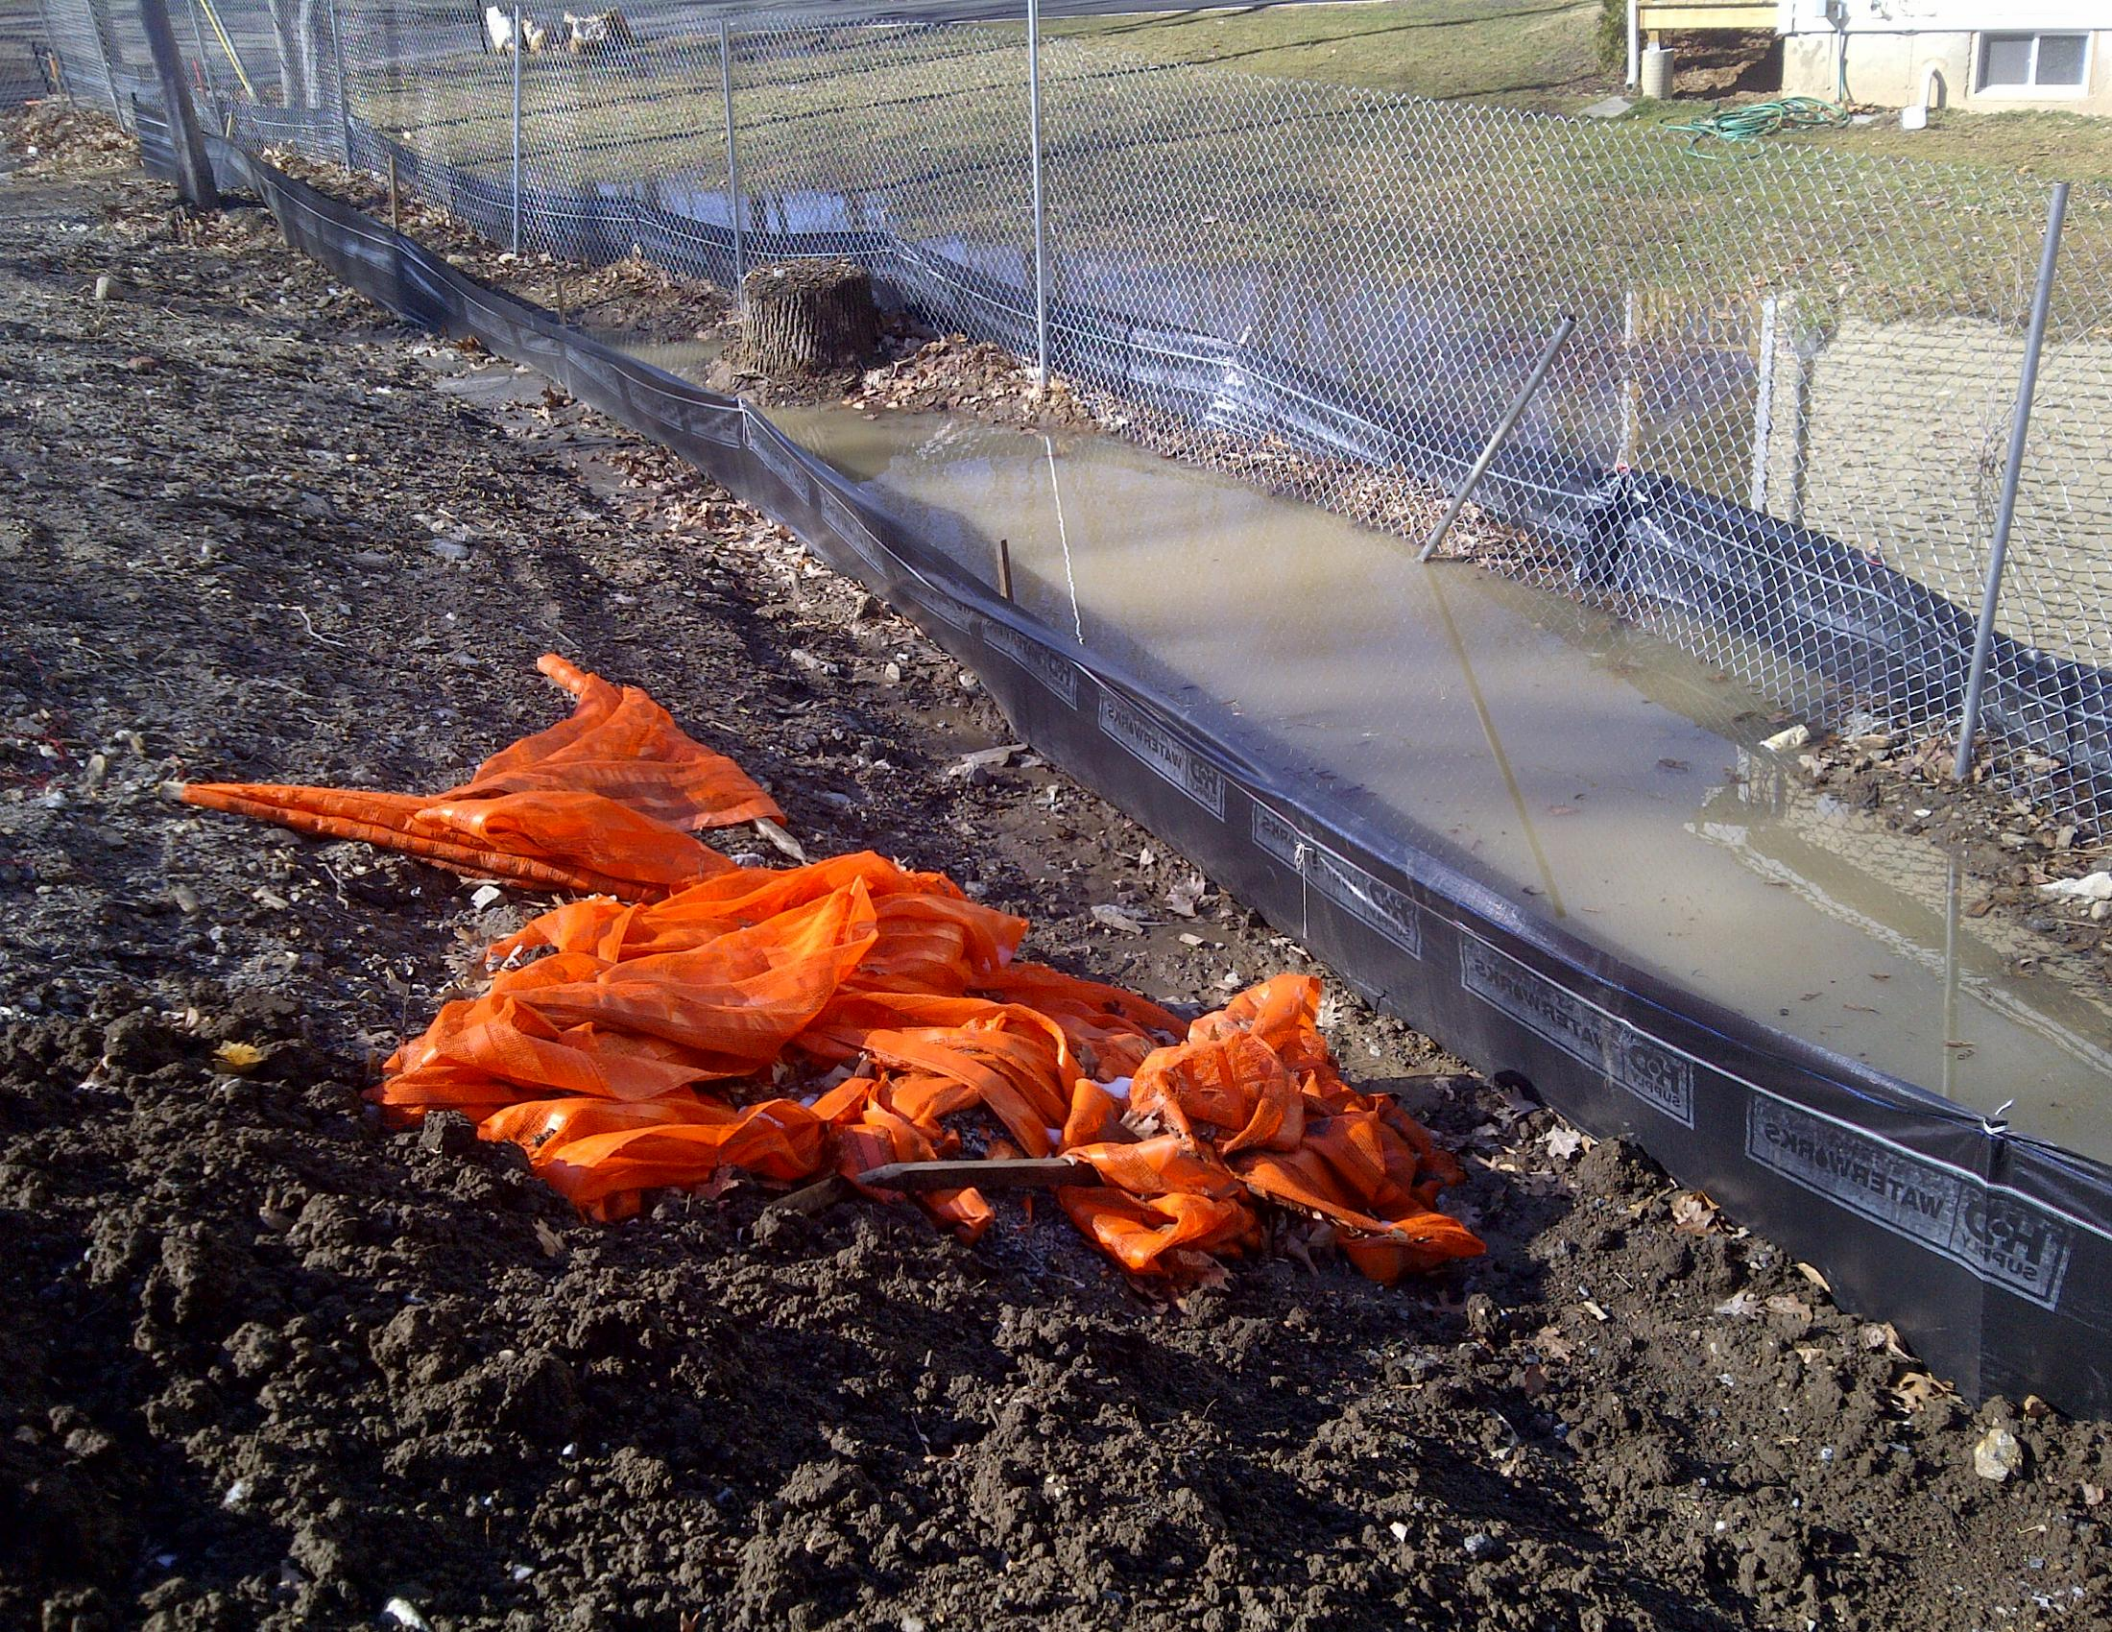
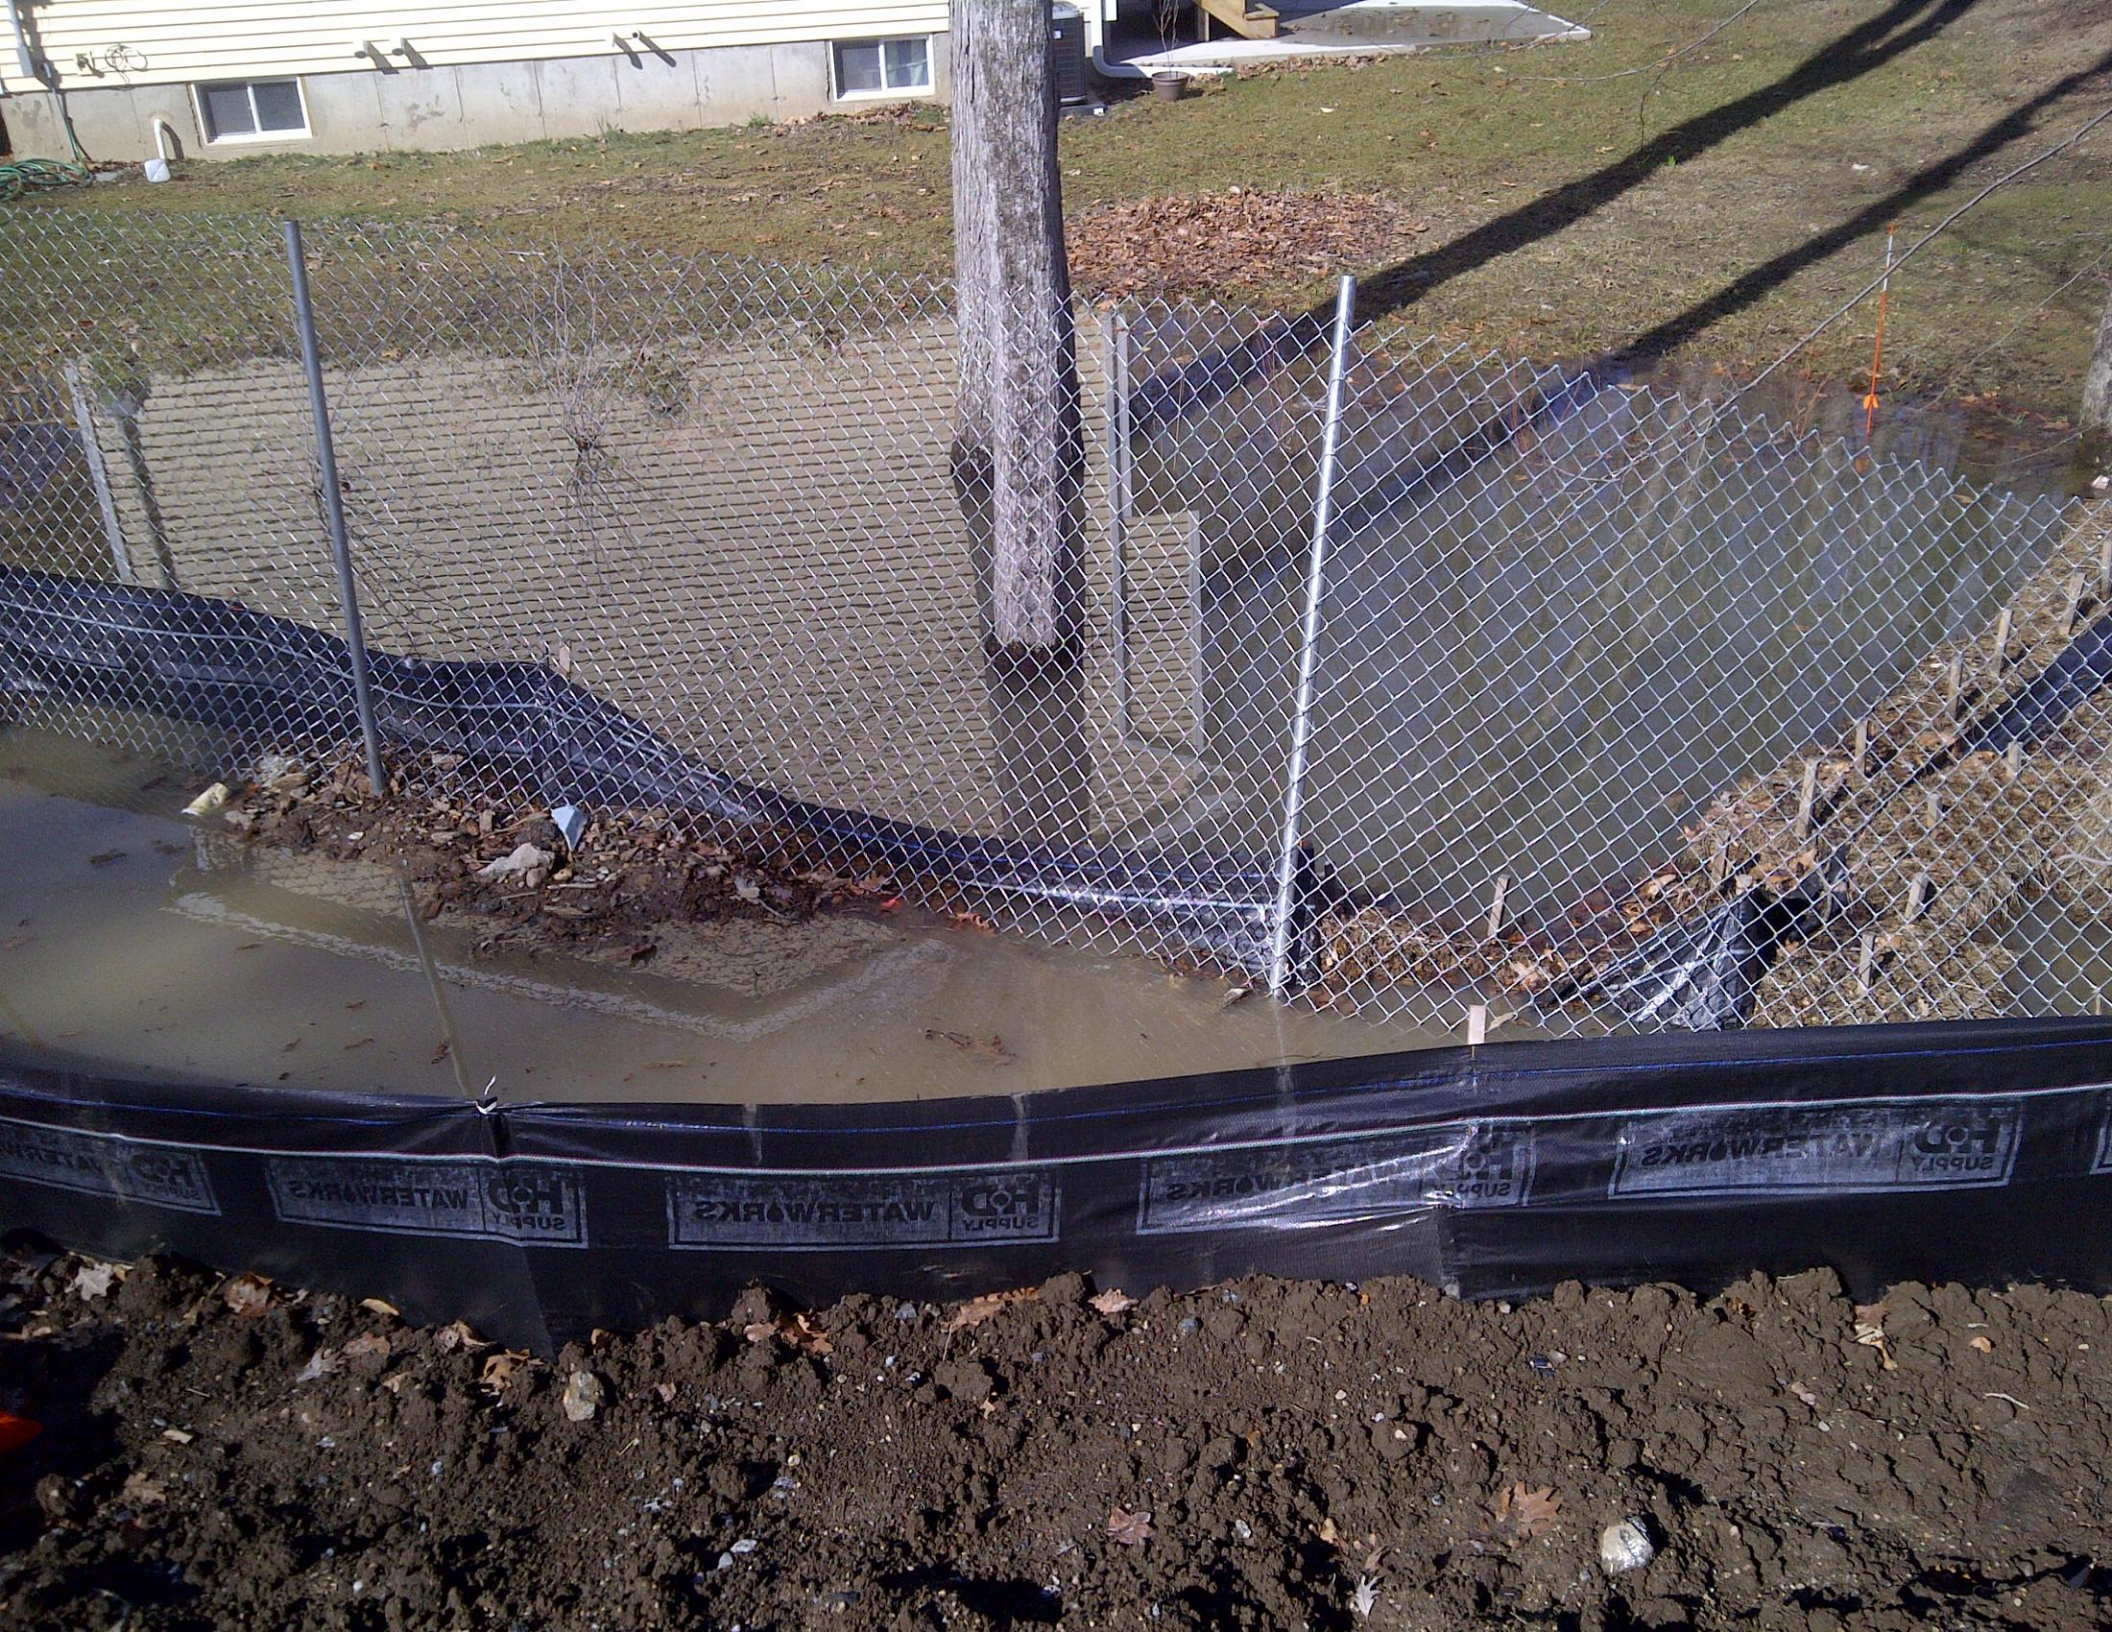
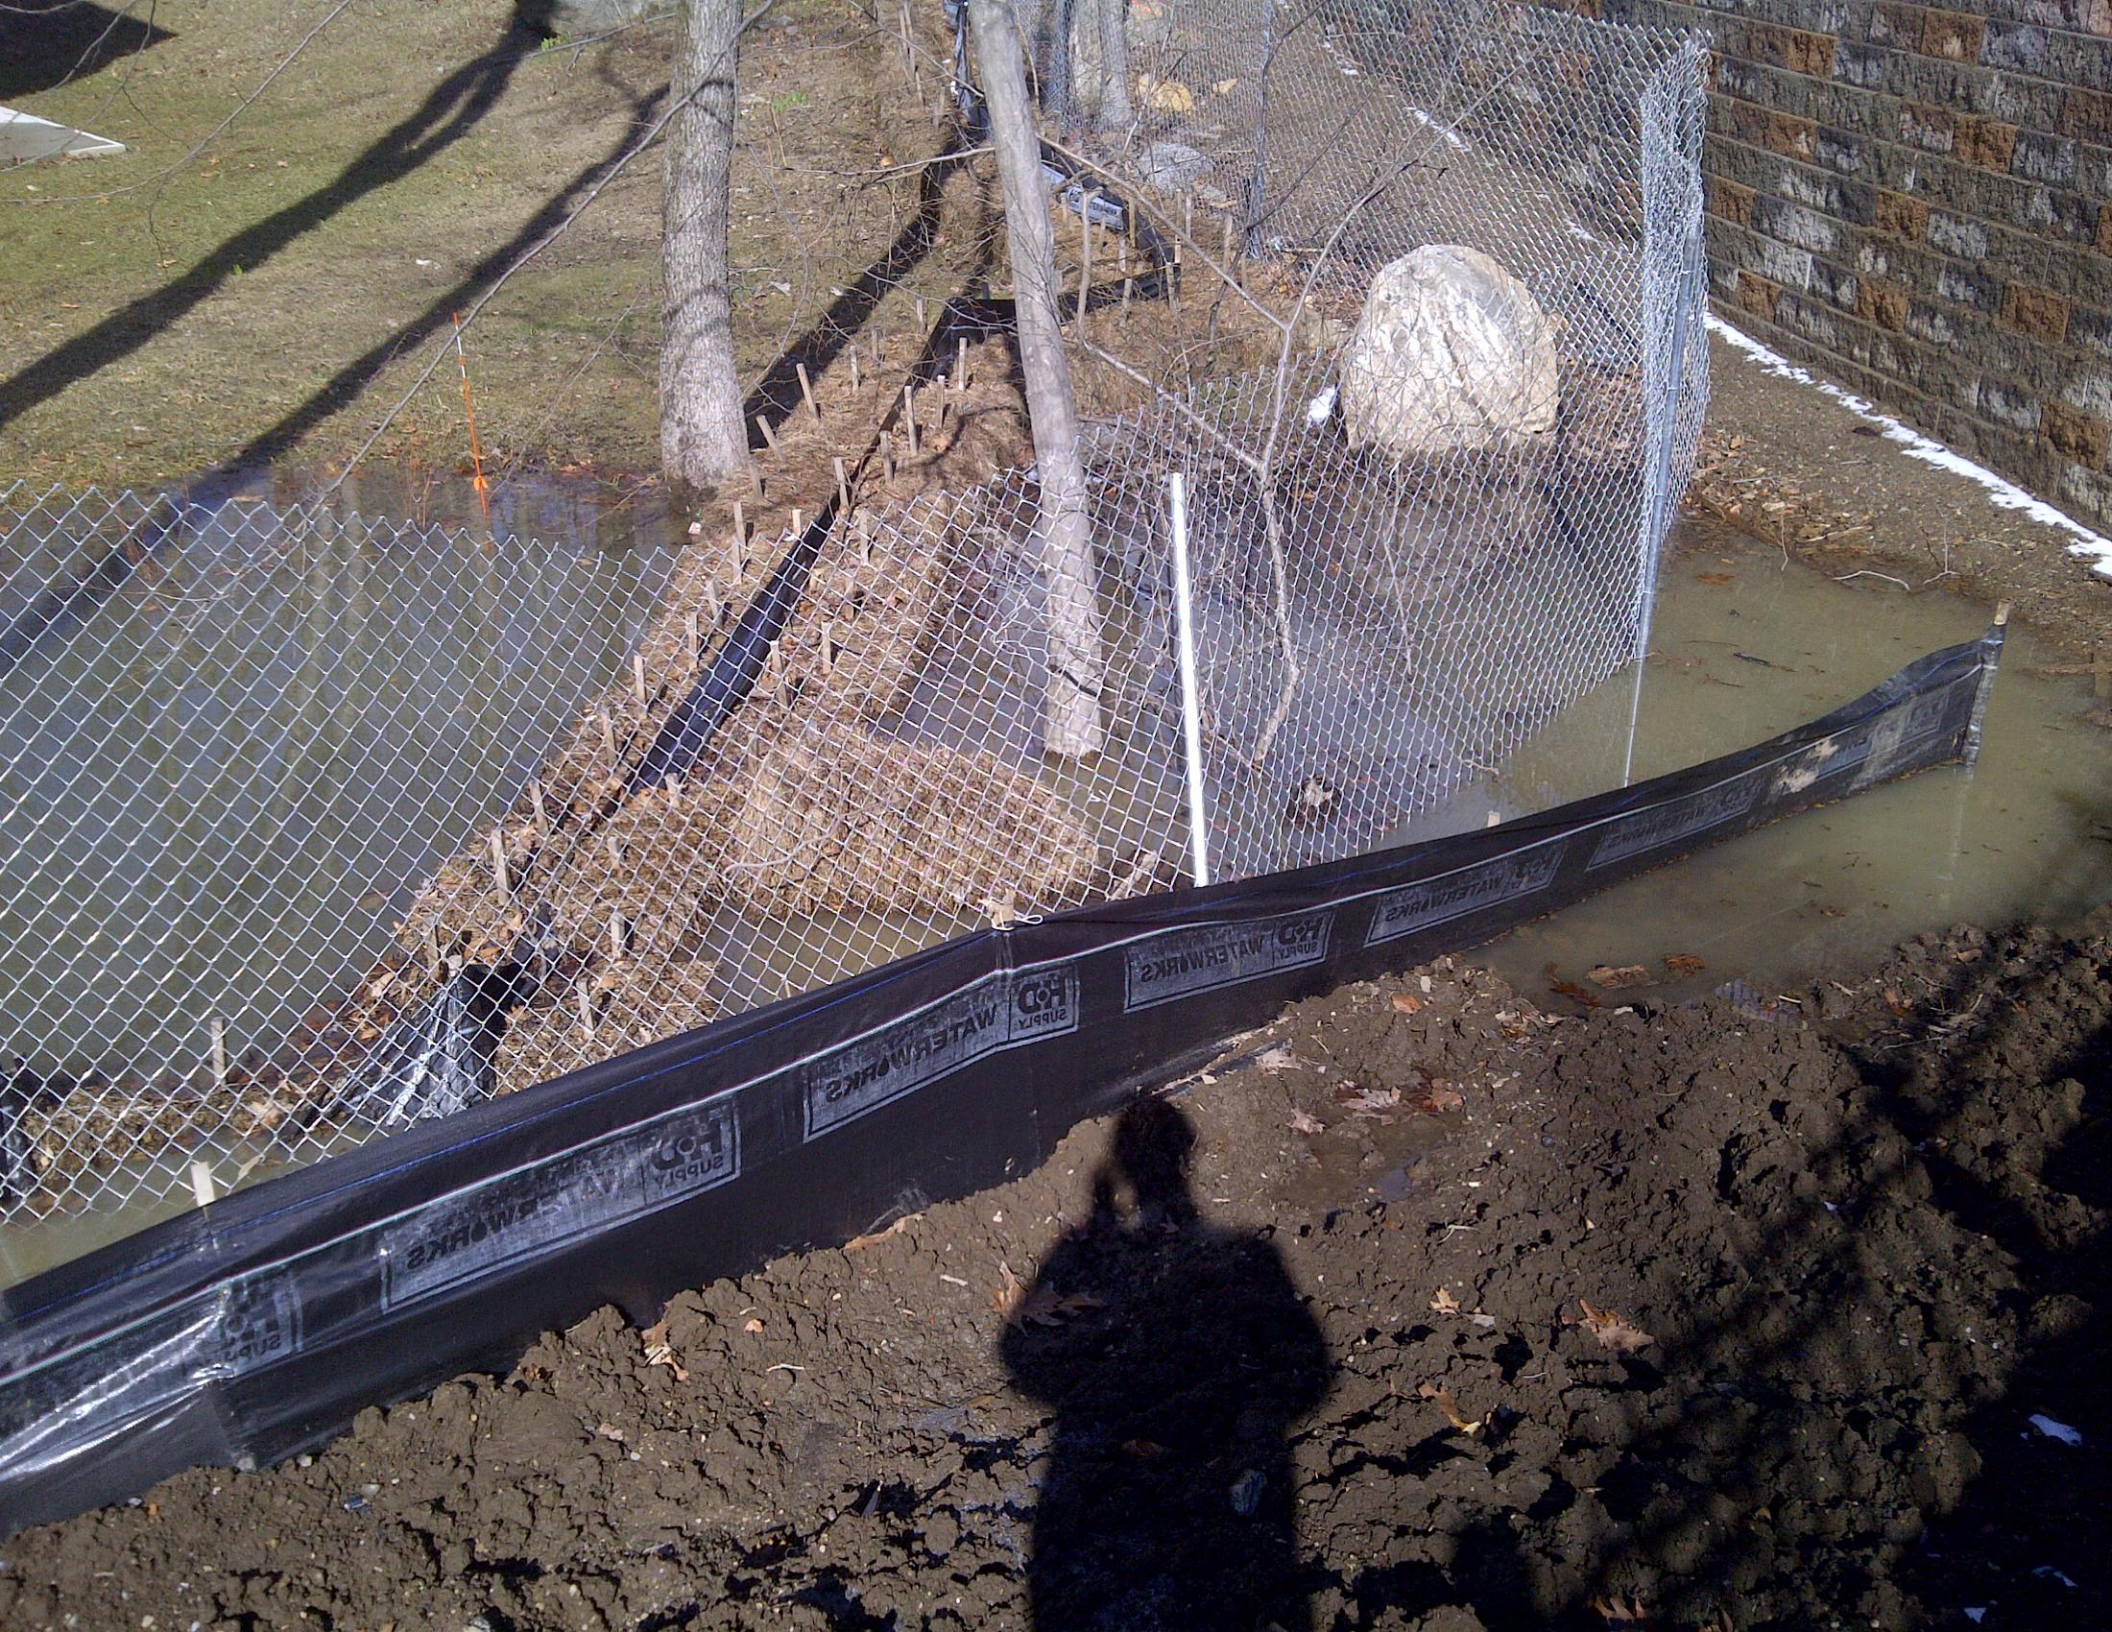
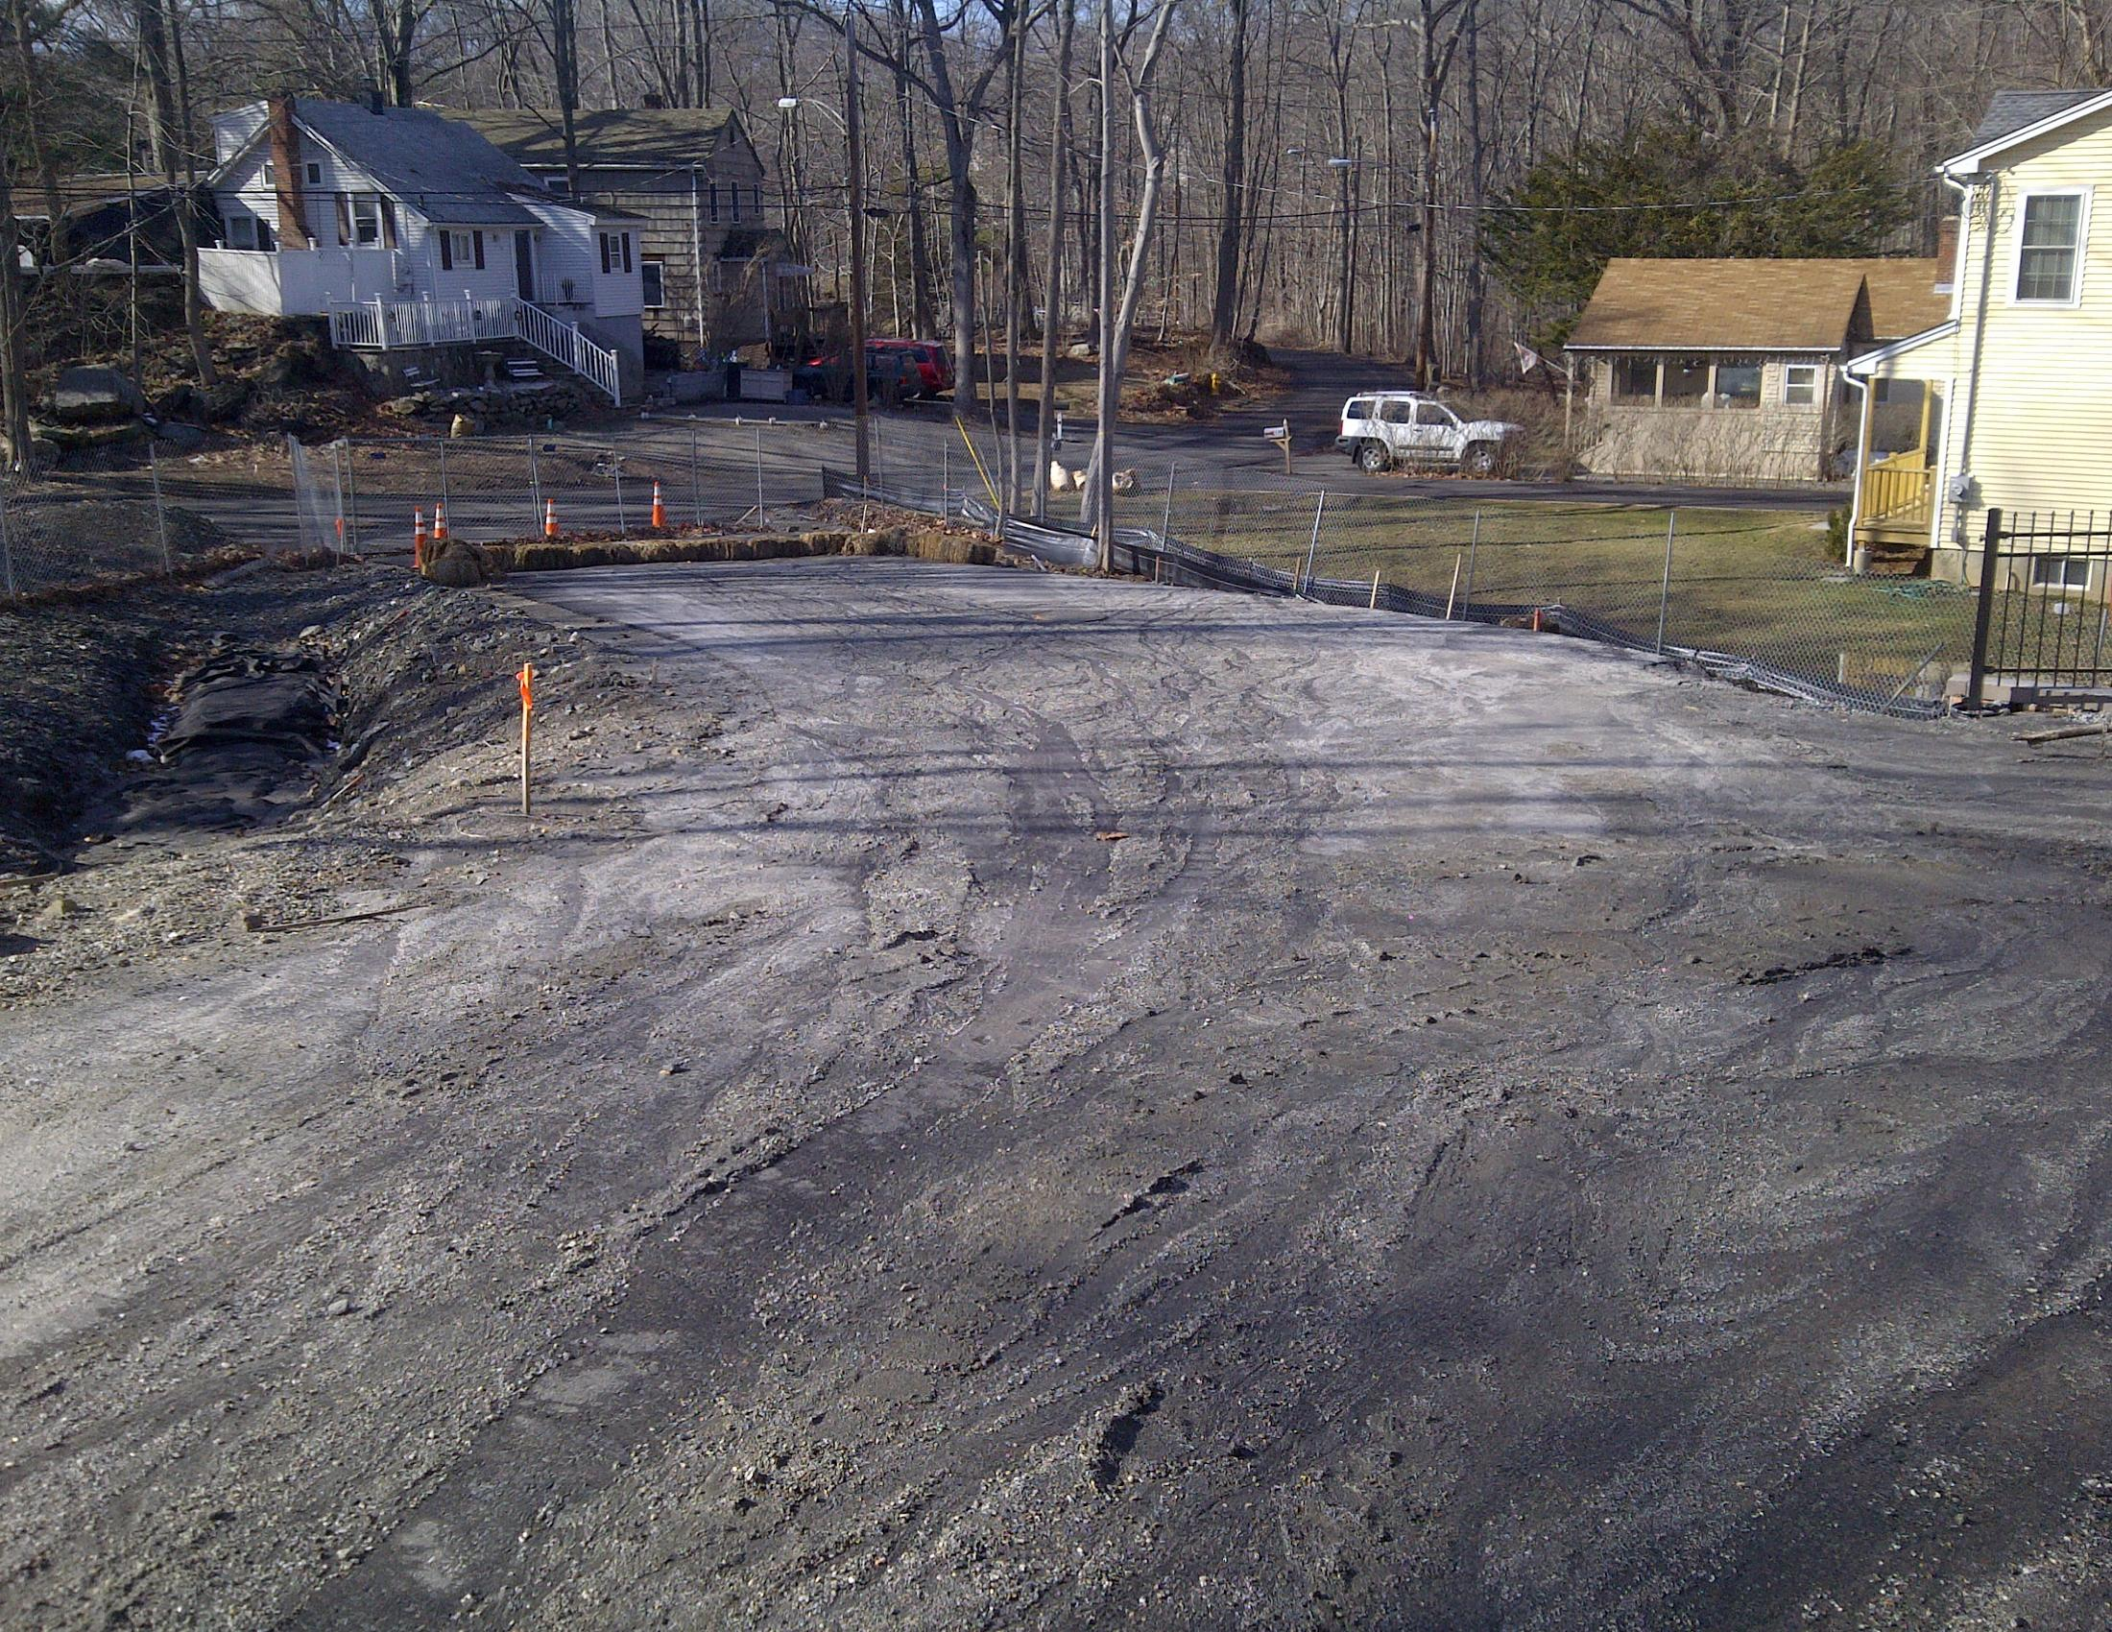
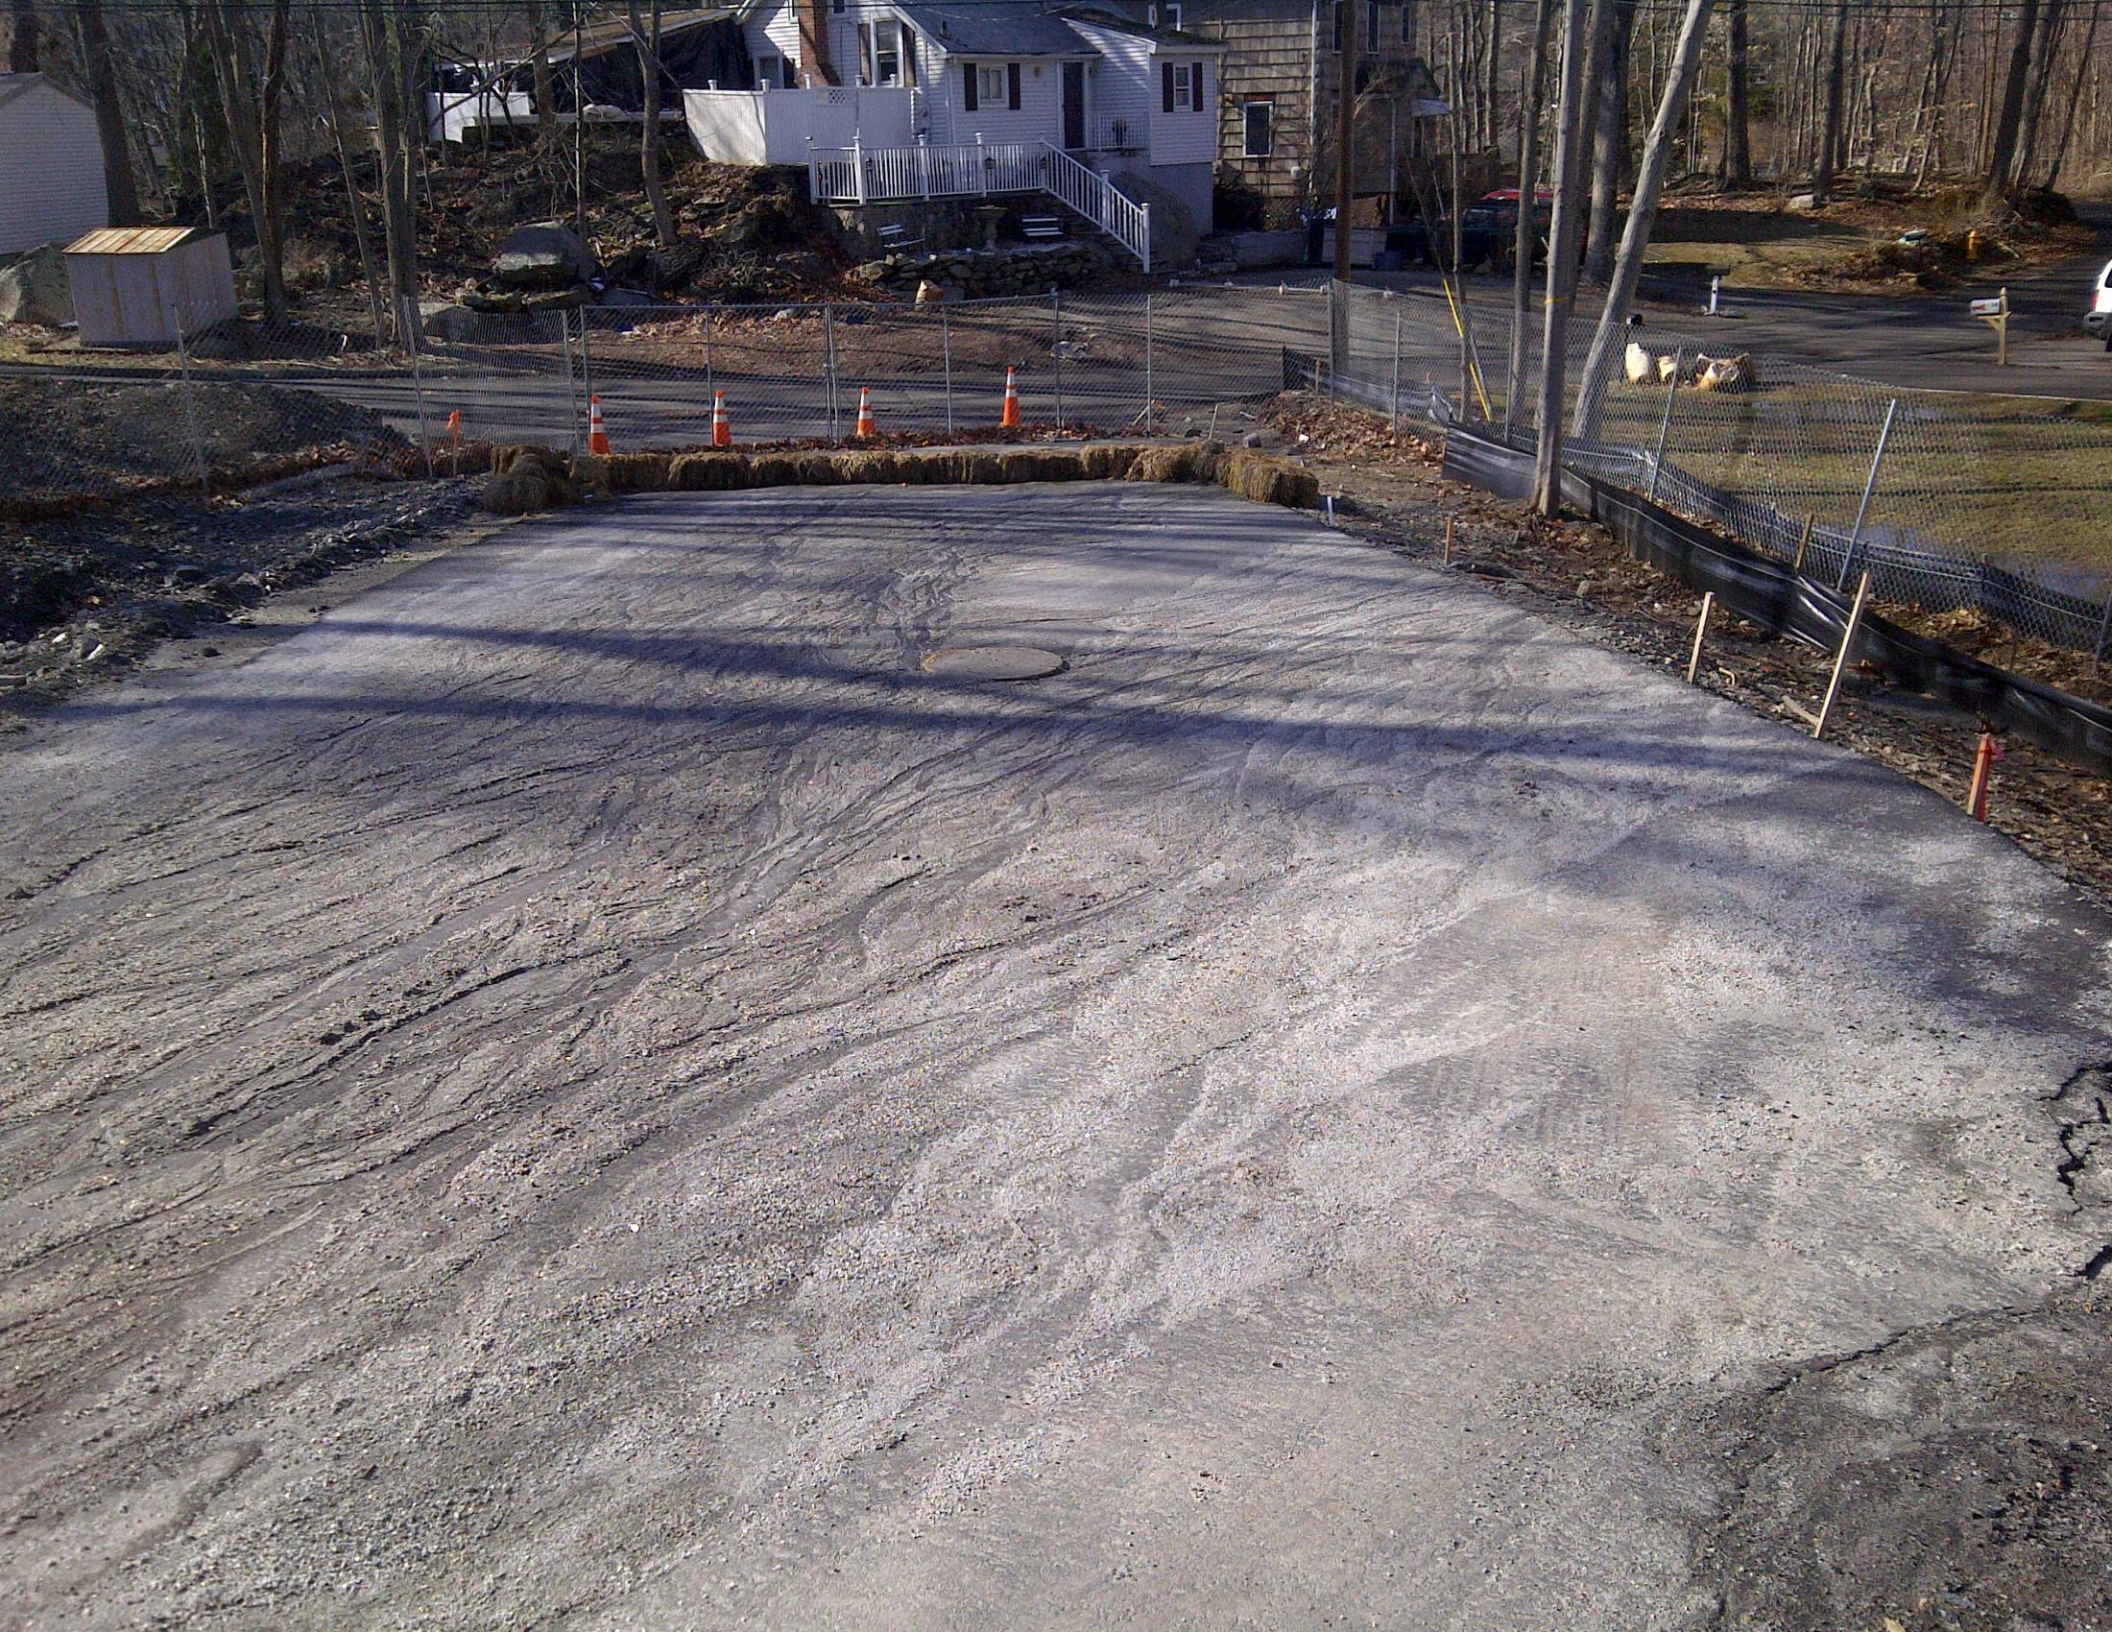
Construction entrance needs new stone. Some sediment passed silt fence along southern property line. Ponding near 152 Circle Drive.

See attached photos of ponding and runoff near 152 Circle Drive (photos 1 through 6) and breached silt fence along southern property line (photos 7 through 11).
