WEEKLY EROSION CONTROL INSPECTION

PROJECT:	Avalon Bay Stratford, CT	DATE:	March 31, 2014
CONTRACTOR:	AMEC	PROJECT NO.:	86 16038
PREPARED BY:	Ken Kohlbrenner, PE	REPORT NO.:	27
SIGNATURE:		PERMIT NO.:	IWWA #2001-9(M)

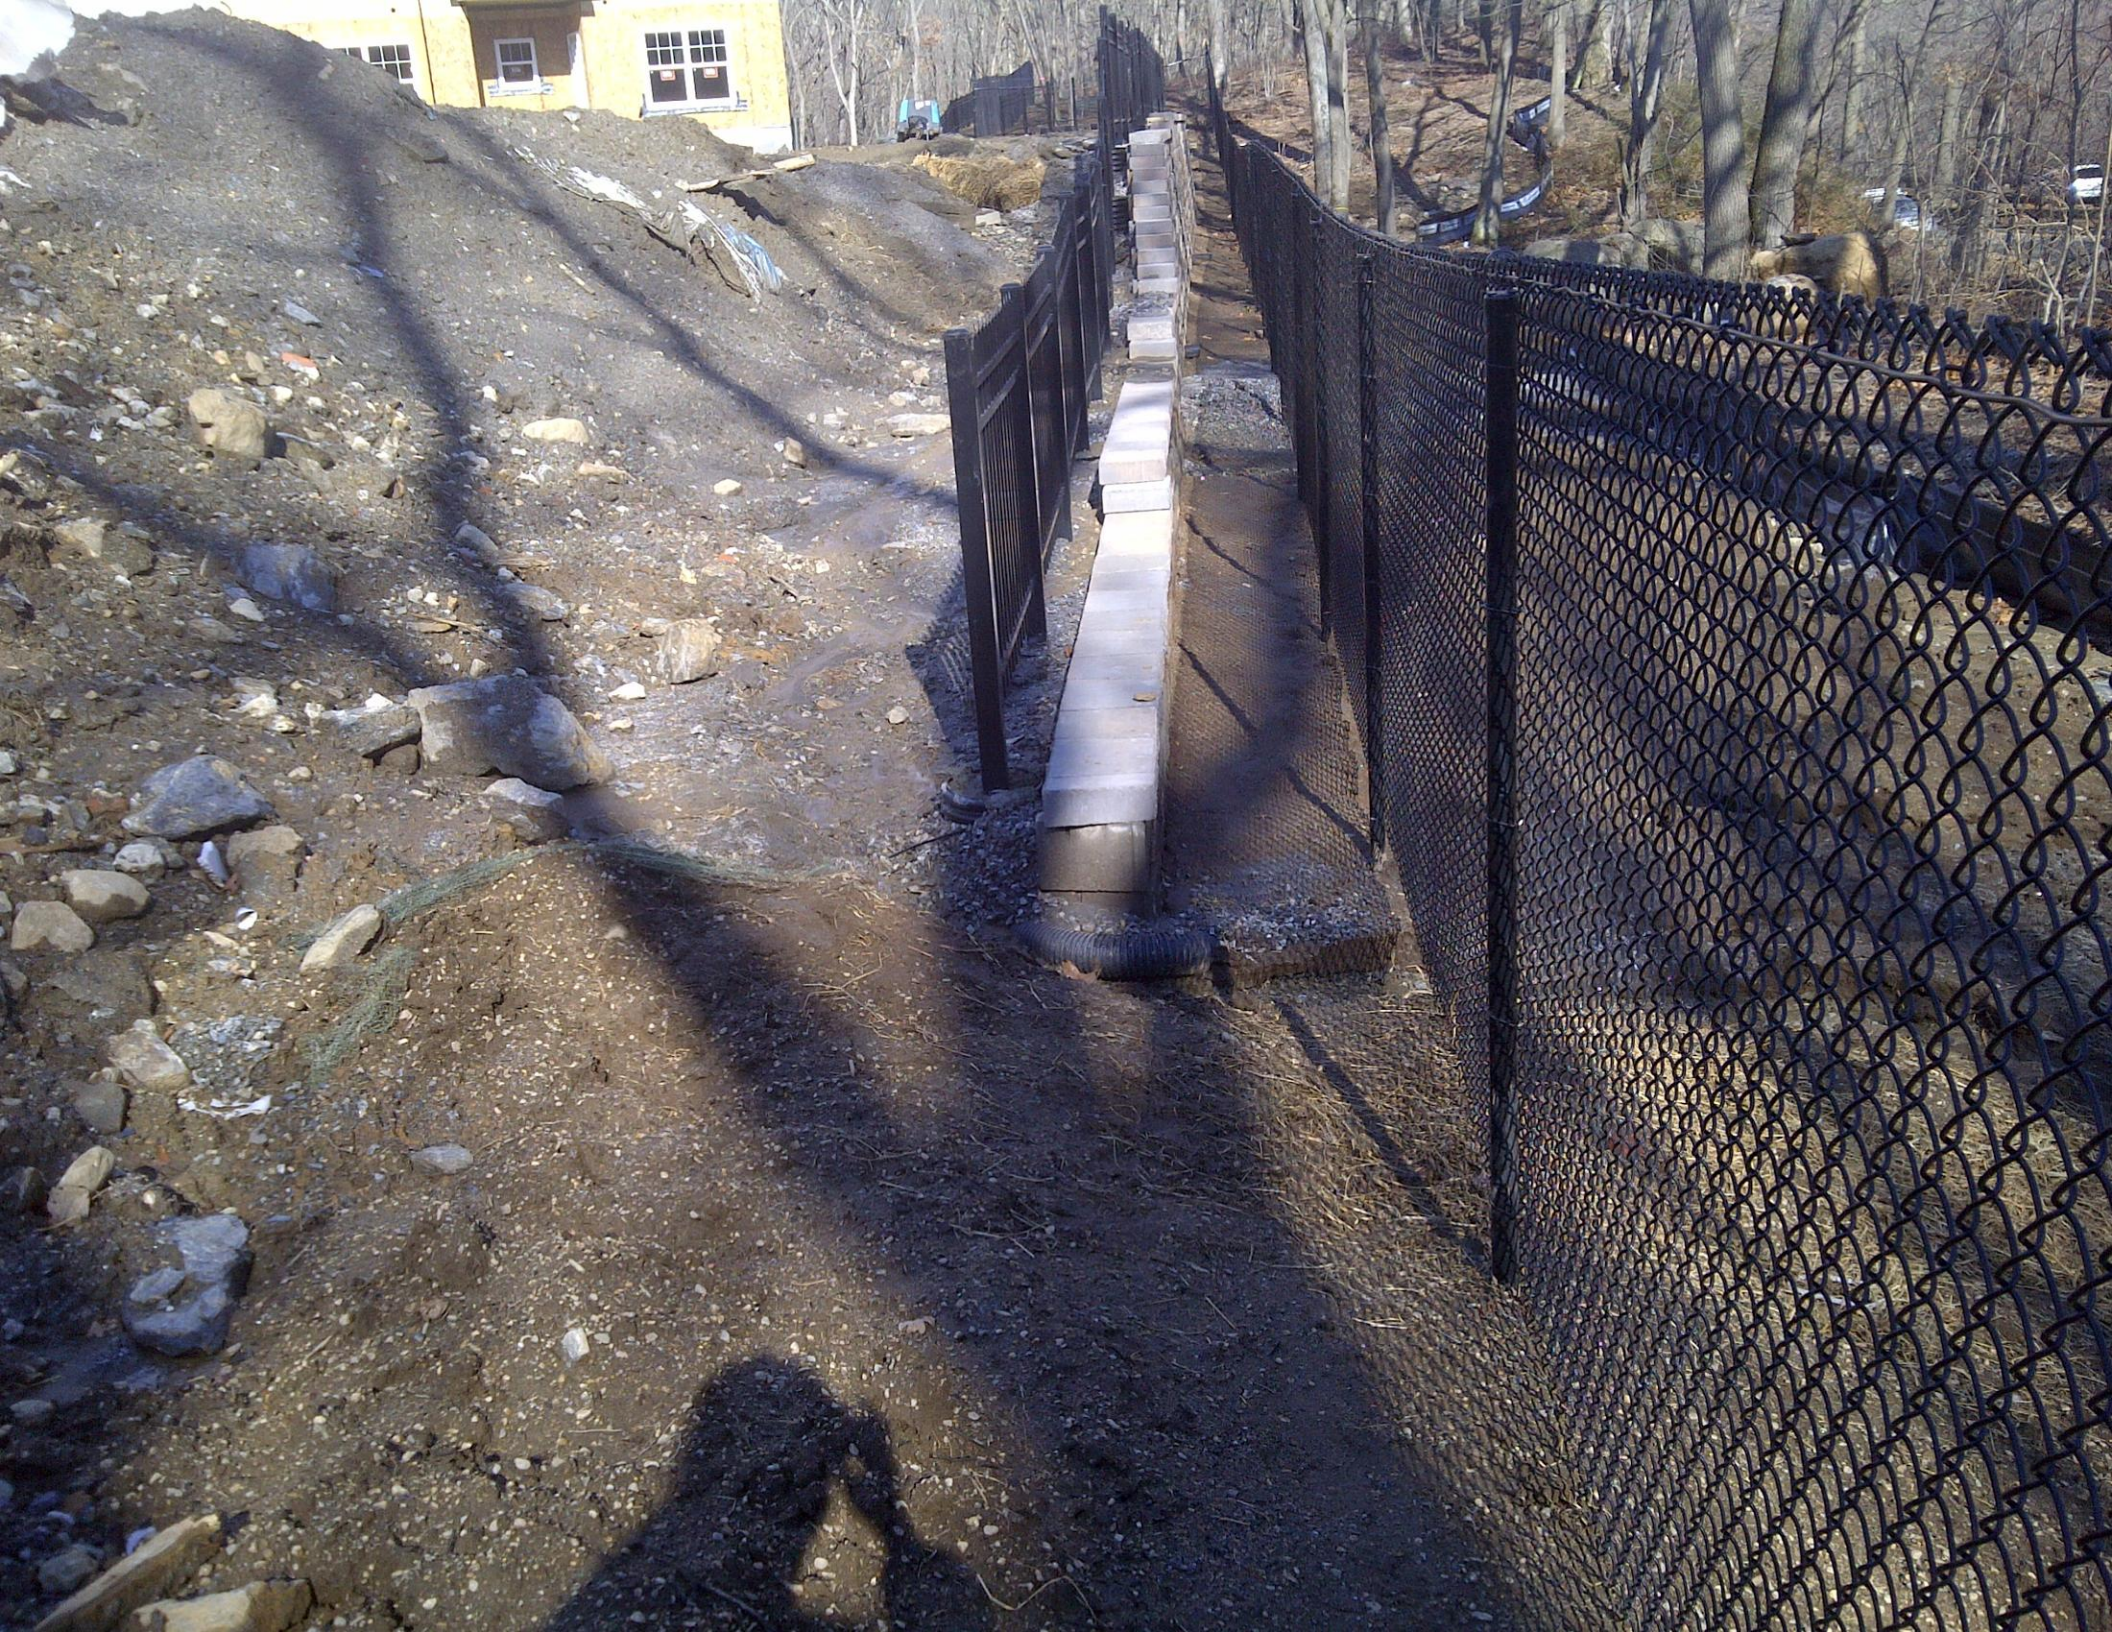
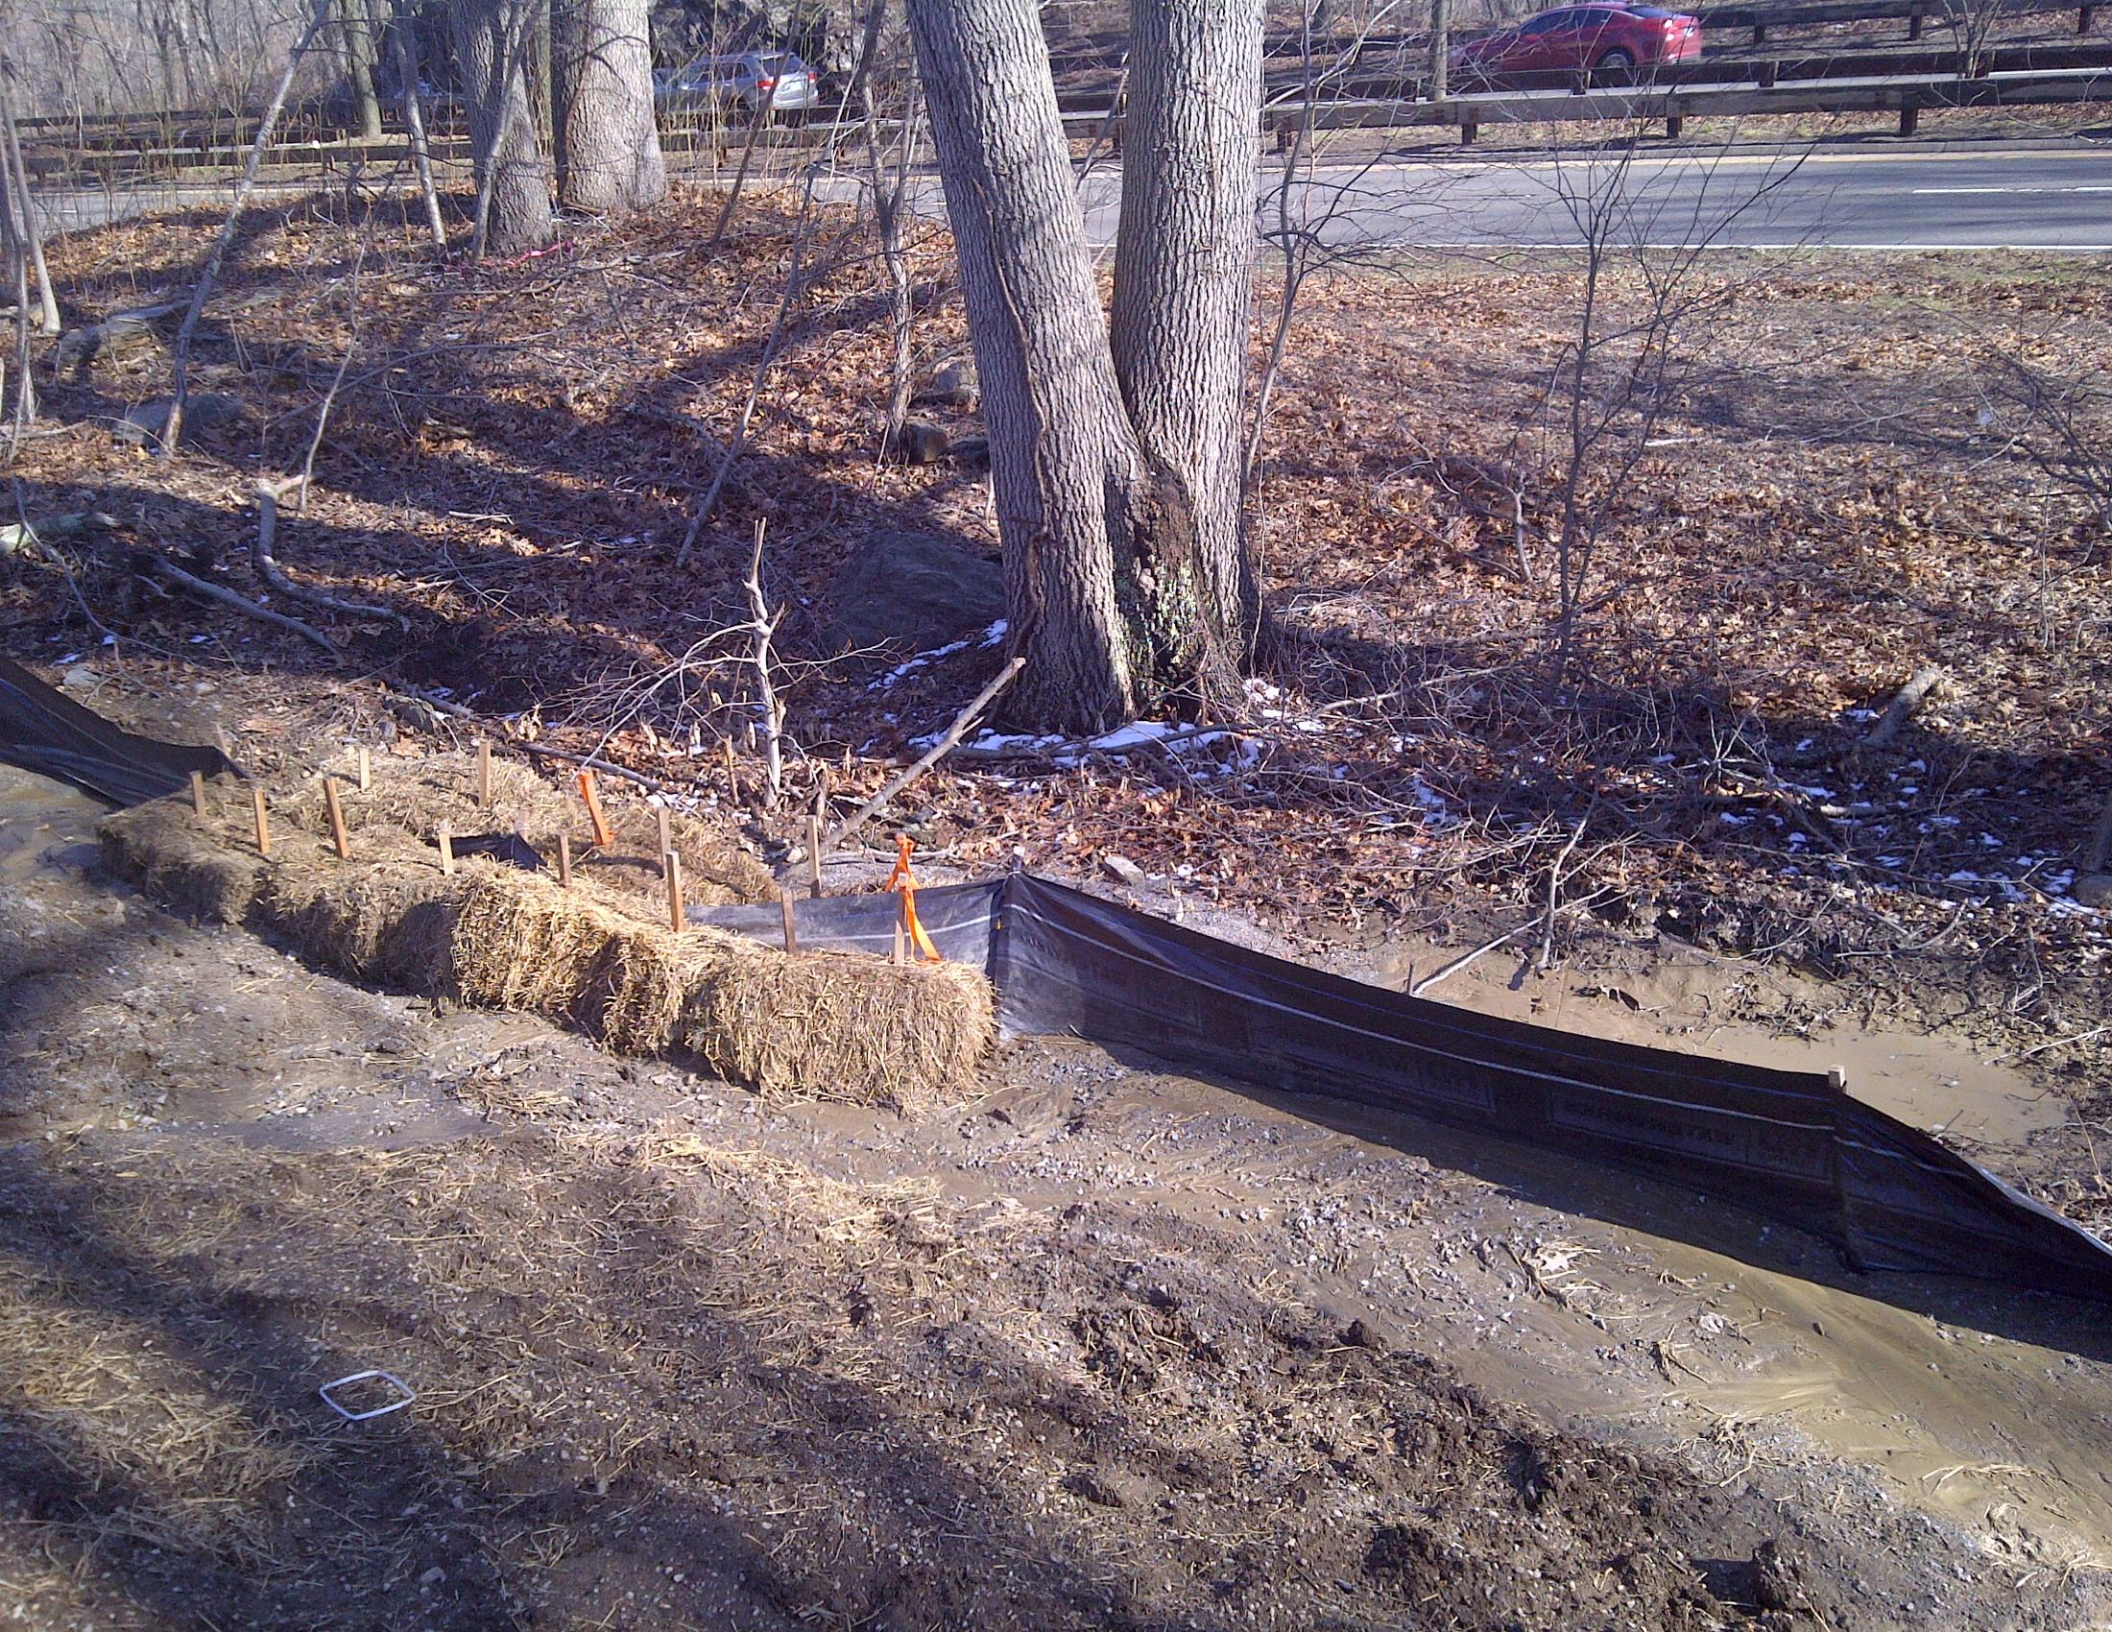
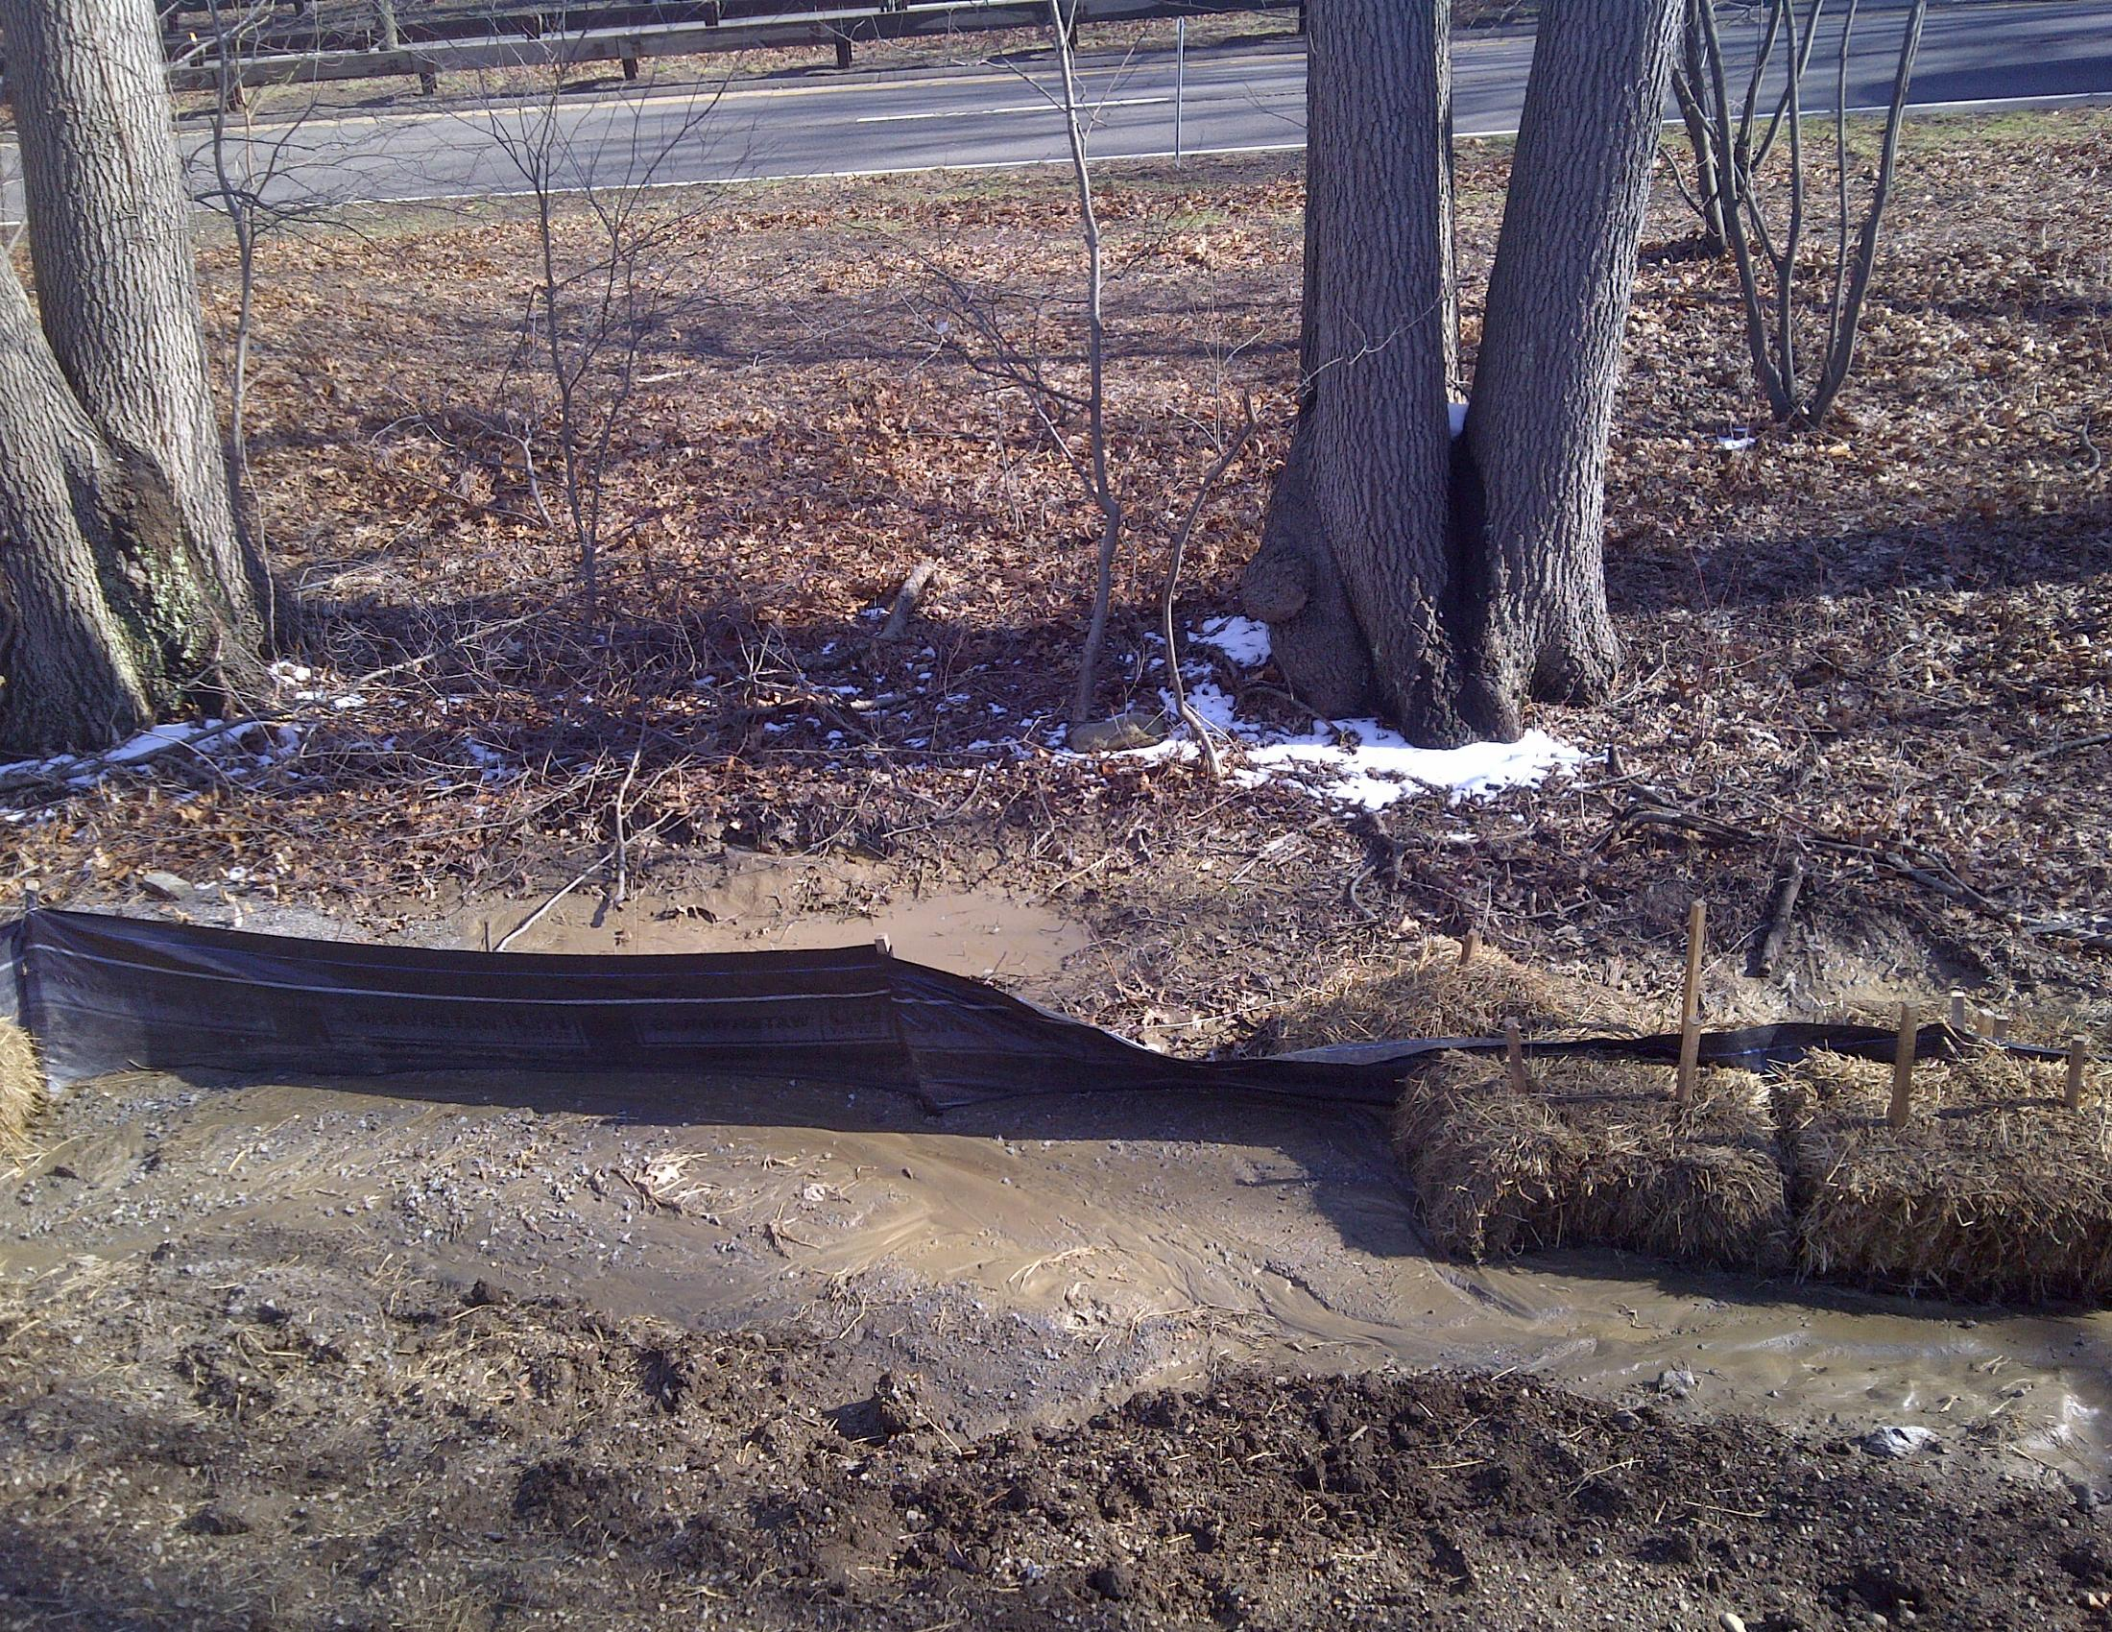
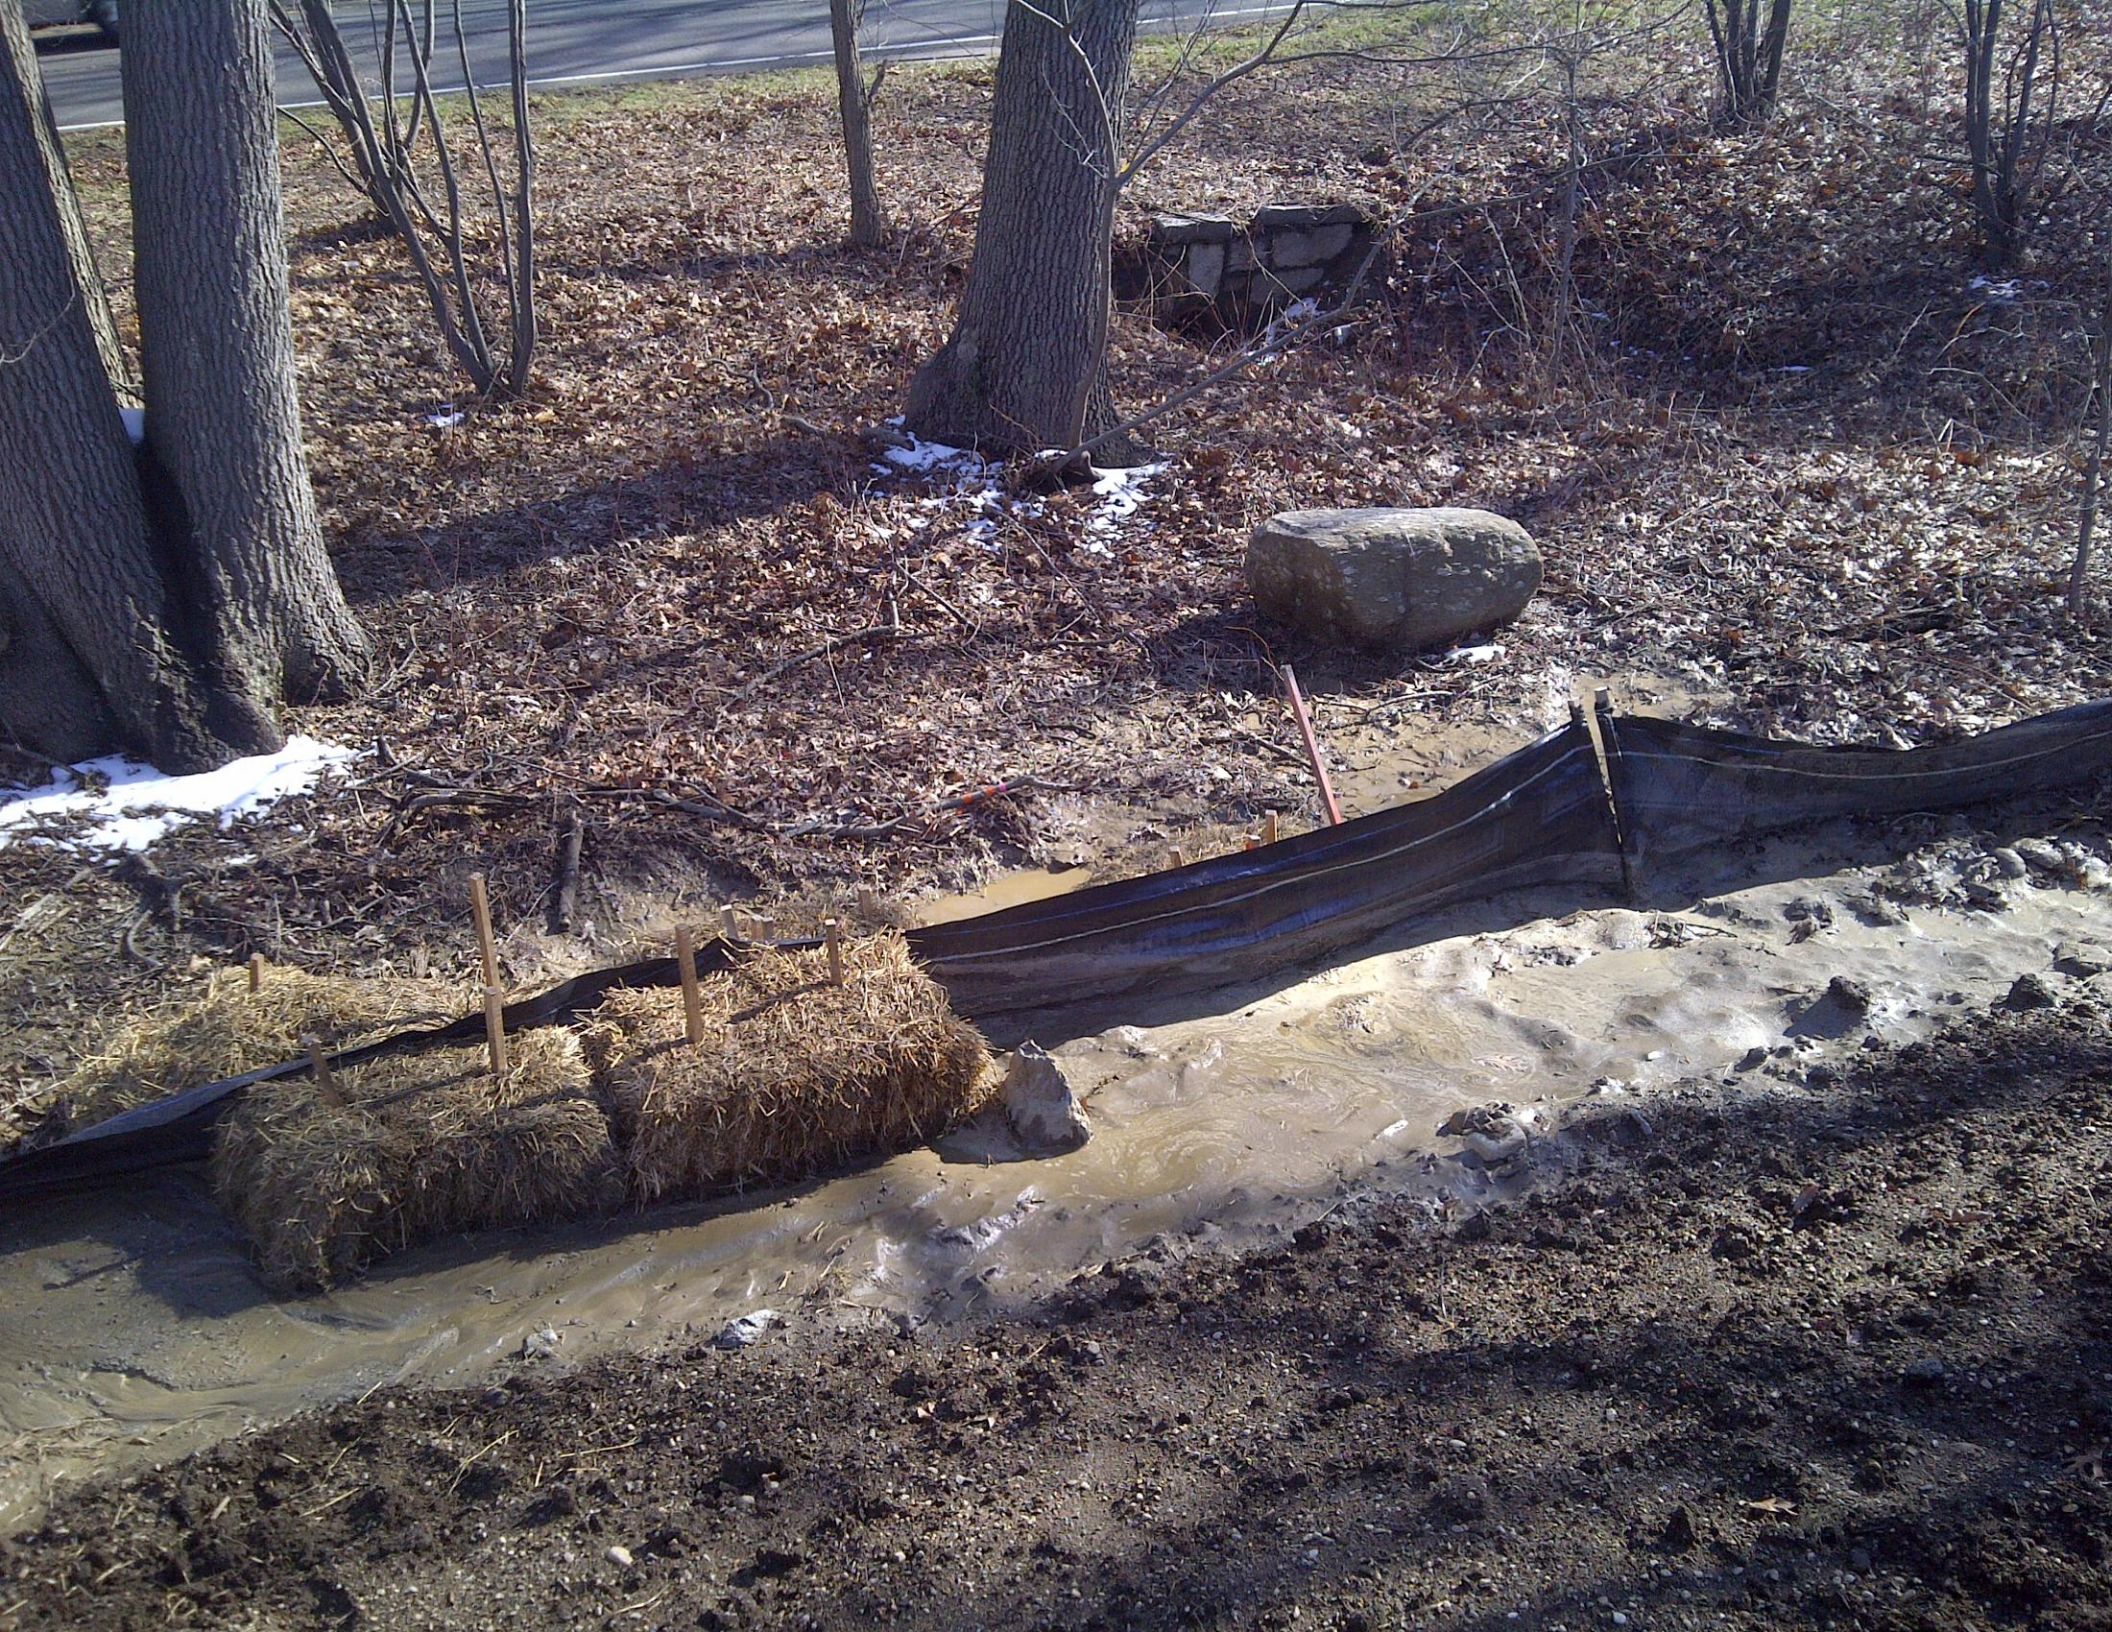
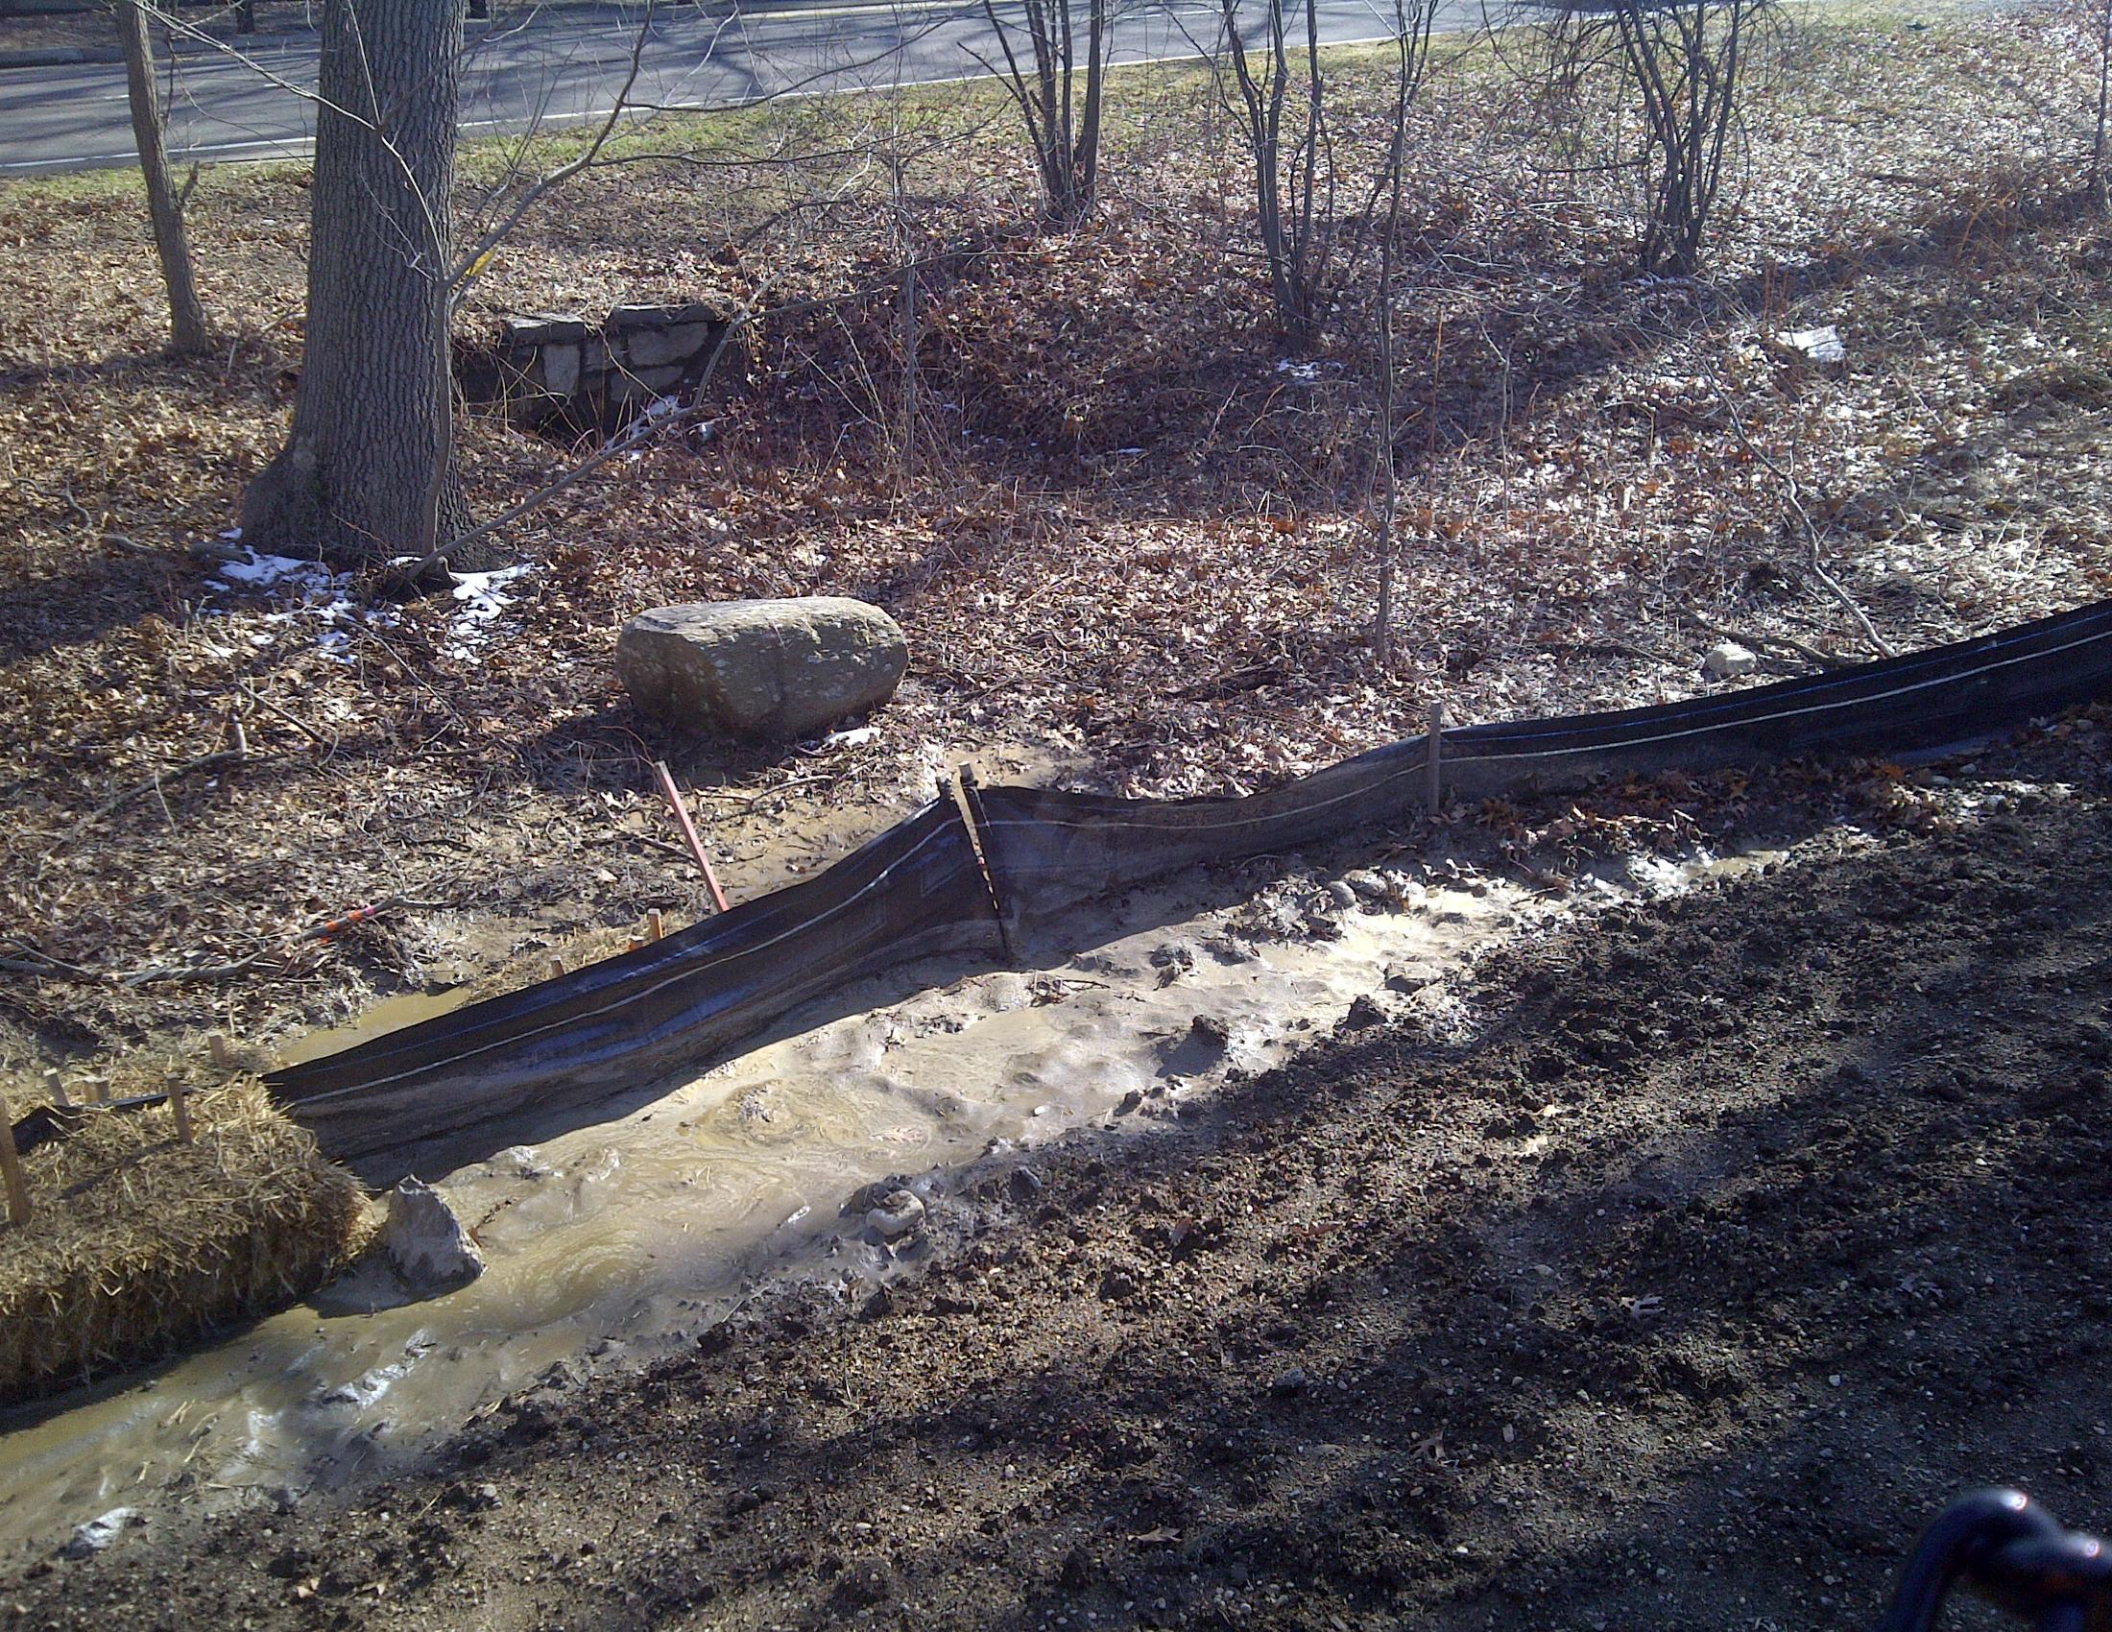
Comment: Minor erosion channels in detention basin and in recently placed topsoil along southern property line.

See attached photos of ponding and runoff near 152 Circle Drive (photos 1 through 6) and breached silt fence along southern property line (photos 7 through 11).

Comment: Silt fence along southern property line will need to be repaired and sediment removed.
