## Community Advisory Group

# Raymark Industries, Inc. Superfund Site Stratford, CT

August 25, 2021

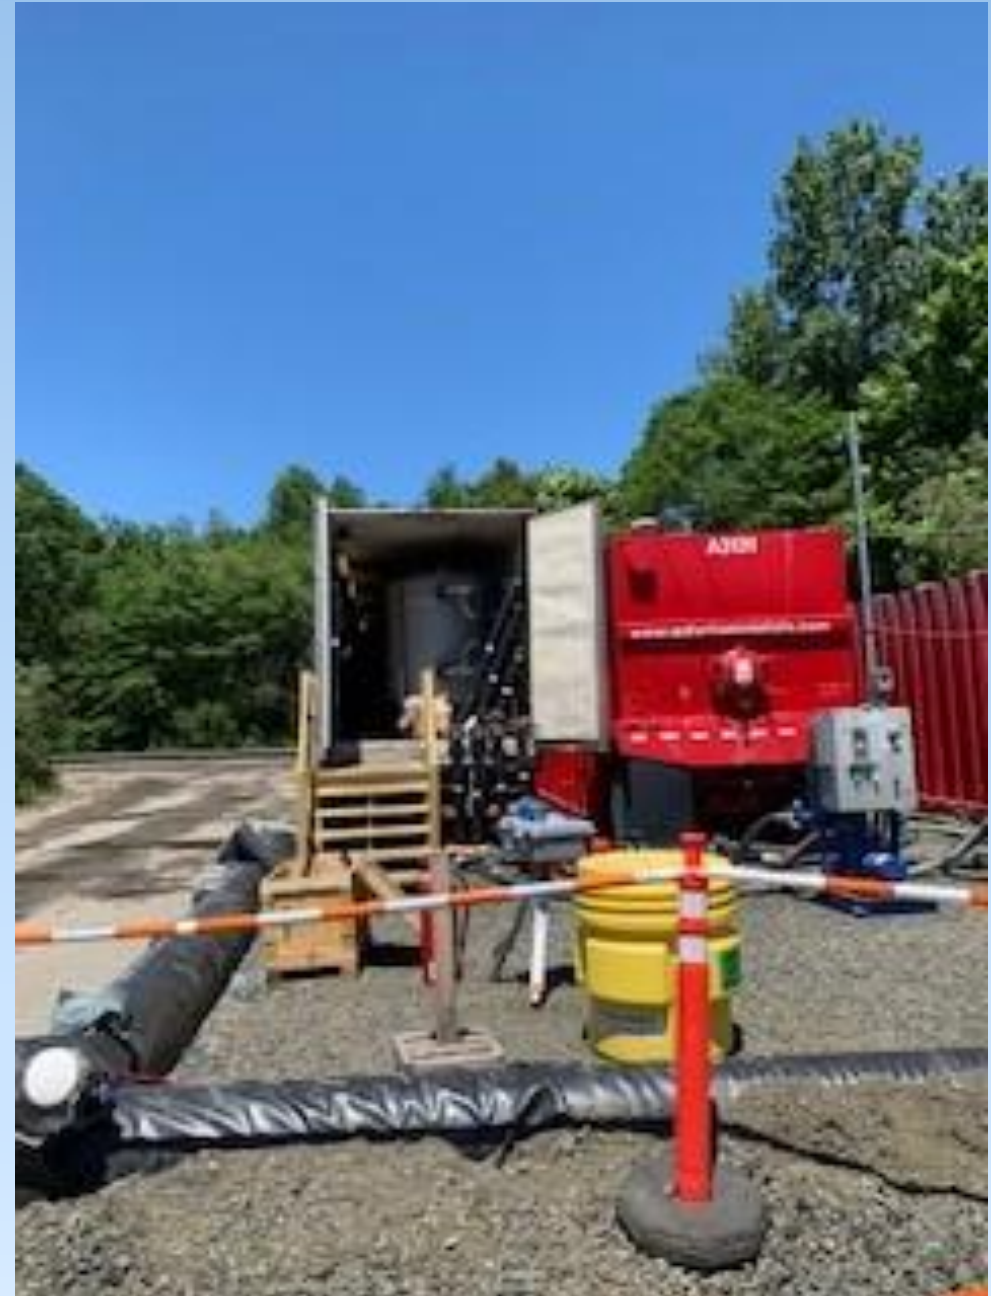
# Ashcroft Rear Frac Tank and Treatment System

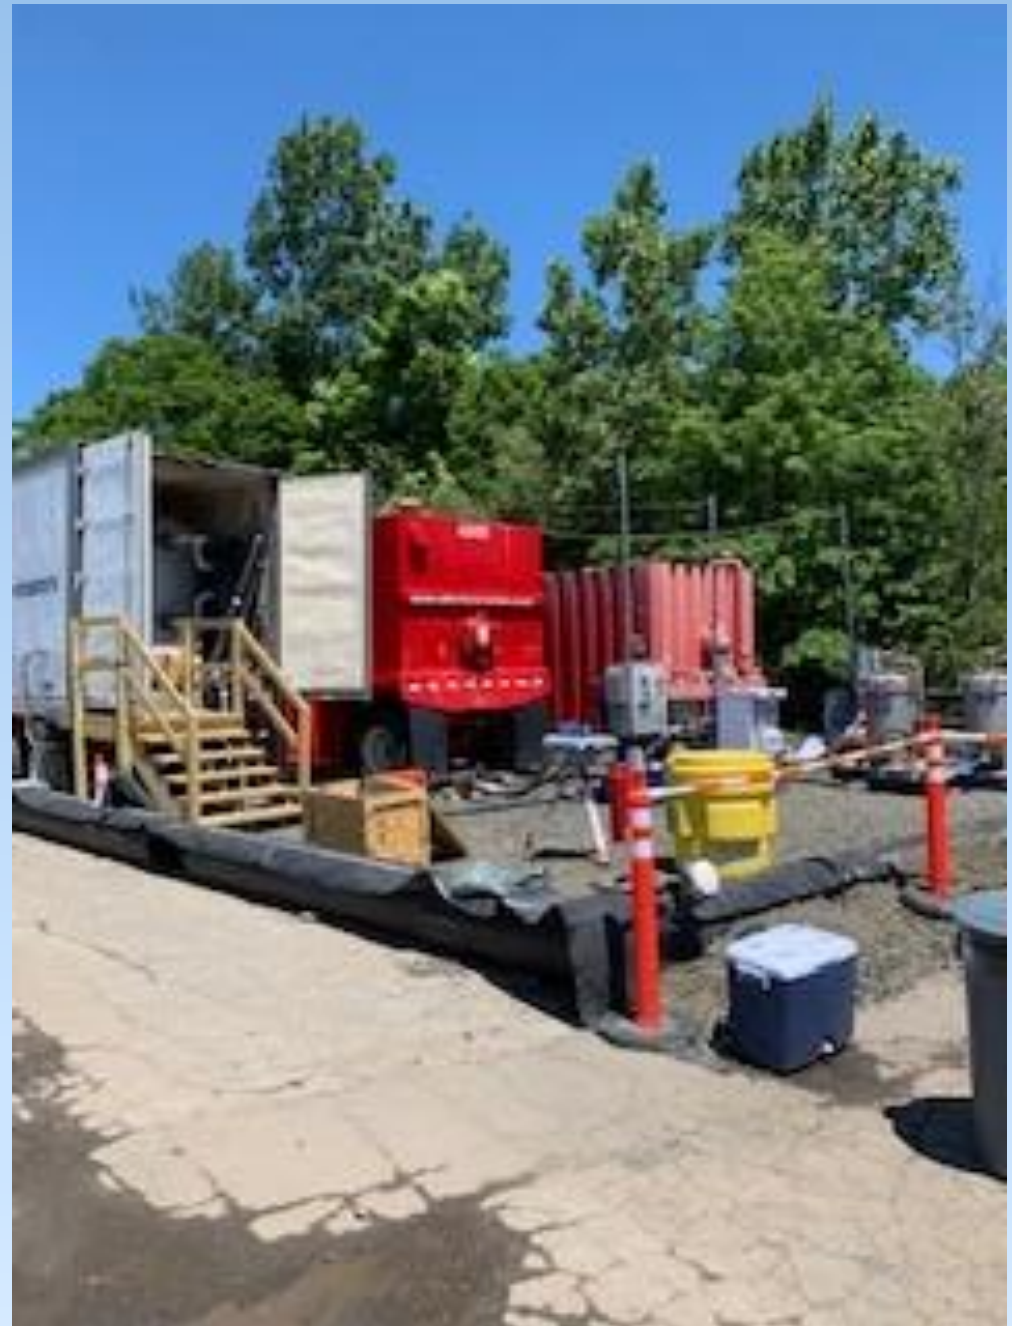
# Ashcroft Rear Water Treatment System Secondary Containment

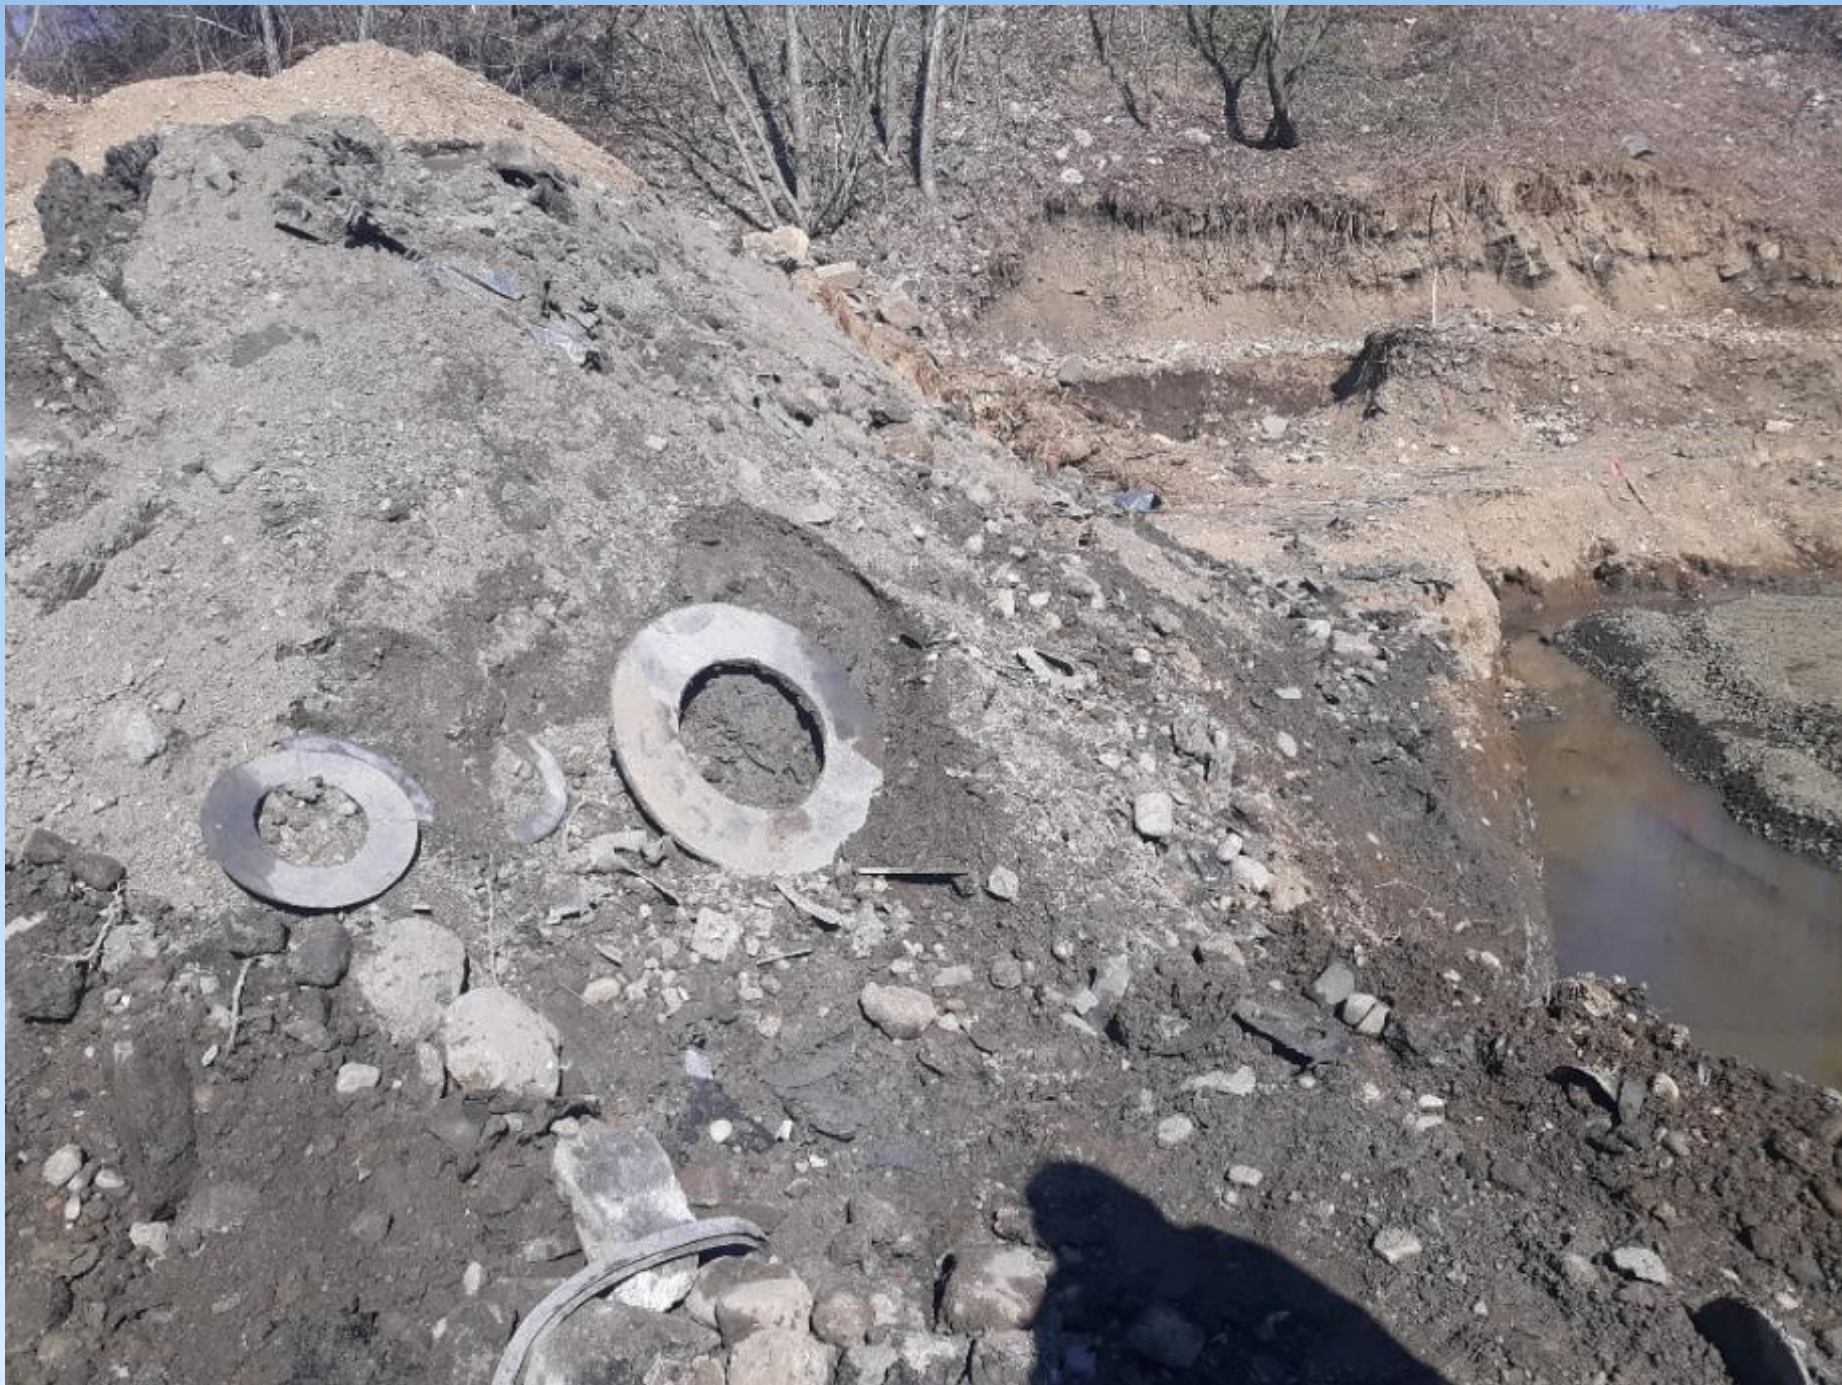
Exposed  
PHC Waste

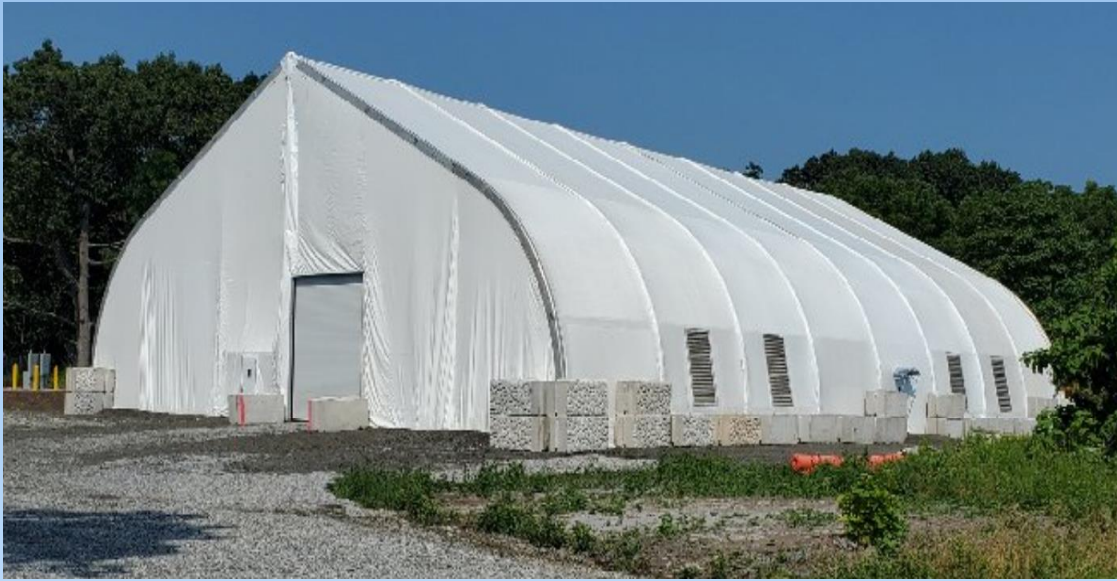
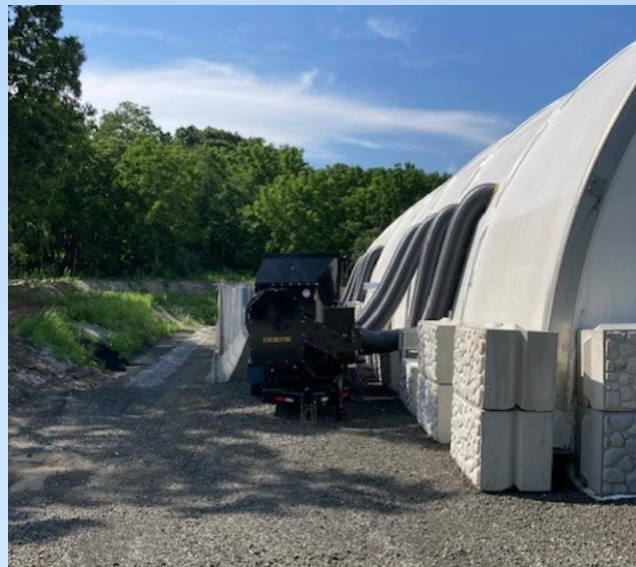
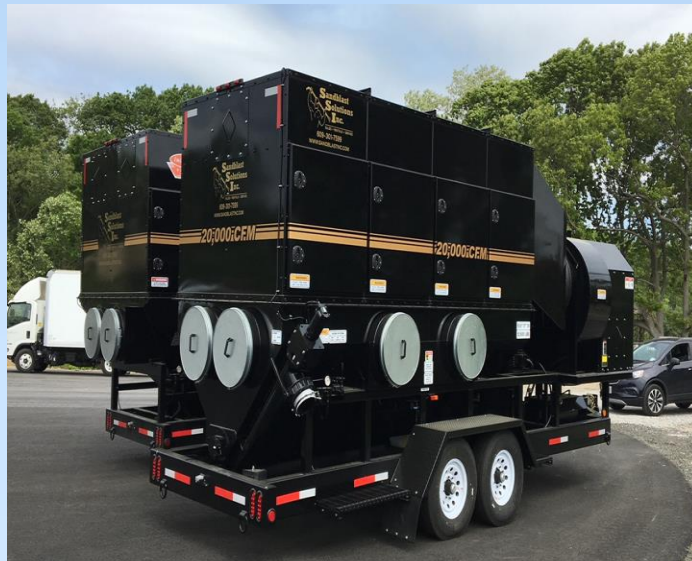
# OU4 Containment Structure

- Material Handling Structure
- Approx. Dimensions (l x w x h) : 100' x 130' x 40'
- Closed system with air treatment
- Used primarily for material additives and dewatering

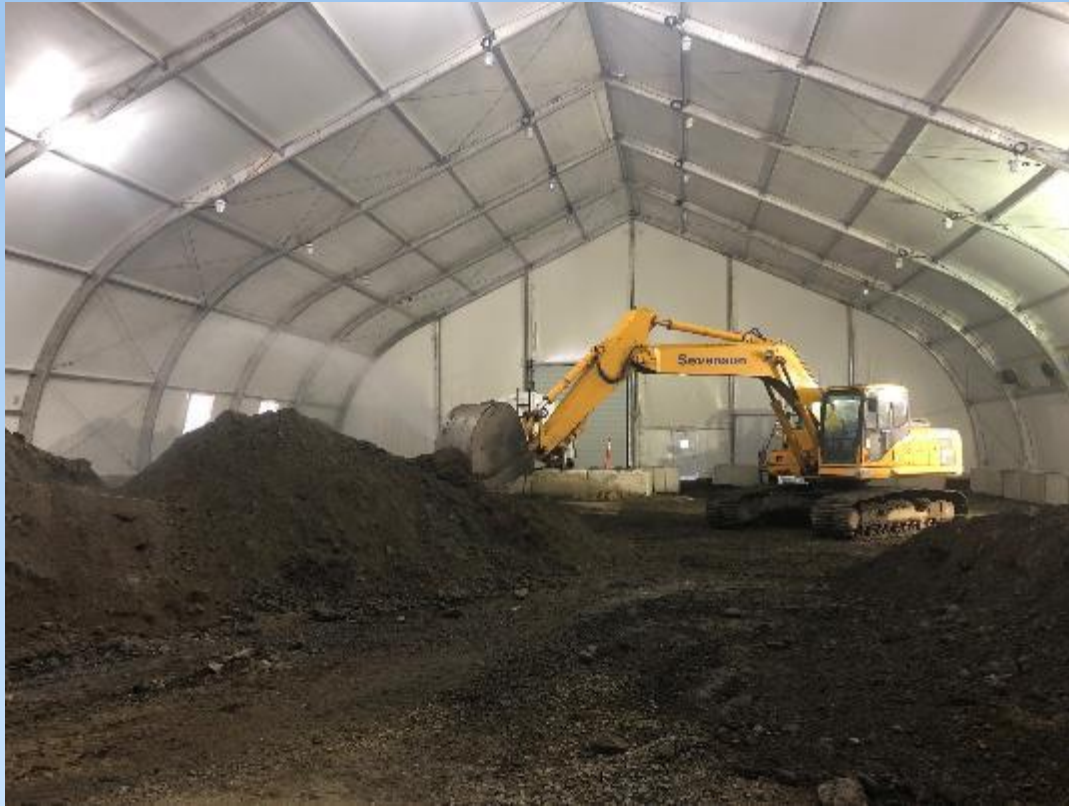
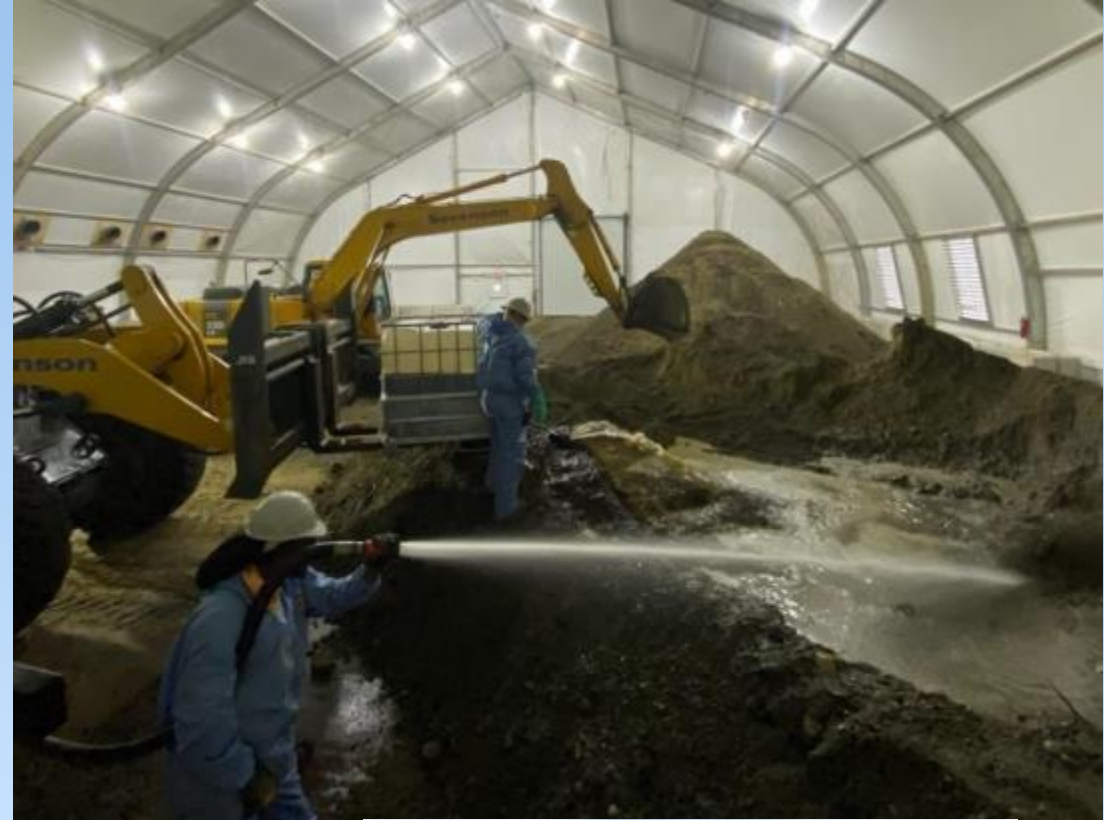
# OU4 Containment Structure

- Additional material handling, additives, drying agents
- MAECTITE additive to bind lead before offsite disposal
- Closed system, complete air change every 10 minutes
- Air scrubbed for contaminants from waste as well as equipment

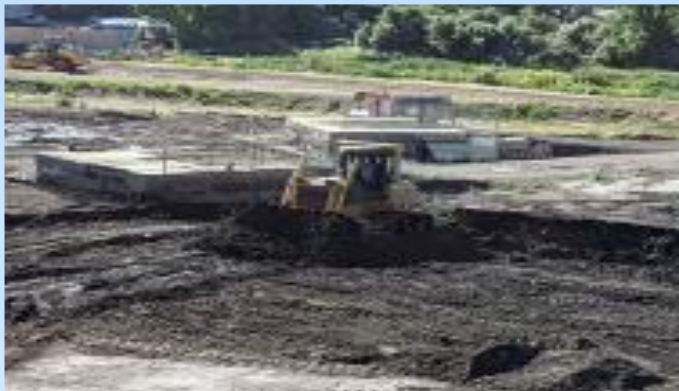
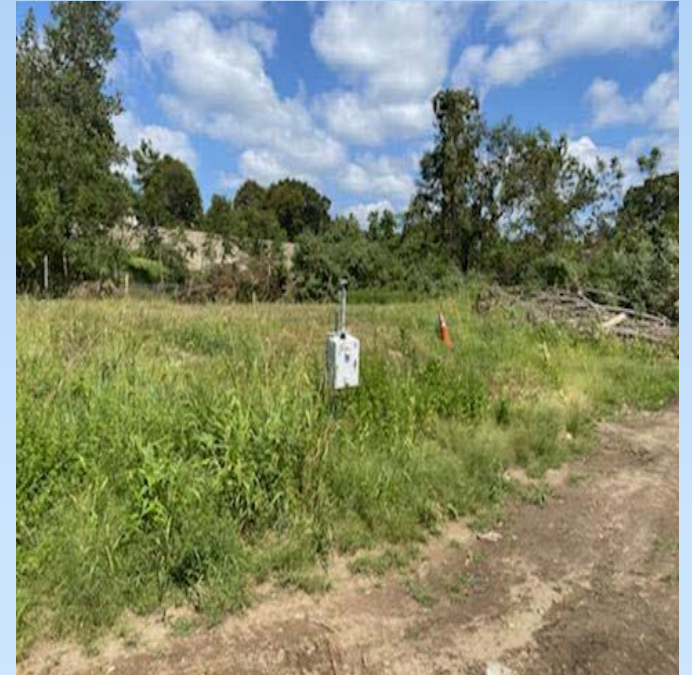
# OU4 - Air Monitoring Results

- Since 6/30/21 public meeting Daily Average Dust = 0.004 to 0.013 mg/m<sup>3</sup>
- No exceedances of the OU4 Dust Action Level criteria (0.014 mg/m<sup>3</sup>)
- We had two days of weather service alerts for bad air days. This regional data is not site related, but we report these data to the Town. Proactive to reduce soil disturbance work those days and increased watering.
- All five dust meters and sample collection systems in operation
- One personnel chemical sample collection system
- No exceedances of chemical health and safety criteria
- Posting Weekly Air Monitoring, Chemical Data and Vibration Monitoring Reports on Town Raymark website

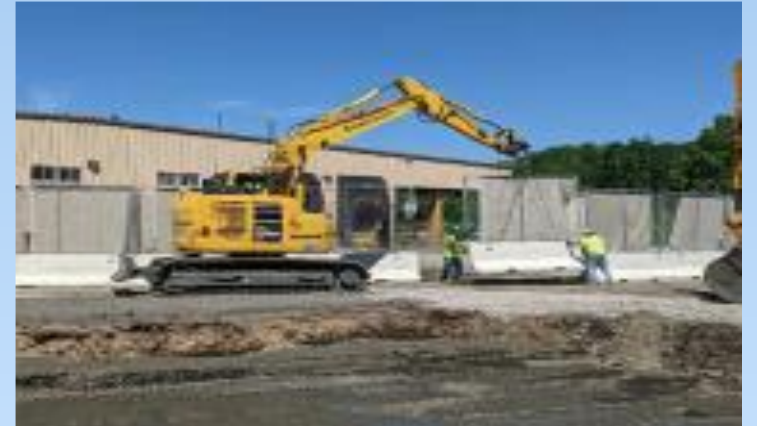
# OU6 - Air Monitoring Results

- Soil excavation and Site Restoration at 250 East Main Street Rear Property
- Daily Average Dust Measurements 0.000 to 0.010 mg/m<sup>3</sup>
- No exceedances of the OU6 Dust Action Level criteria (0.019 mg/m<sup>3</sup>)
- Two dust meters and sample collection systems in operation
- One personnel chemical sample collection system
- No exceedances of chemical health and safety criteria
- Posting Weekly Air Monitoring Reports, Chemical Data, and Vibration Monitoring Reports on Town Website

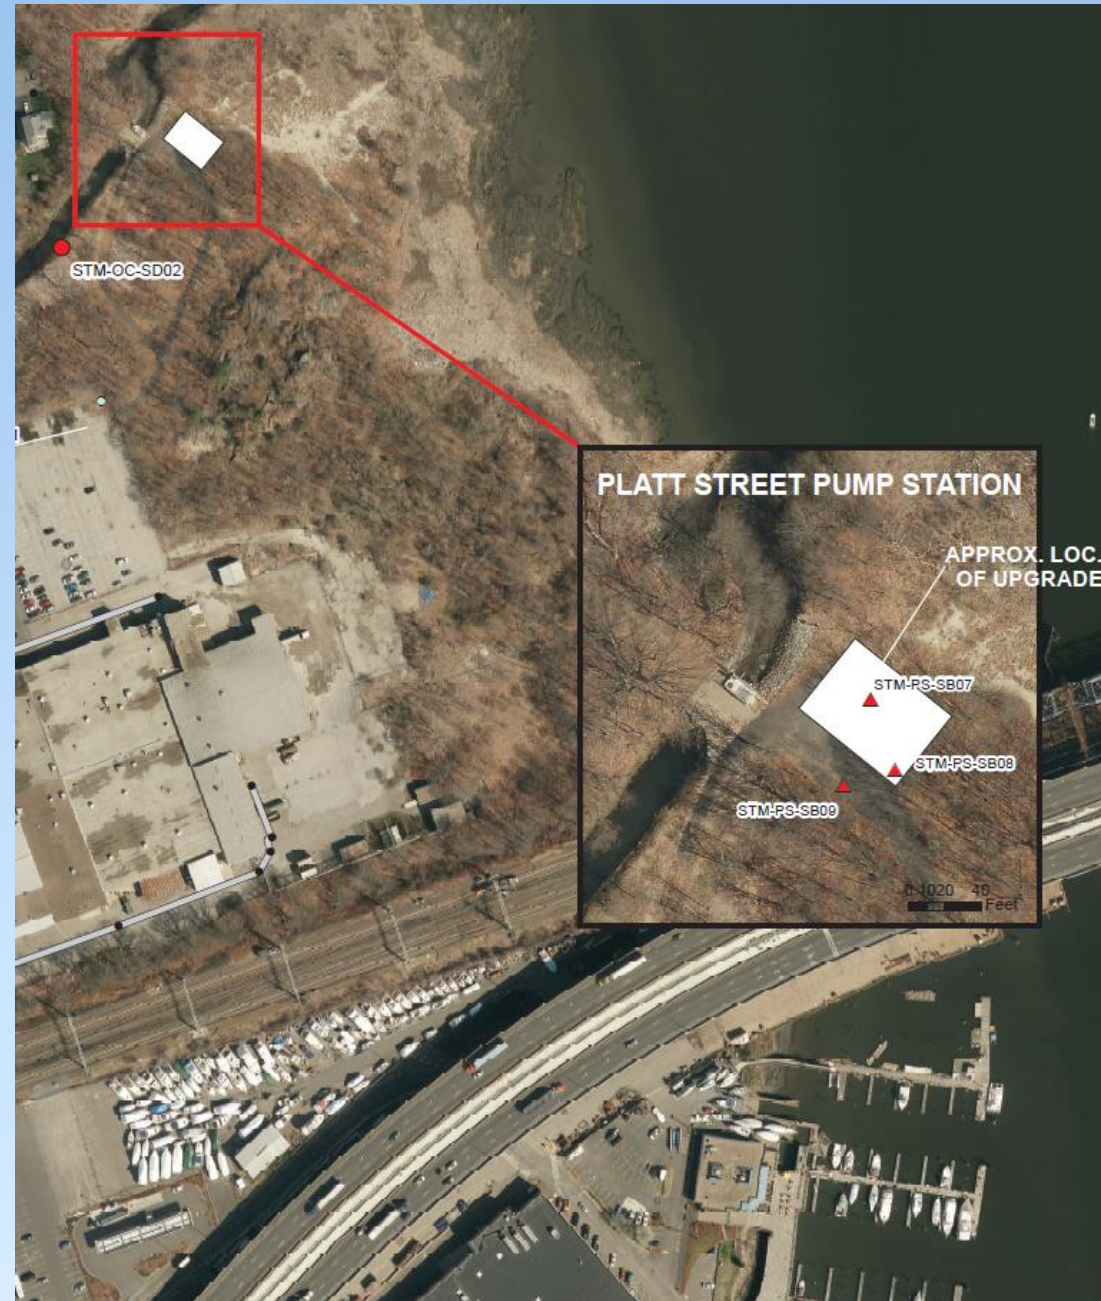
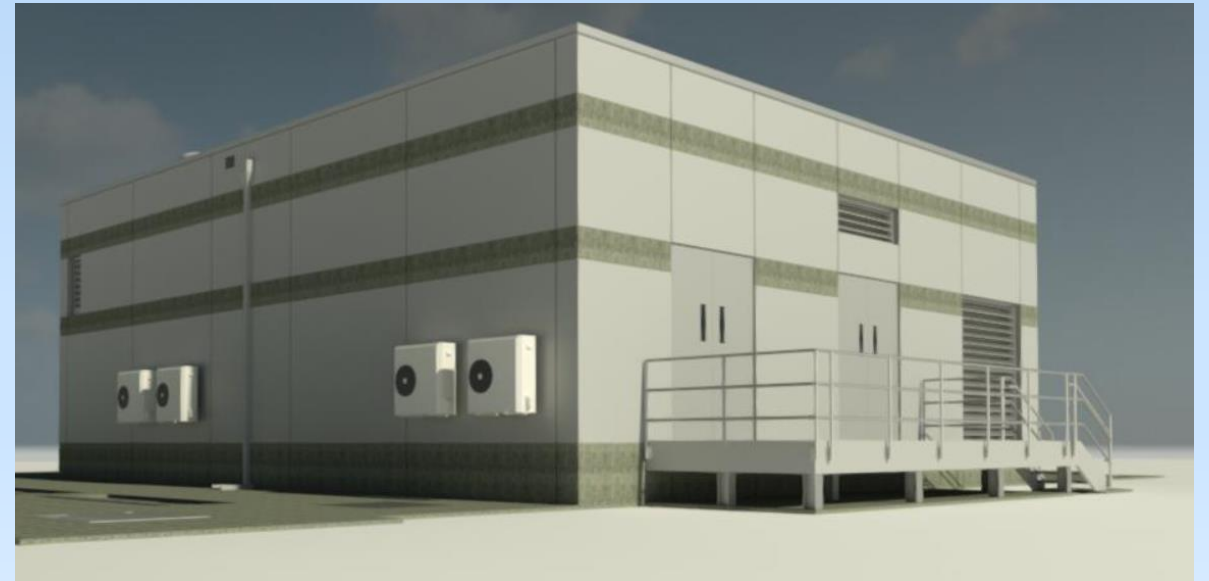
# New Pump Station

- 4 Axial Flow Pumps
- 200 CFS Capacity
- Operates during significant storm and high-water events
- Masonry Pumphouse
