Community Advisory Group

Raymark Industries, Inc. Superfund Site Stratford, CT

June 30, 2021

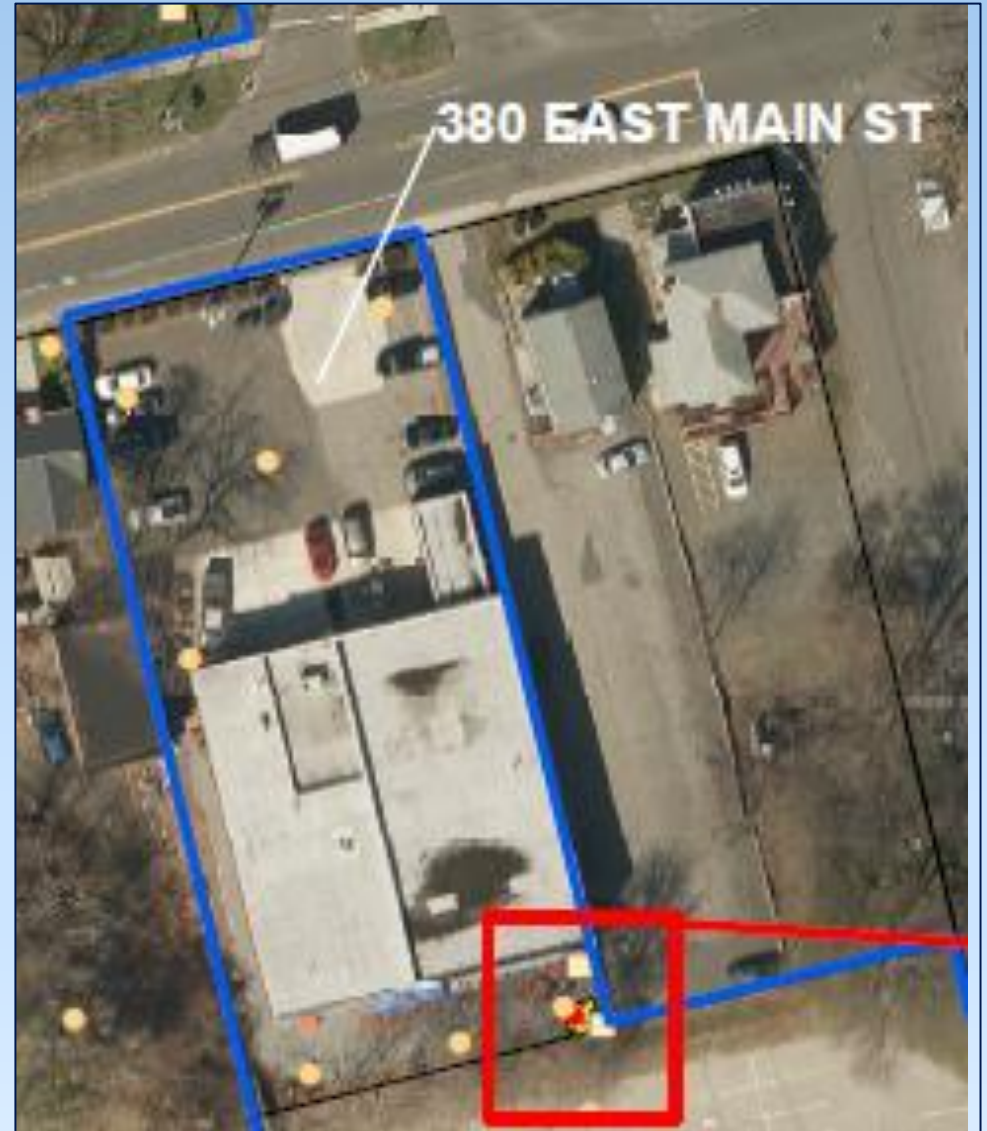
380 E. Main Street (Glyne Manufacturing)

- First of the OU6 removals
- 2 days to excavate, September 16 & 17, 2020
- Estimated 40 cubic yards
- Actual 51.7 cubic yards
- 4 truck trips

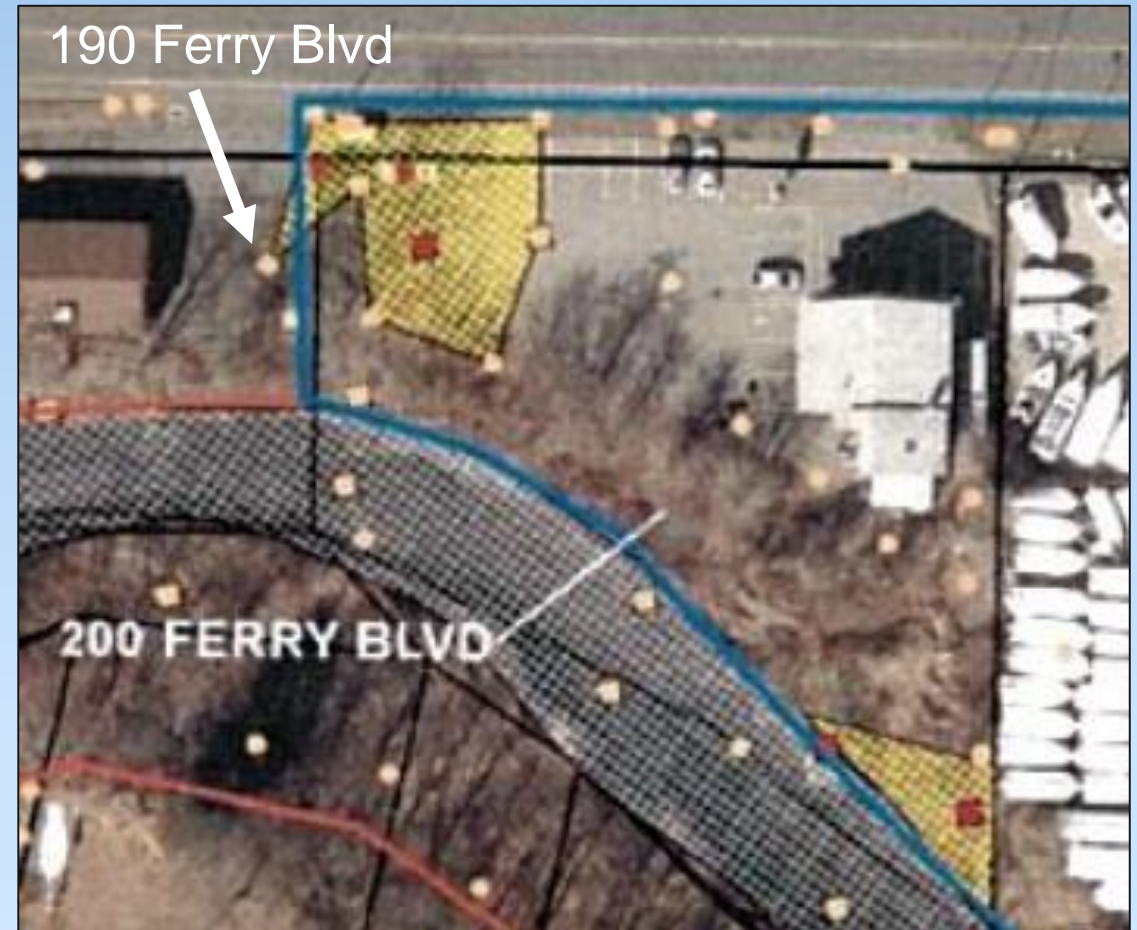
190 Ferry Boulevard (Karate Studio)

- ROD identified RW only at 200 FB
- RW confirmed at 190 FB during PDI
- 8 days to excavate, December 2 to 10, 2020
- Estimated 500 cubic yards
- Actual 481.83 cubic yards
- 10 truck trips

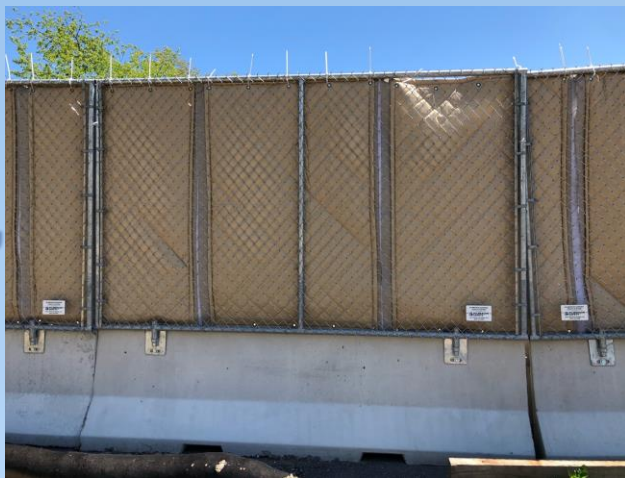
- Apply water, material always wet

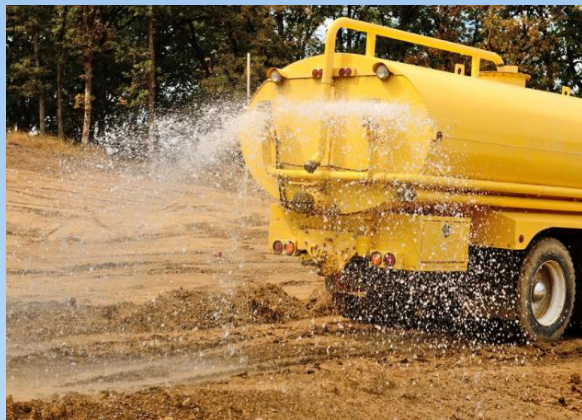
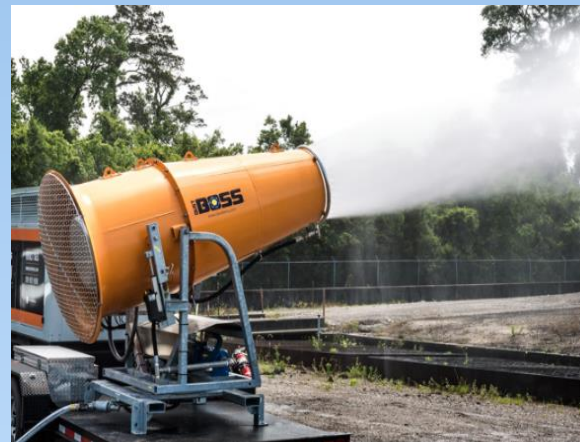
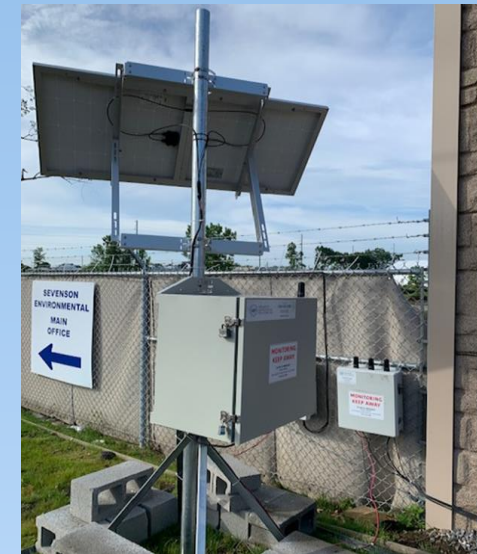
- Perimeter concrete barrier, steel fence, heavy duty sound blanket

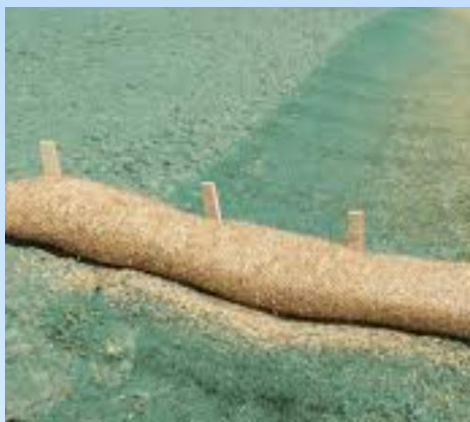
- Vibration and Noise Monitoring

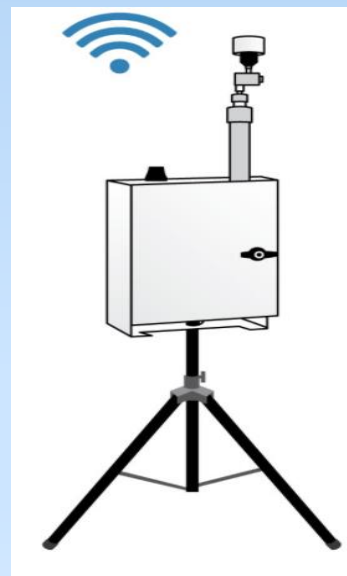
- Tightly sealed trucks / containers with gasketed gates

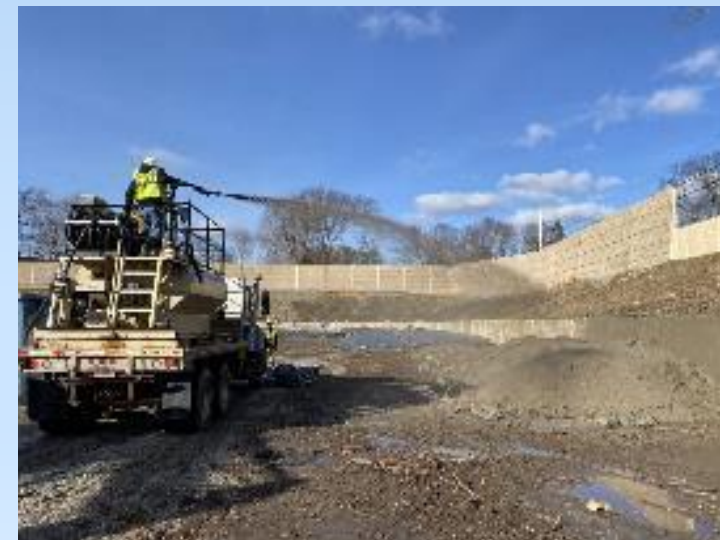
- Real time air monitoring

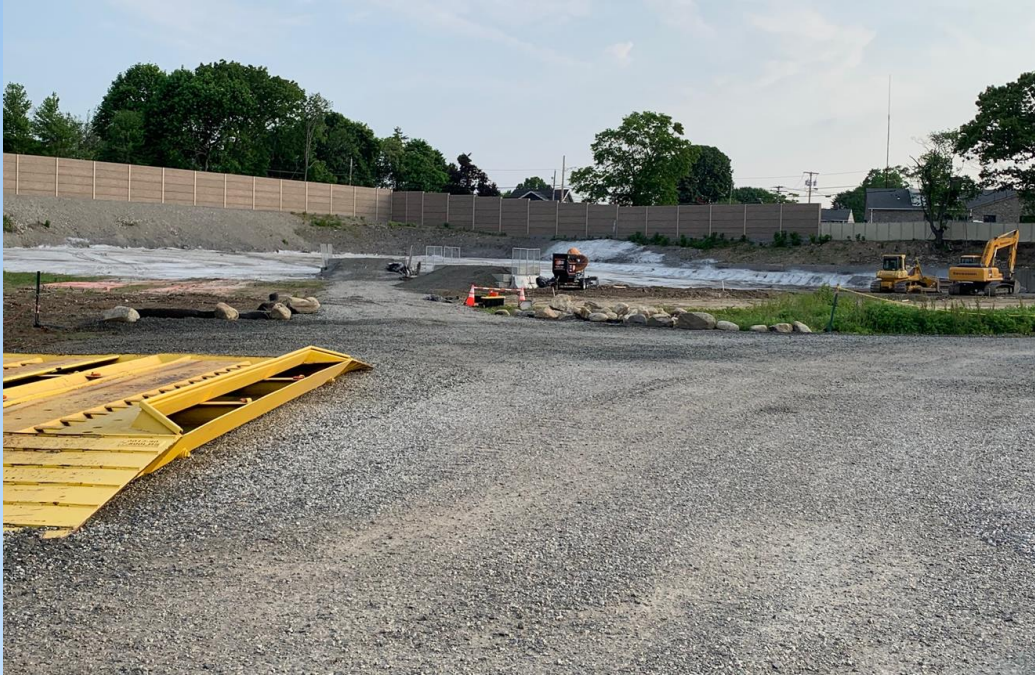
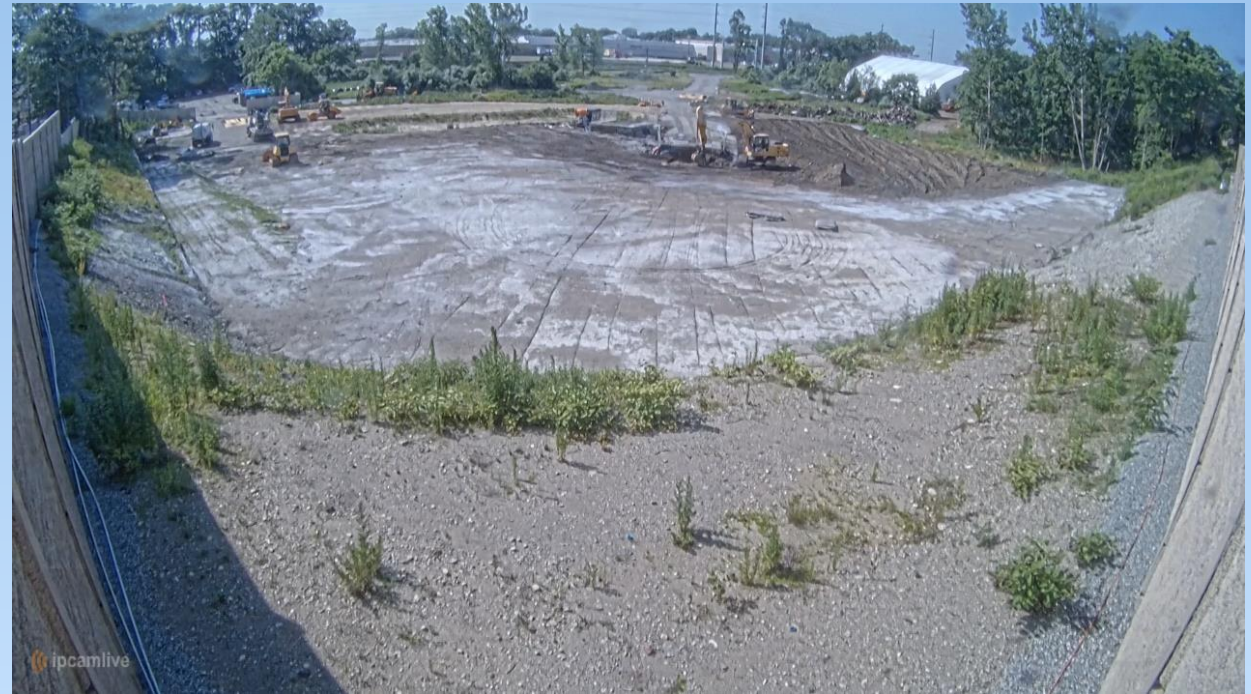
OU4 Ballfield Work Completed or Ongoing Since May

- Approximately 5,300 CY consolidated, compacted and covered.
- Posi-Shell cover applied on all previously imported Raymark Waste at OU4 Ballfield
- OU4 site and cap design ongoing
- Stormwater control and conveyance system design complete
- 5 perimeter air monitors at OU4 and 2 at East Main Street are operating daily

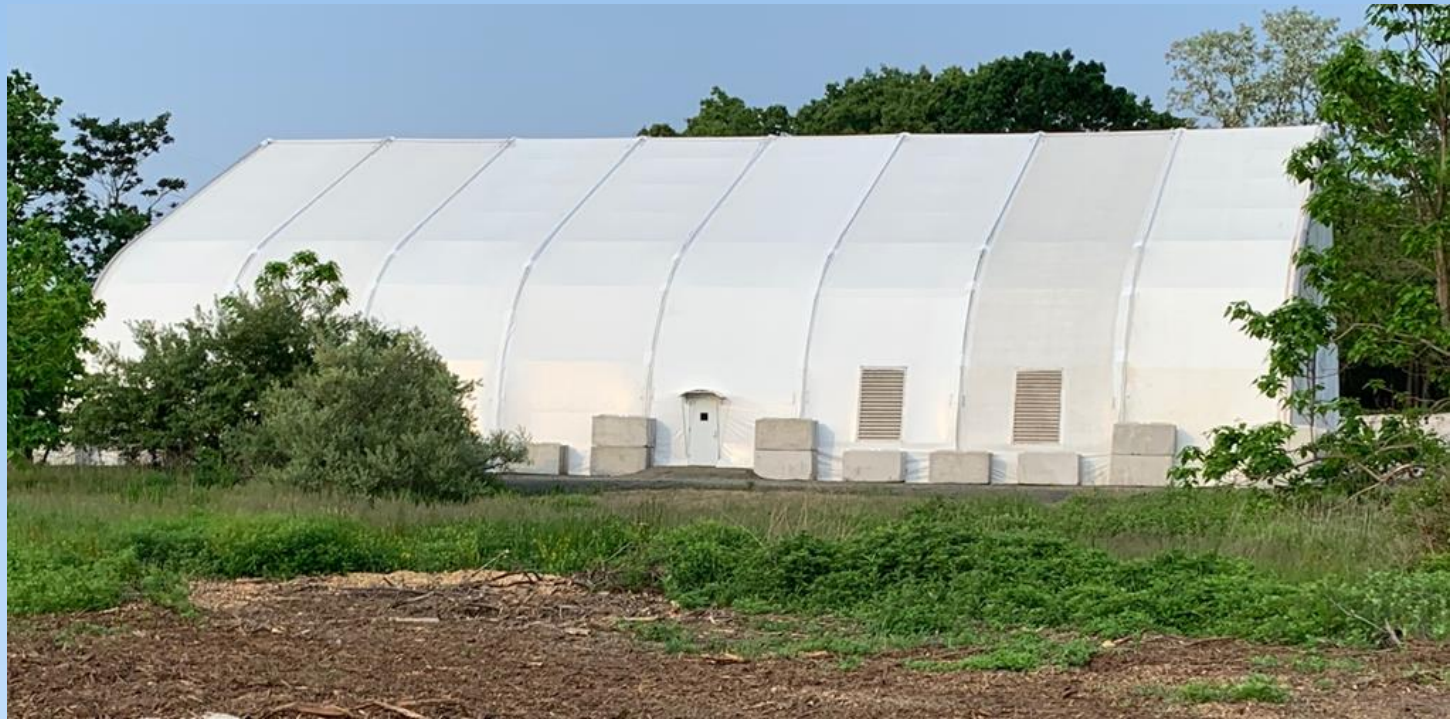
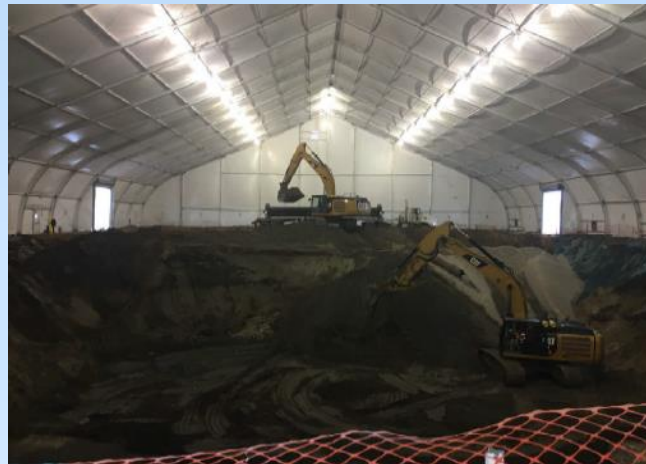
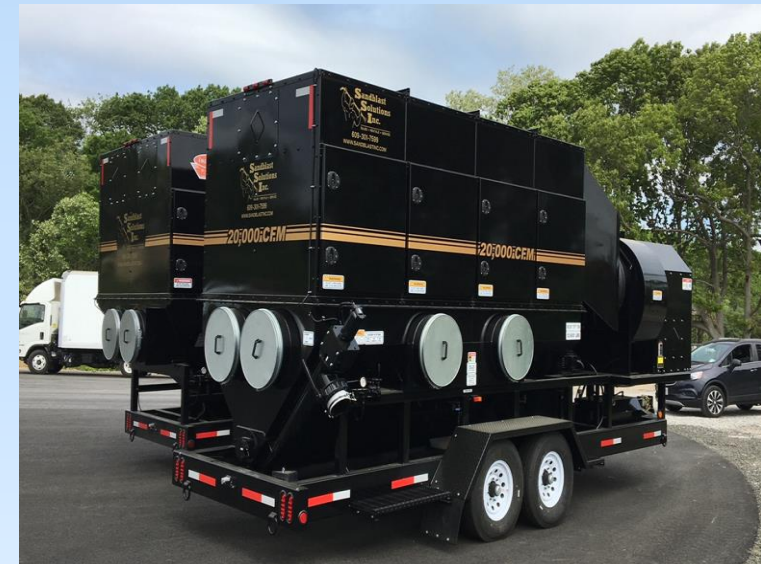
OU4 Containment Structure

- Temporary Fabric Structure (TFS)
- Approx. Dimensions (l x w x h) : 100' x 130' x 40'
- Used primarily for material additives and dewatering
- Closed system with air treatment
- Aluminum structural frame with PVC coated fabric membrane

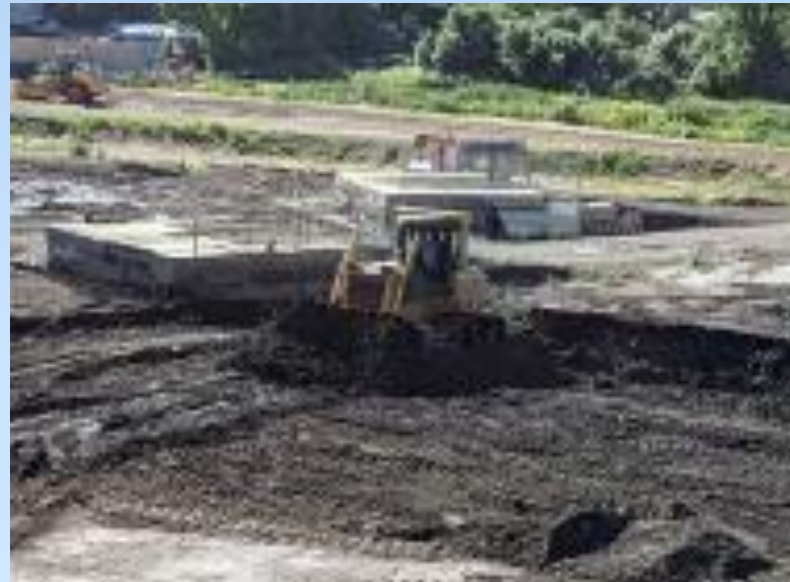
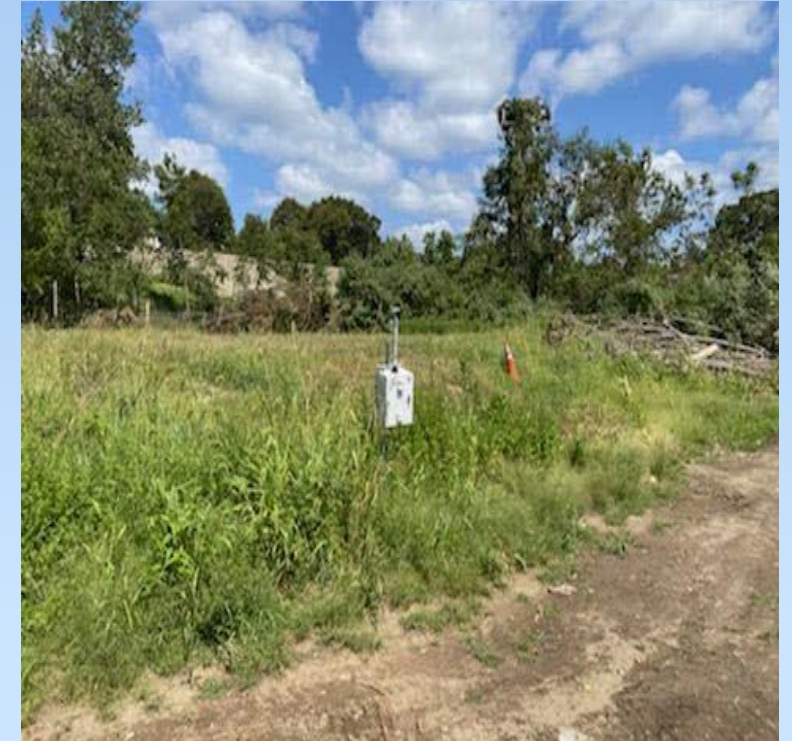
OU4 - Air Monitoring Results

- Since 5/26/21 public meeting Daily Average Dust = 0.004 to 0.010 mg/m³
- No exceedances of the OU4 Dust Action Level criteria (0.014 mg/m³)
- All five dust meters and sample collection systems in operation
- One personnel chemical sample collection system
- No exceedances of chemical health and safety criteria
- Posting Weekly Air Monitoring, Chemical Data and Vibration Monitoring Reports on Town Raymark website

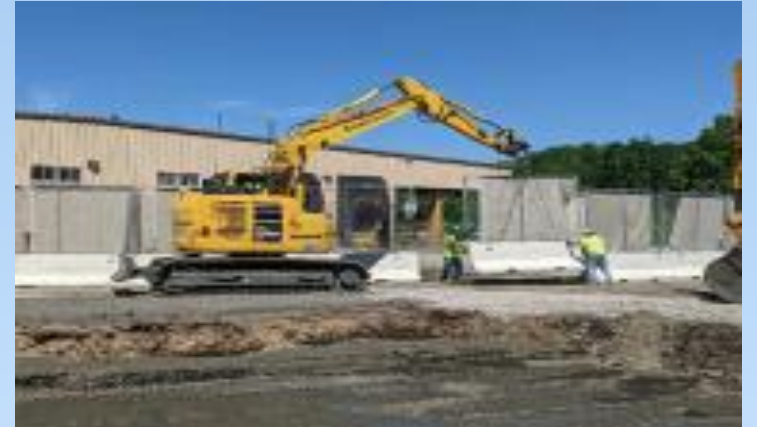
OU6 - Air Monitoring Results

- Soil excavation and Site Restoration at 250 East Main Street Rear Property
- Daily Average Dust Measurements 0.001 to 0.006 mg/m³
- No exceedances of the OU6 Dust Action Level criteria (0.019 mg/m³)
- Two dust meters and sample collection systems in operation
- One personnel chemical sample collection system
- No exceedances of chemical health and safety criteria
- Posting Weekly Air Monitoring Reports, Chemical Data, and Vibration Monitoring Reports on Town Website

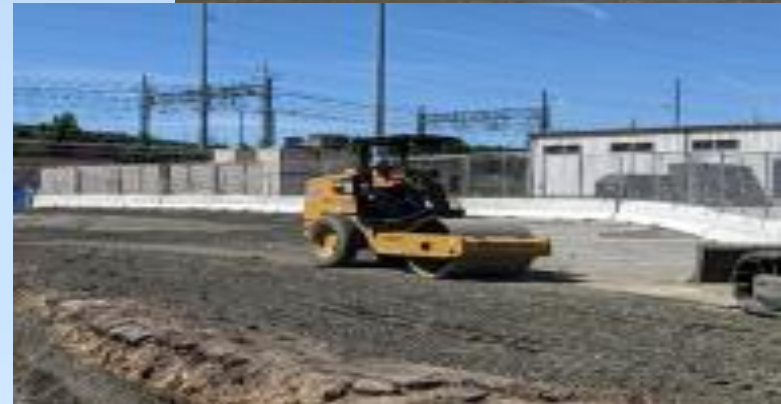
Perimeter Air Monitoring Updates - OU4/ OU6 Restoration

- All imported clean soil tested every 500-1000 cy to verify meets CT Residential Soil Criteria
- Only during site restoration Dust Action Level raised to 0.150 mg/m³
