Raymark Community Advisory Group Meeting

March 31, 2021

Raymark Industries, Inc. Superfund Site Stratford, CT

OU6 Update

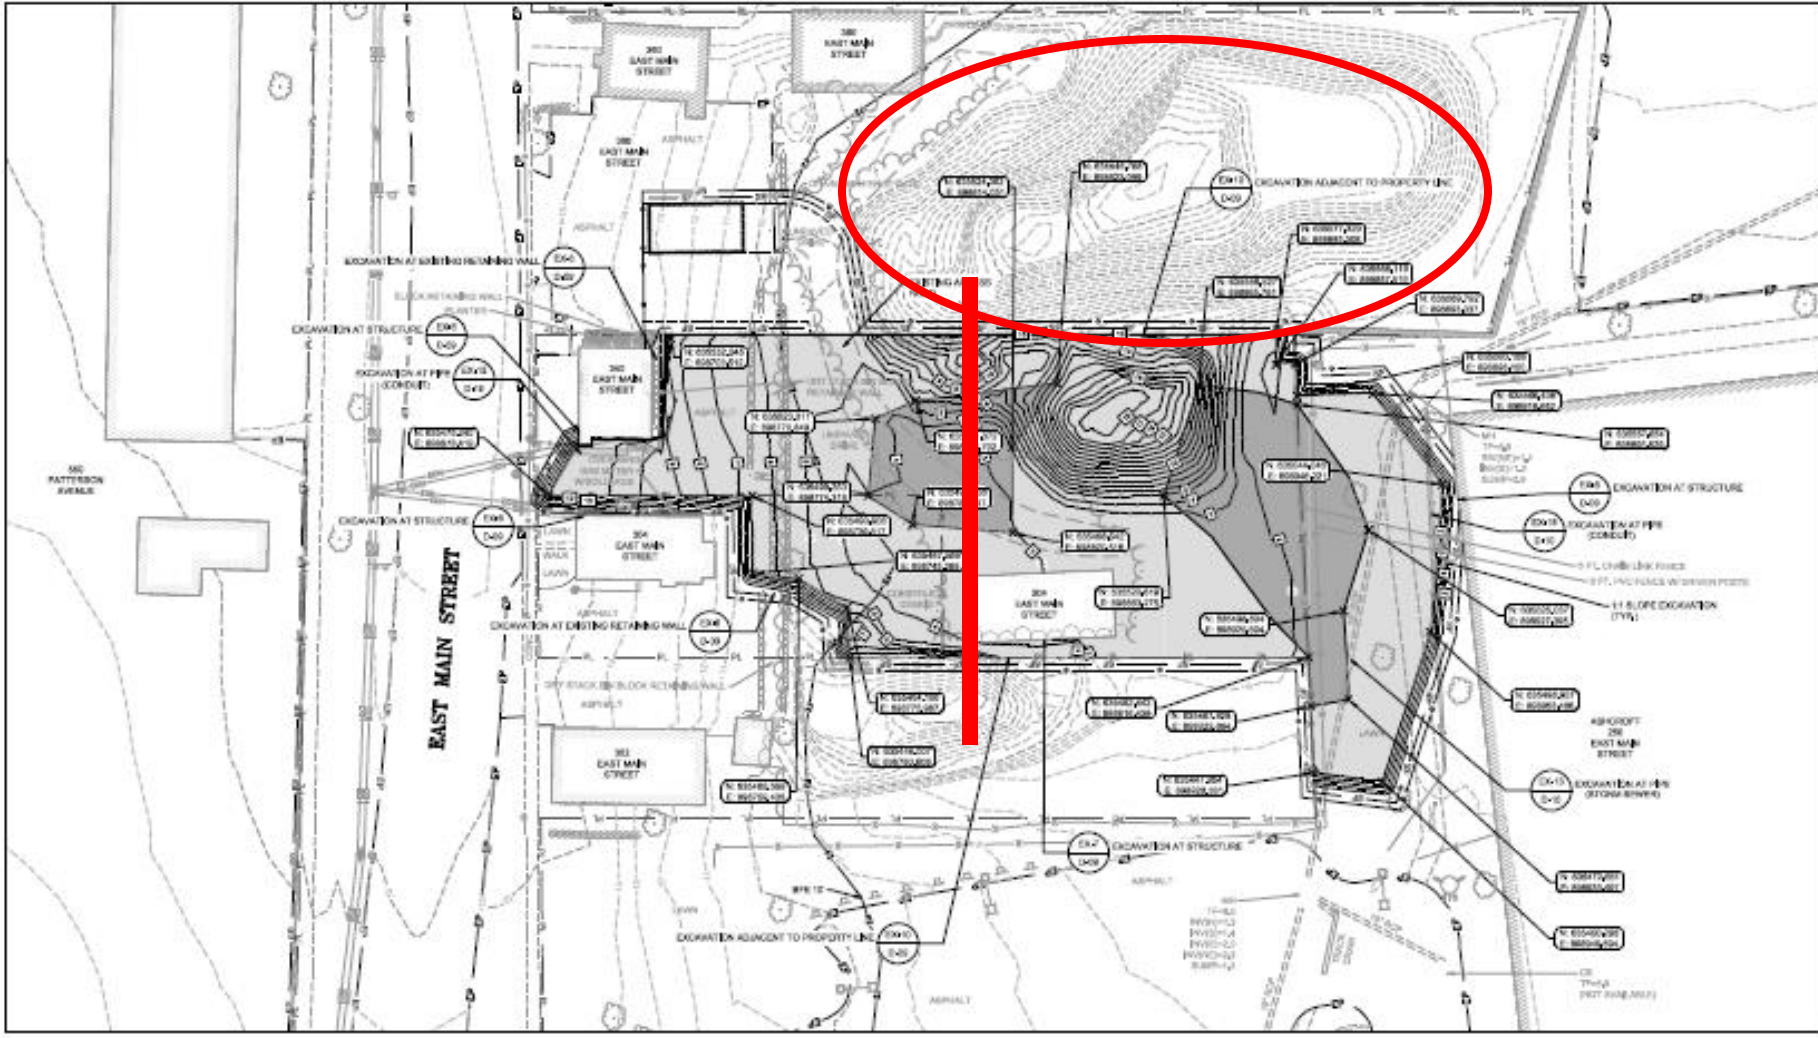
Excavation at 250 East Main (shingles and roof tar)

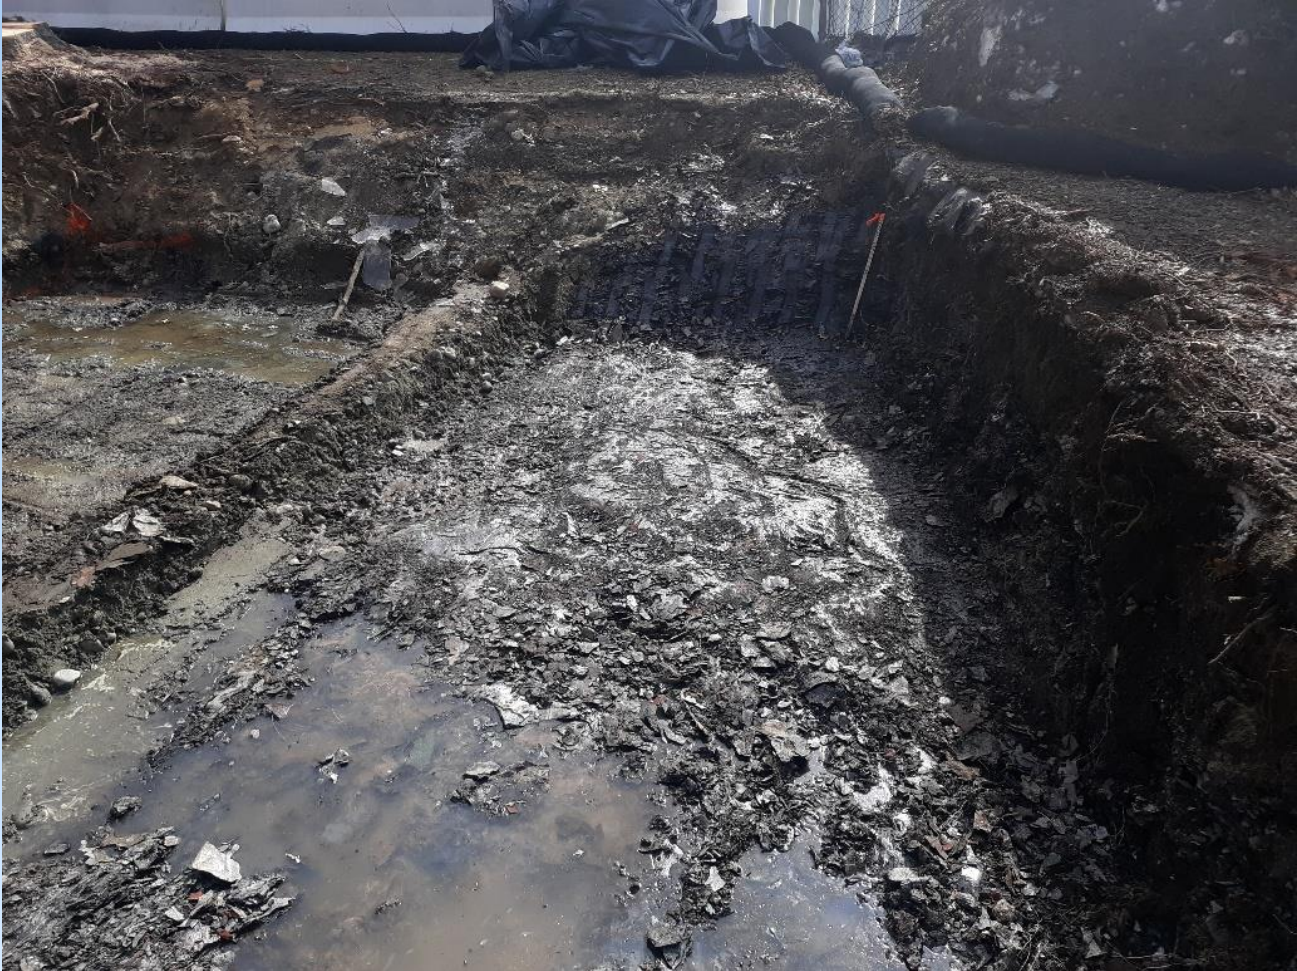
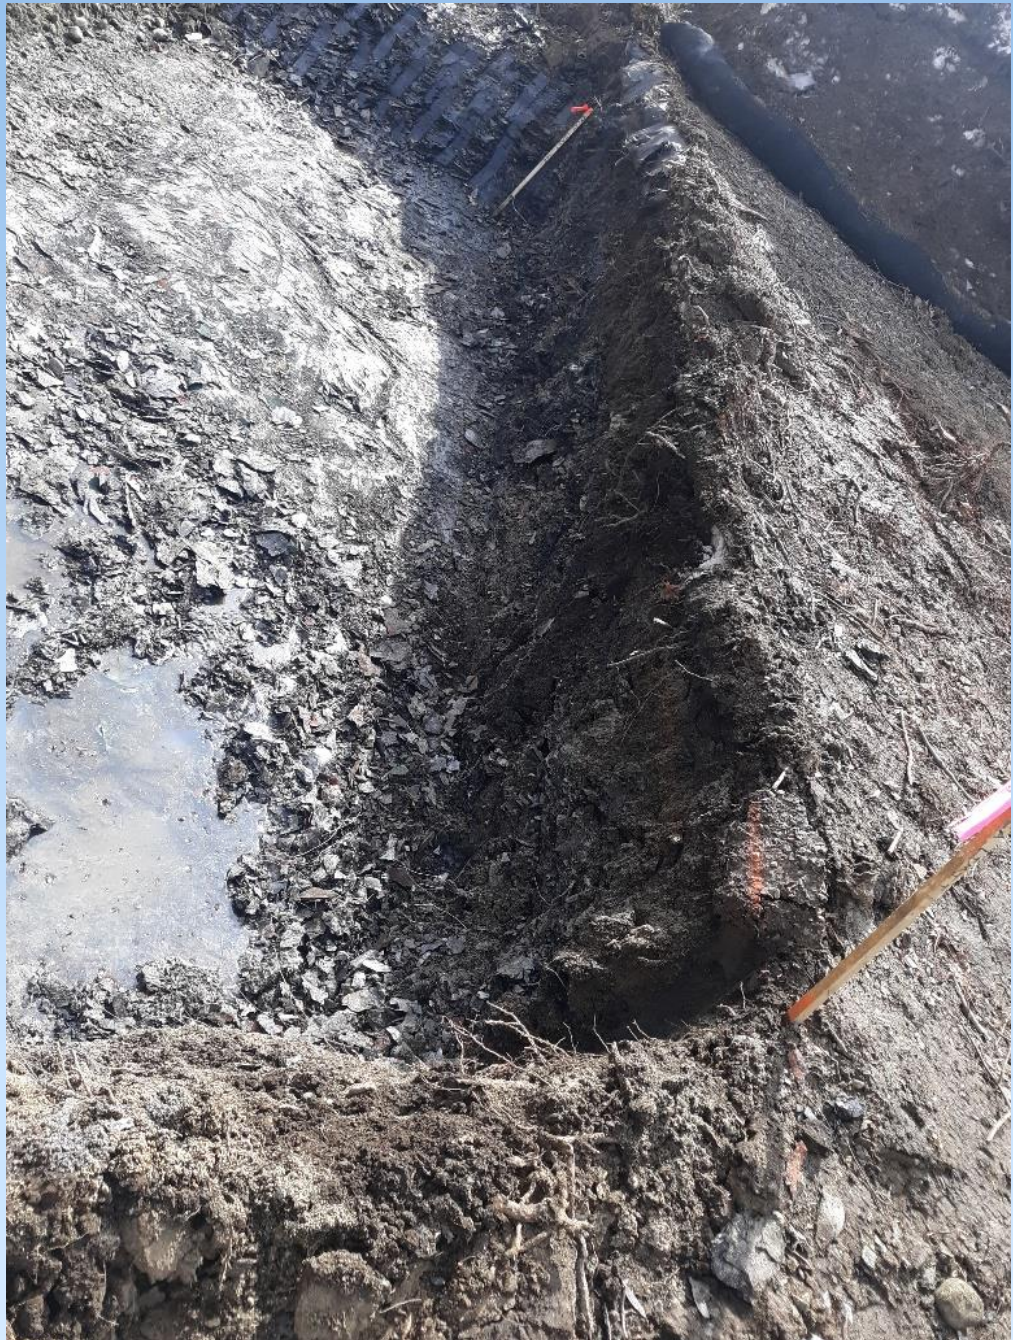
Excavation of PHC Waste

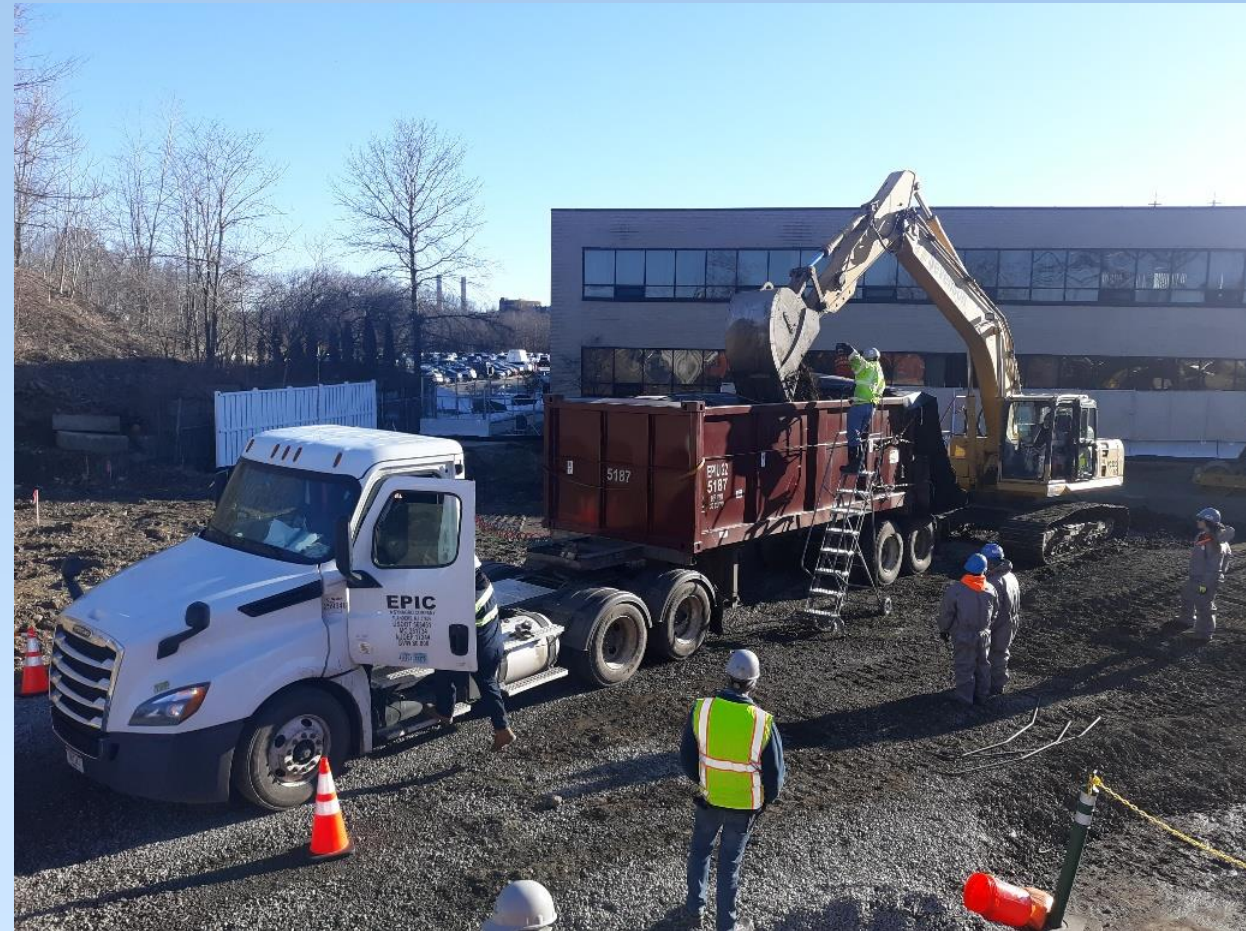
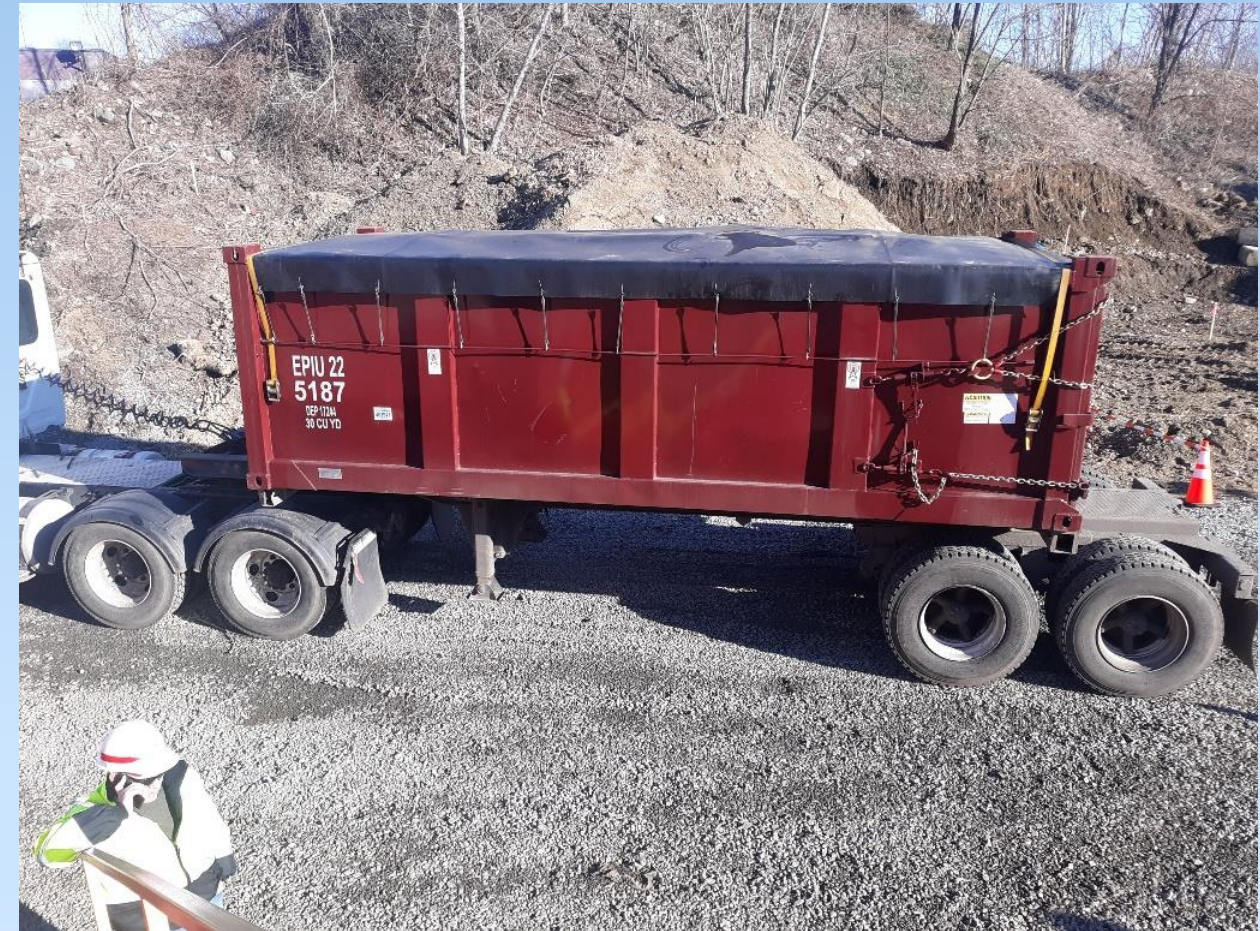
Excavation of PHC Waste

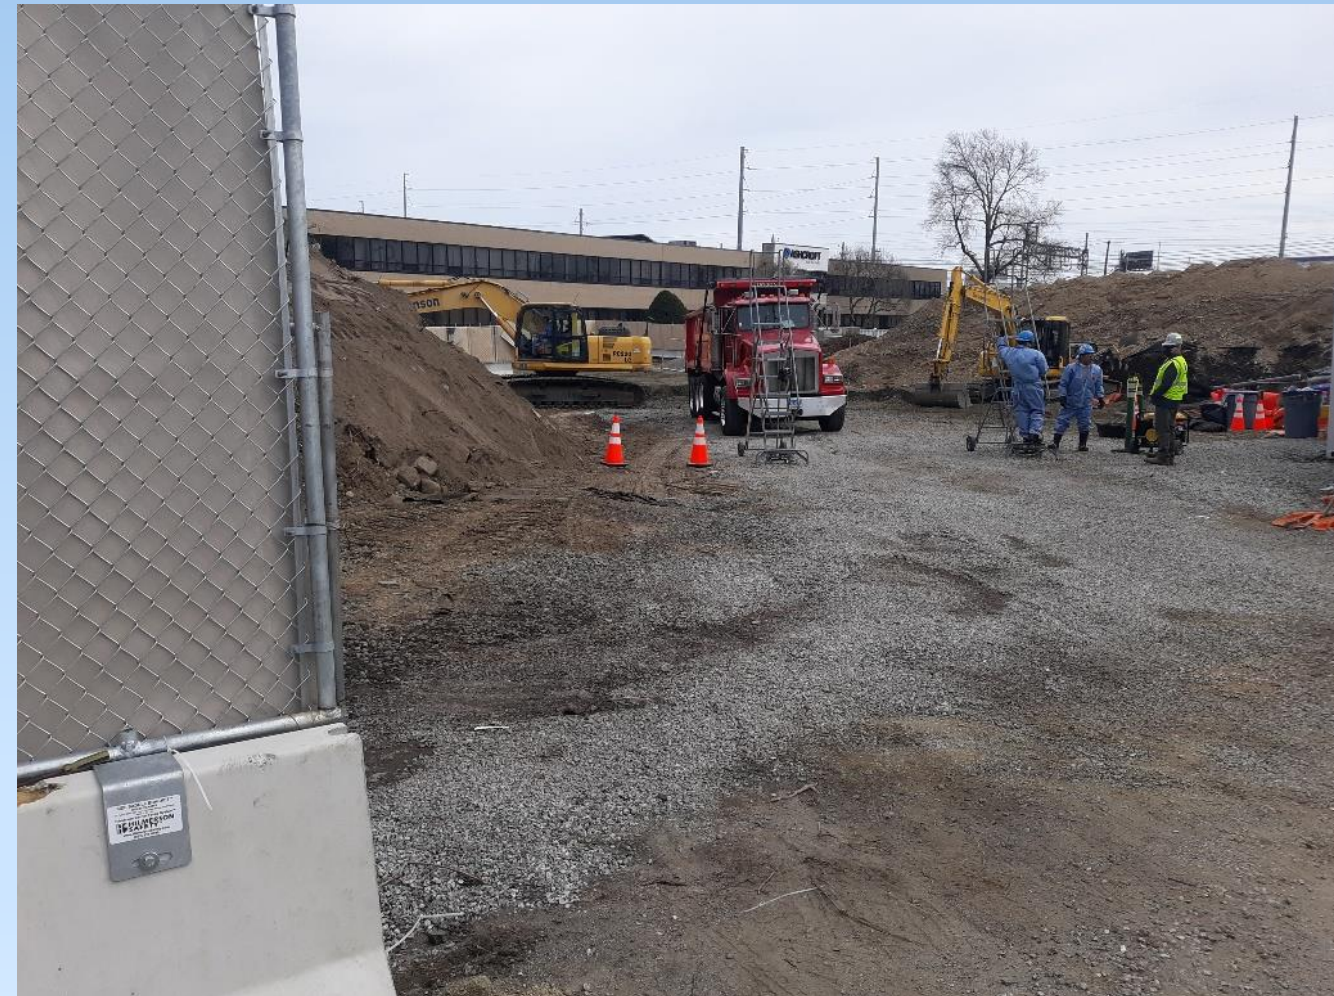
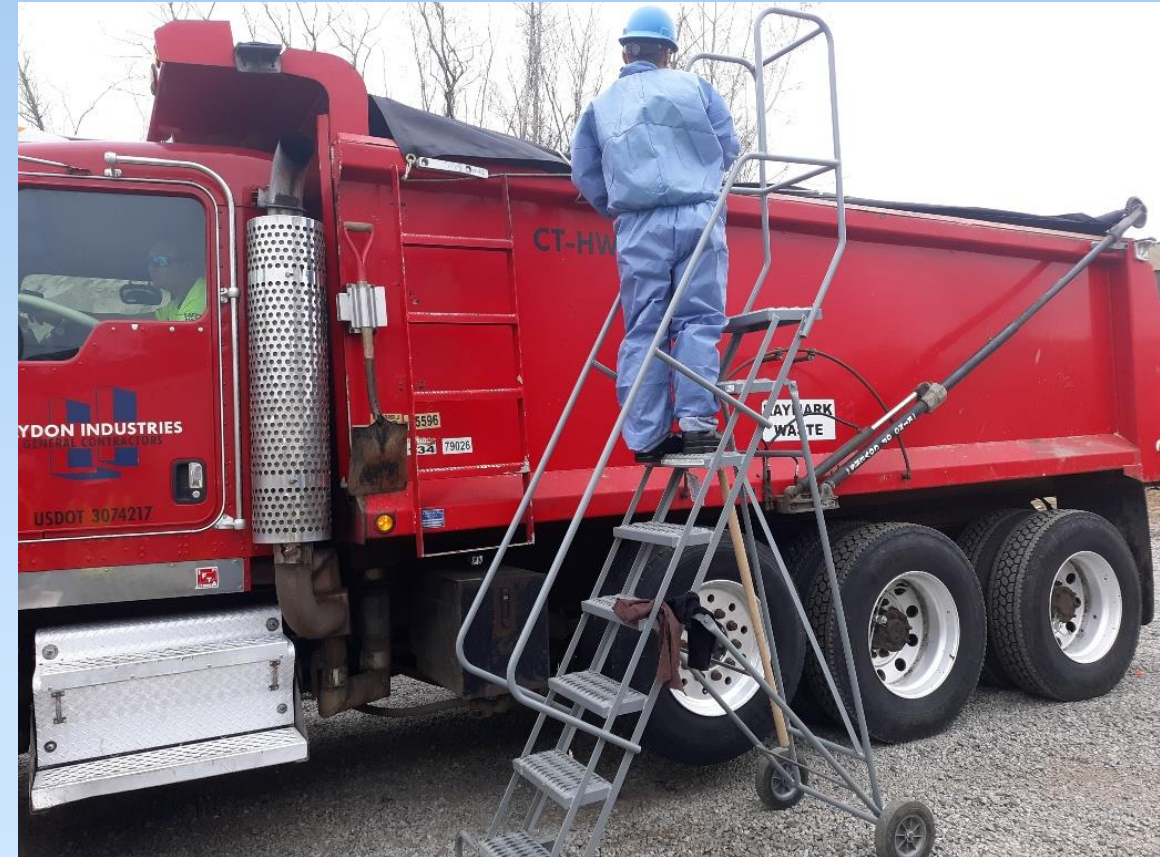
Raymark Waste Being Loaded at East Main Street

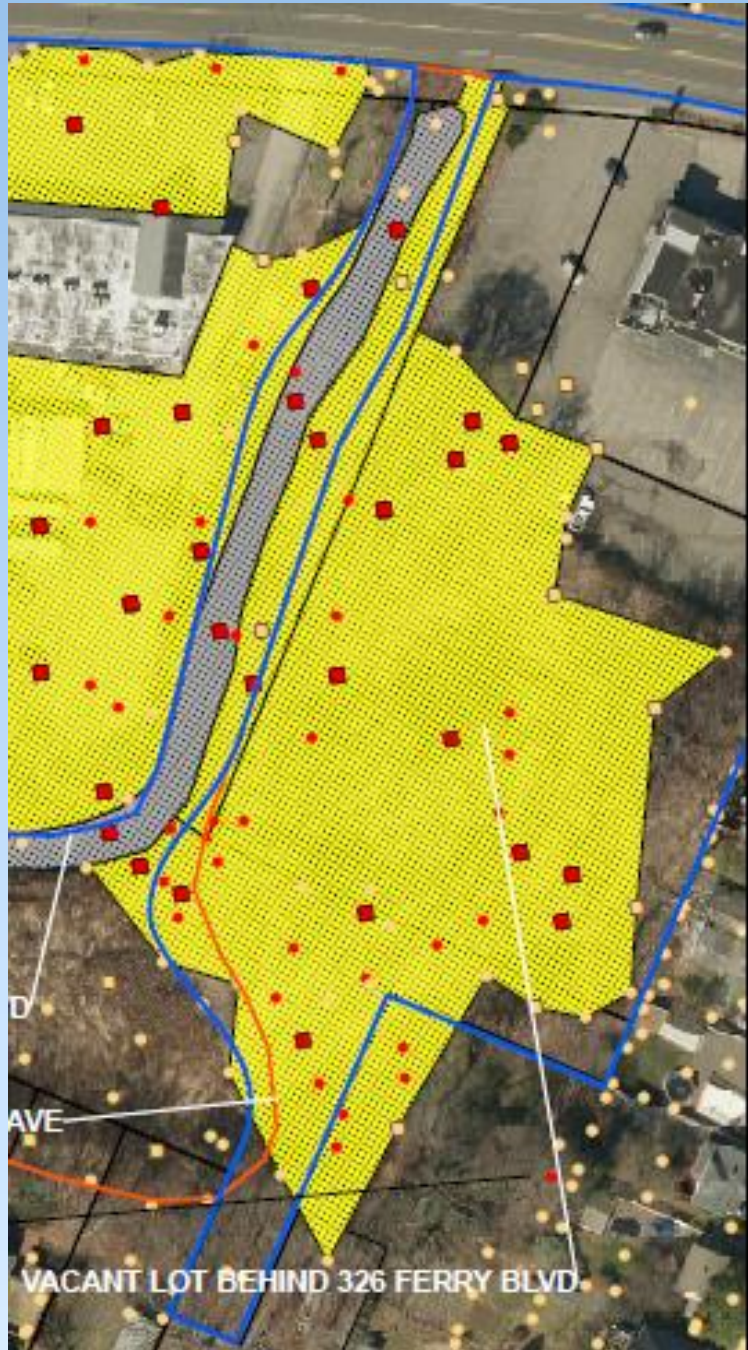
Vacant Lot Behind Blue Goose

- ~ 4,400 yds = 400 trucks
- ~ 660 yds = 60 trucks PHC waste
- Summer or Fall 2021?
- About 12 weeks to complete

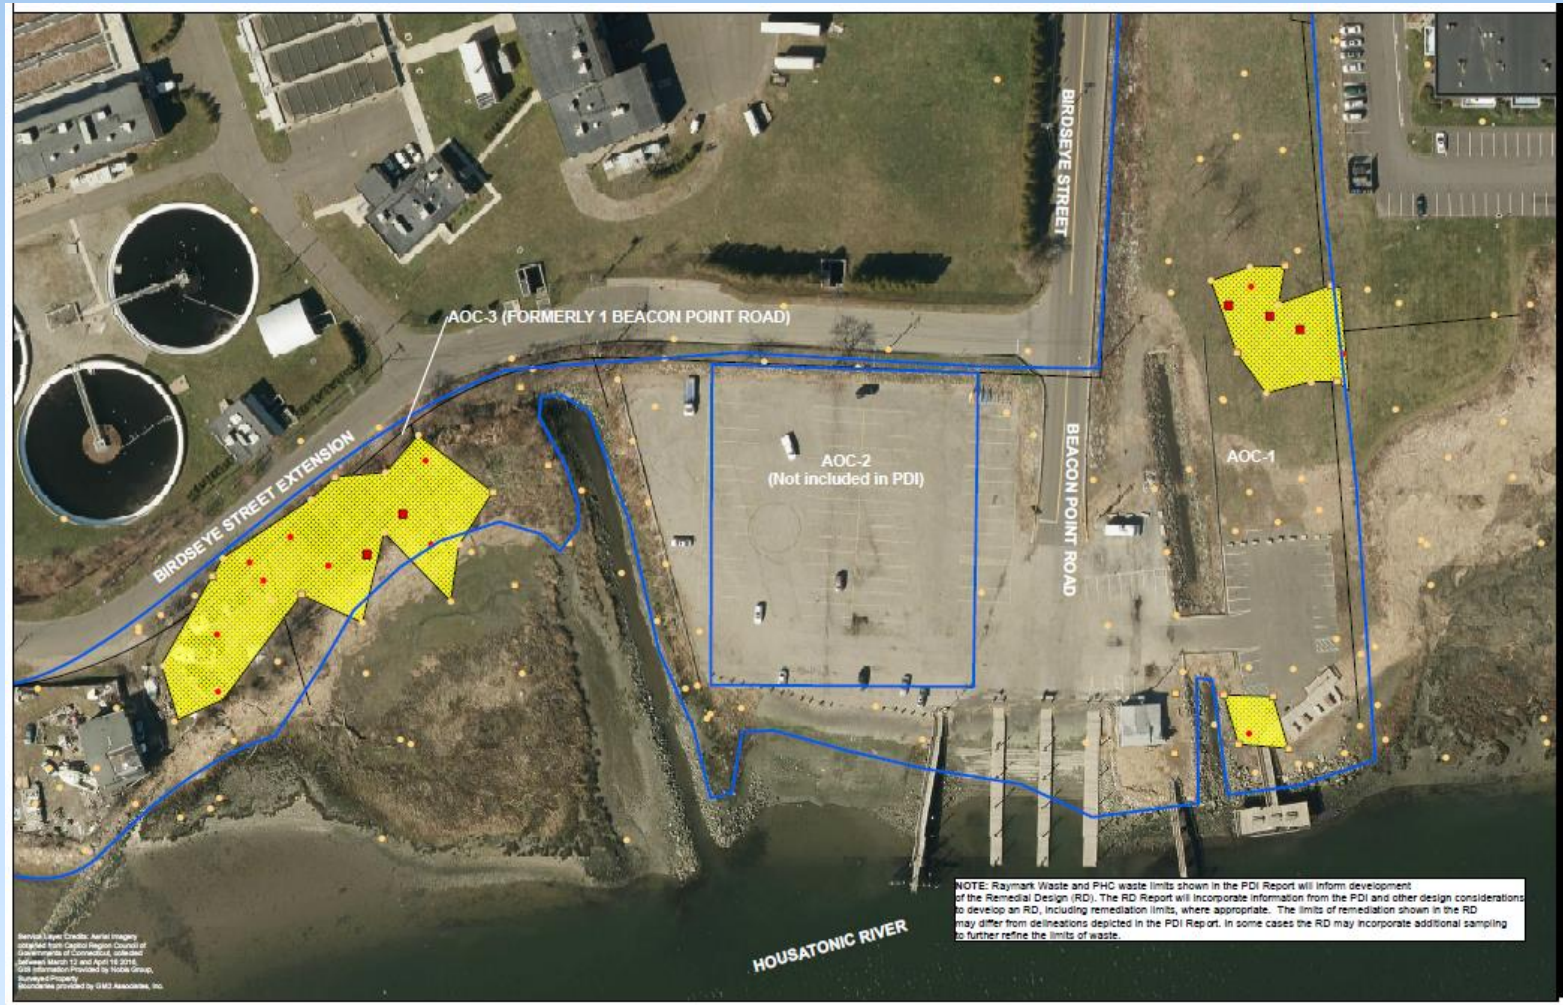
Beacon Point

- ~ 2,400 yds = 200 trucks
- ~ 250 yds = 20 trucks PHC waste
- Trying to gain access to private property
- Fall 2021
- About 10 weeks to complete

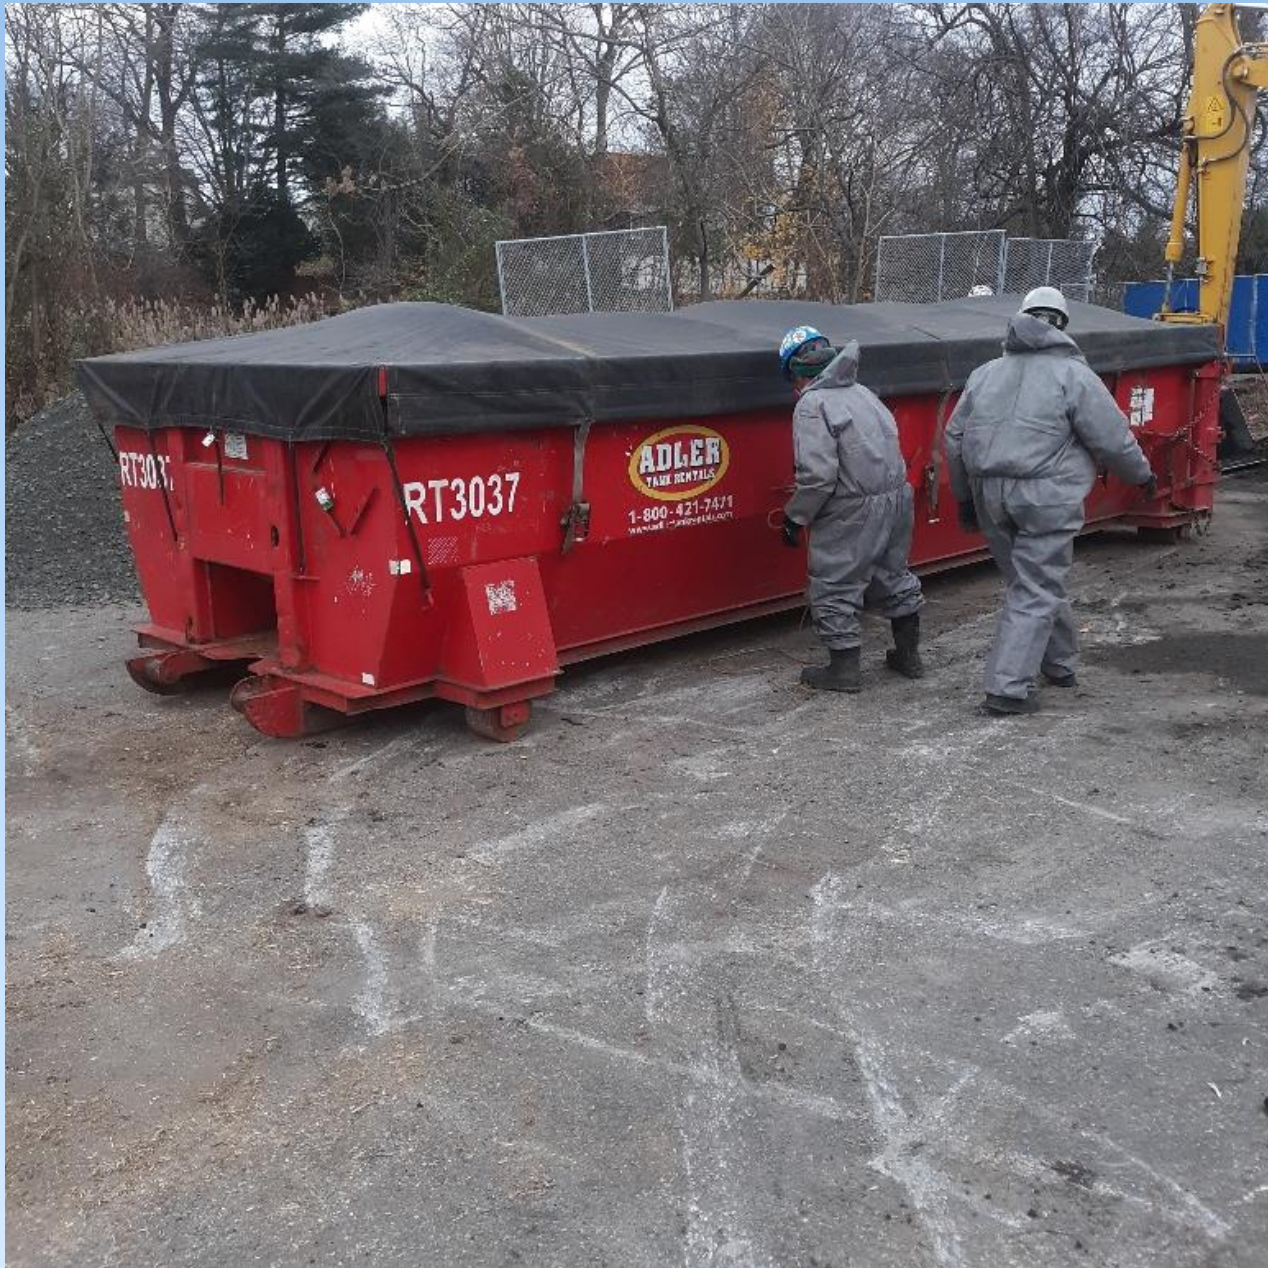
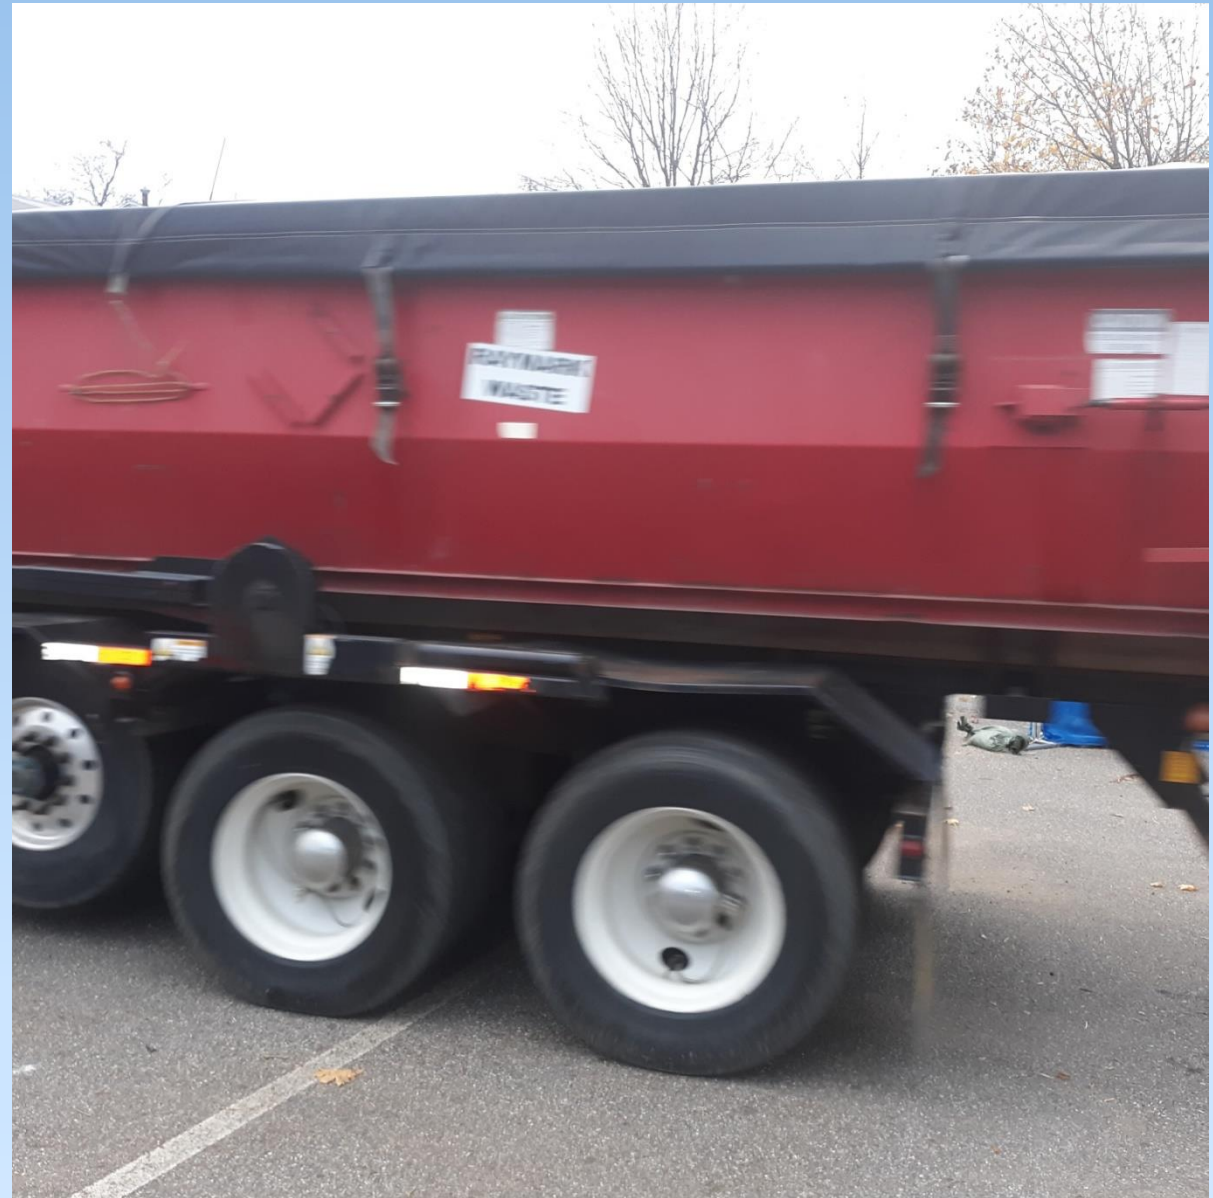
Hauling Waste Trucks vs. Containers

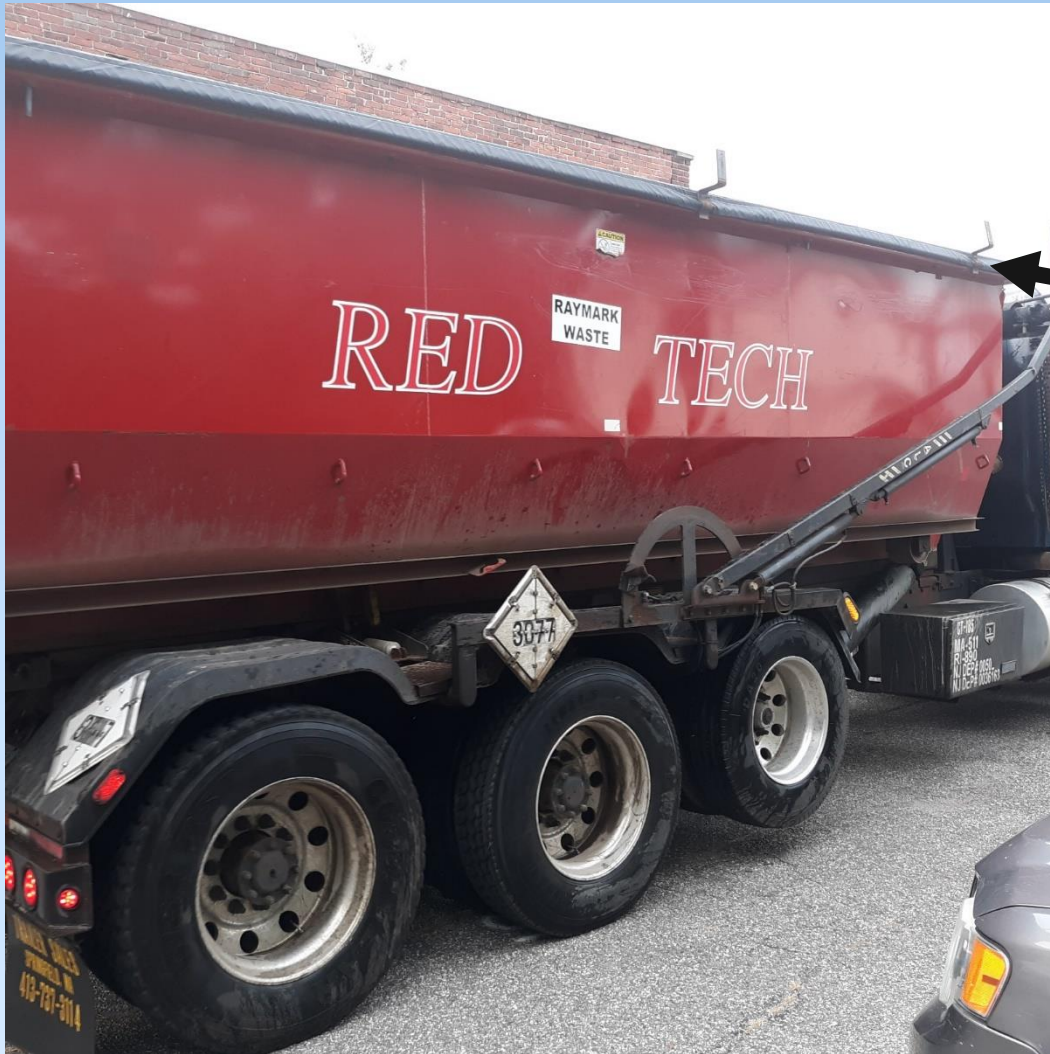
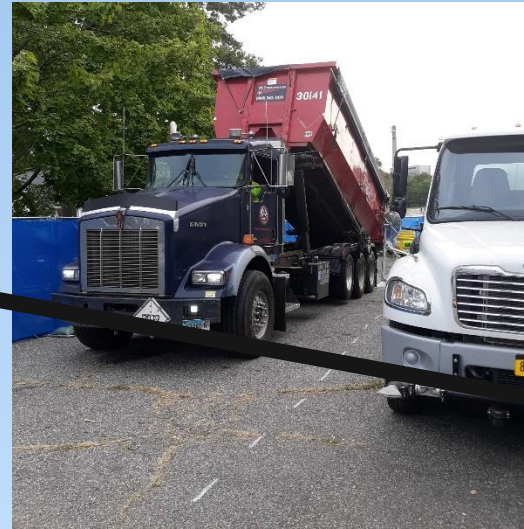
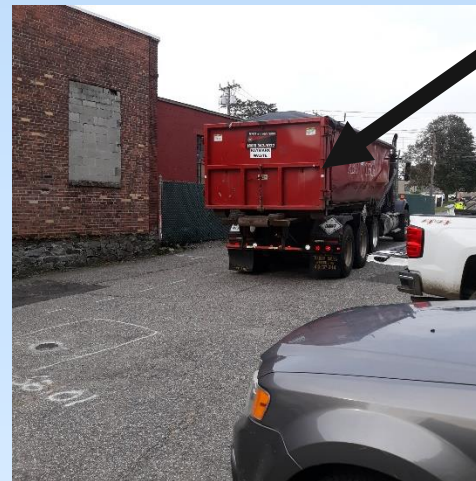
CONTAINERS

- 1.) Tight Cover
- 2.) Full Gasket

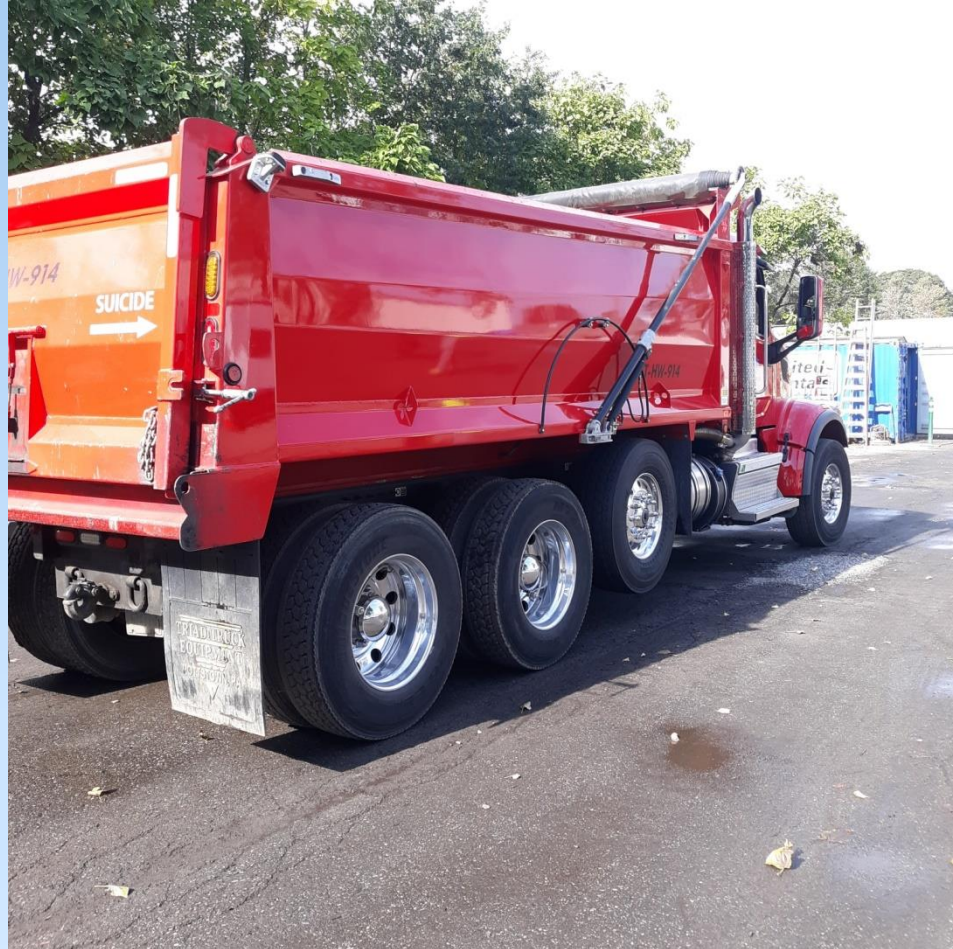
TRUCKS

- 1.) Tight Cover
- 2.) Full Gasket

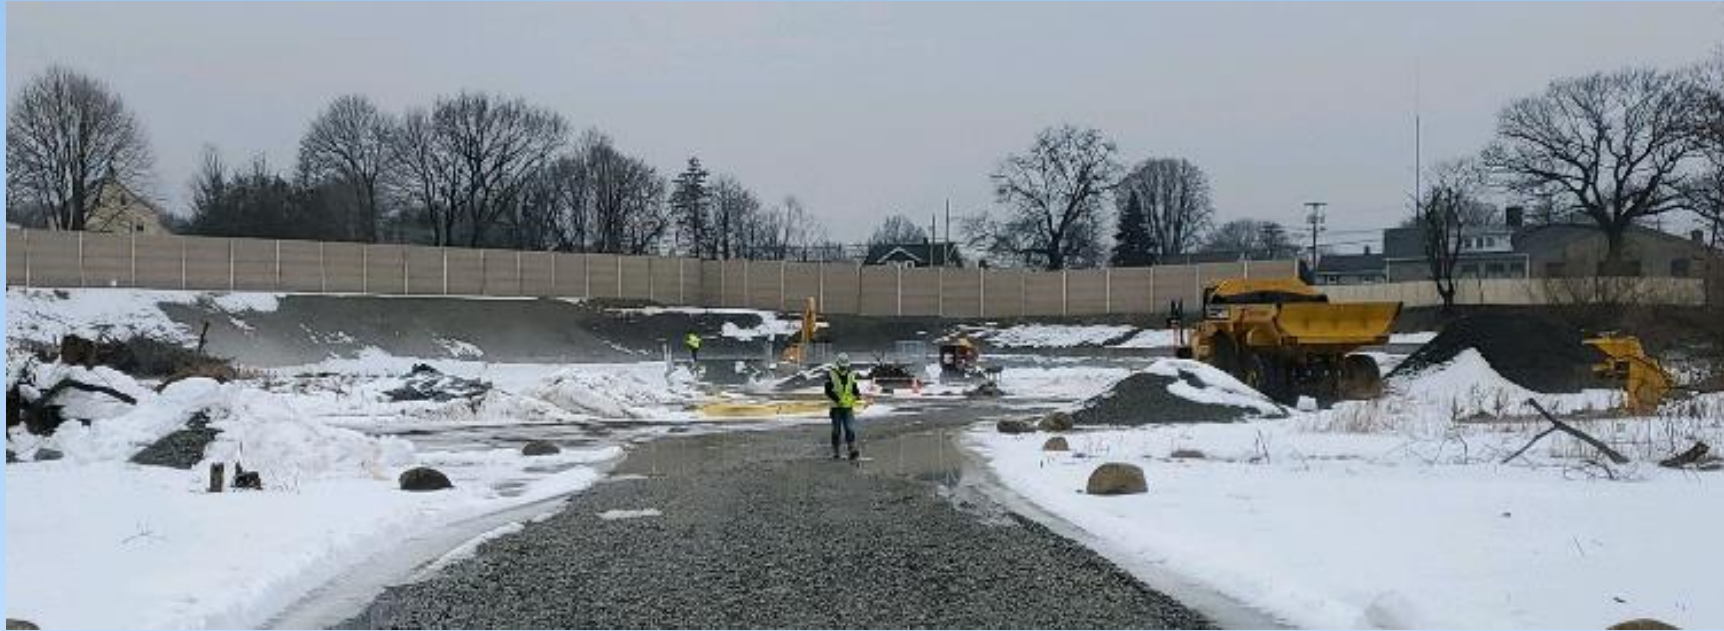
OU4 Ballfield Work Completed or Ongoing Since February

- Waste material from 250, 304 and 340 East Main Street currently being excavated and transported to ballfield
- Posi-Shell cover applied on all previously imported Raymark Waste at OU4 Ballfield
- OU4 site and cap design ongoing
- Stormwater control and conveyance system design complete
- 5 perimeter air monitors at OU4 and 2 at East Main Street are operating daily

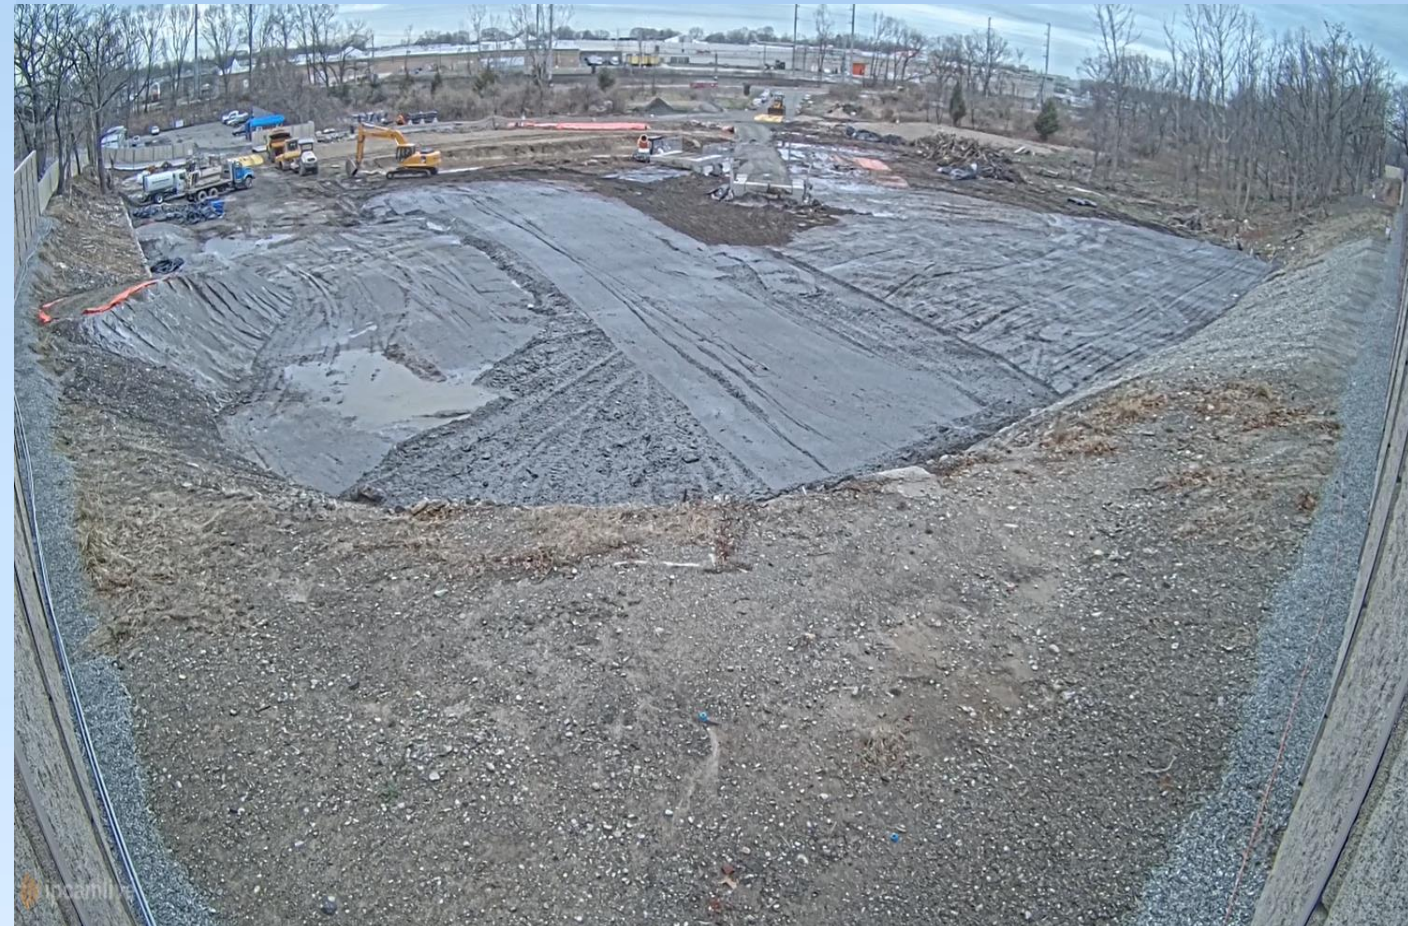
OU4 Containment Structure

- Temporary Fabric Structure (TFS)
- Approx. Dimensions (l x w x h) : 100' x 130' x 40'
- Used primarily for material additives and dewatering
- Closed system with air treatment
- Aluminum structural frame with PVC coated fabric membrane

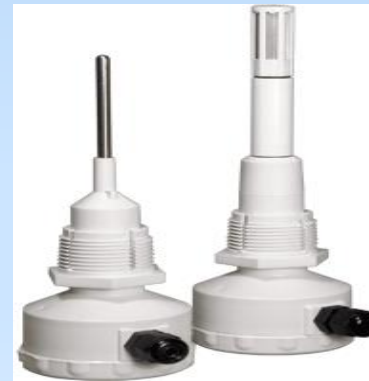
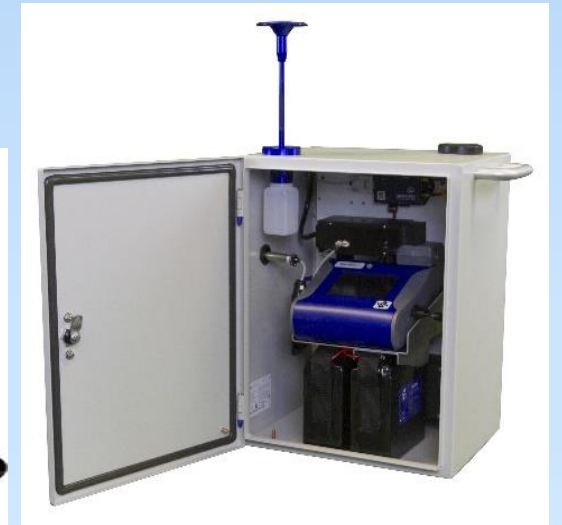
- 5 Air Monitors/Chemical Sample Locations at OU4
- 2 Air Monitors/Chemical Sample Locations at OU6 Site
- Dust Action Level criteria derived to protect workers and community abutting the sites
 - Dust Action Levels incorporated chemicals on each OU
 - Dust Action Level criteria incorporated additional safety factors
- Chemical samples collected from all 7 stations and onsite personnel
 - Safety based individual chemical criteria monitored for worker safety and perimeter stations for community safety
- Submitting Weekly Air Monitoring Reports, Chemical Results and Vibration Monitoring Reports
- All reports posted on Town Health Dept Raymark website

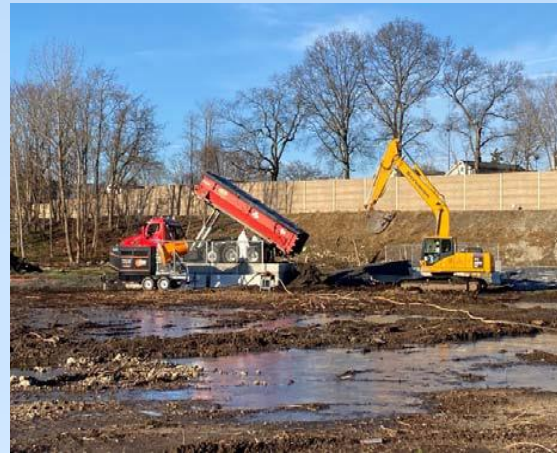
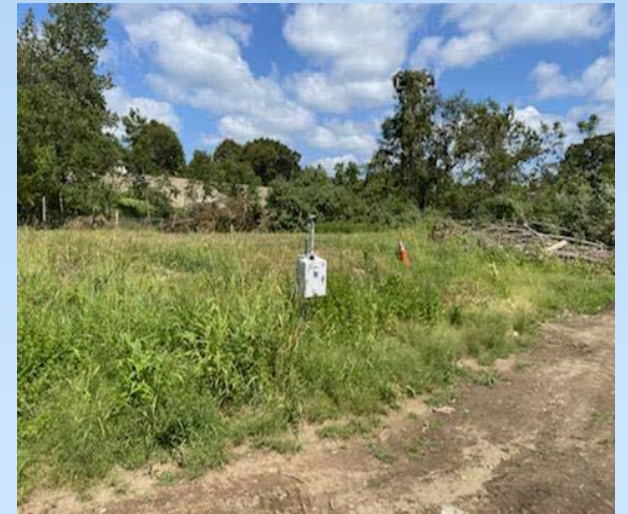
OU4 - Air Monitoring Results

- Since 2/24/21 public meeting Daily Average Dust = 0.002 to 0.013 mg/m³
- March 11th exceeded OU4 Dust Action Level criteria (0.016 mg/m³ vs 0.014 mg/m³)
- Associated with community wide dust (background conditions)
- Similar dust concentrations found at all 7 meters (OU4 and OU6)
- Reported the exceedance and posted on Town Raymark website
- Included chemical data from air monitoring confirming no risks posed to workers or community
- No exceedances of chemical health and safety criteria
- Posting Weekly Air Monitoring Reports
Chemical Data and Vibration Monitoring
Reports on Town Raymark website
