WEEKLY EROSION CONTROL INSPECTION

PROJECT:	Avalon Bay Stratford, CT	DATE:	August 22, 2013
CONTRACTOR:	AMEC	PROJECT NO.:	86 16038
PREPARED BY:	Ken Kohlbrenner, PE	REPORT NO.:	3
SIGNATURE:

PERMIT NO.:	IWWA #2001-9(M)

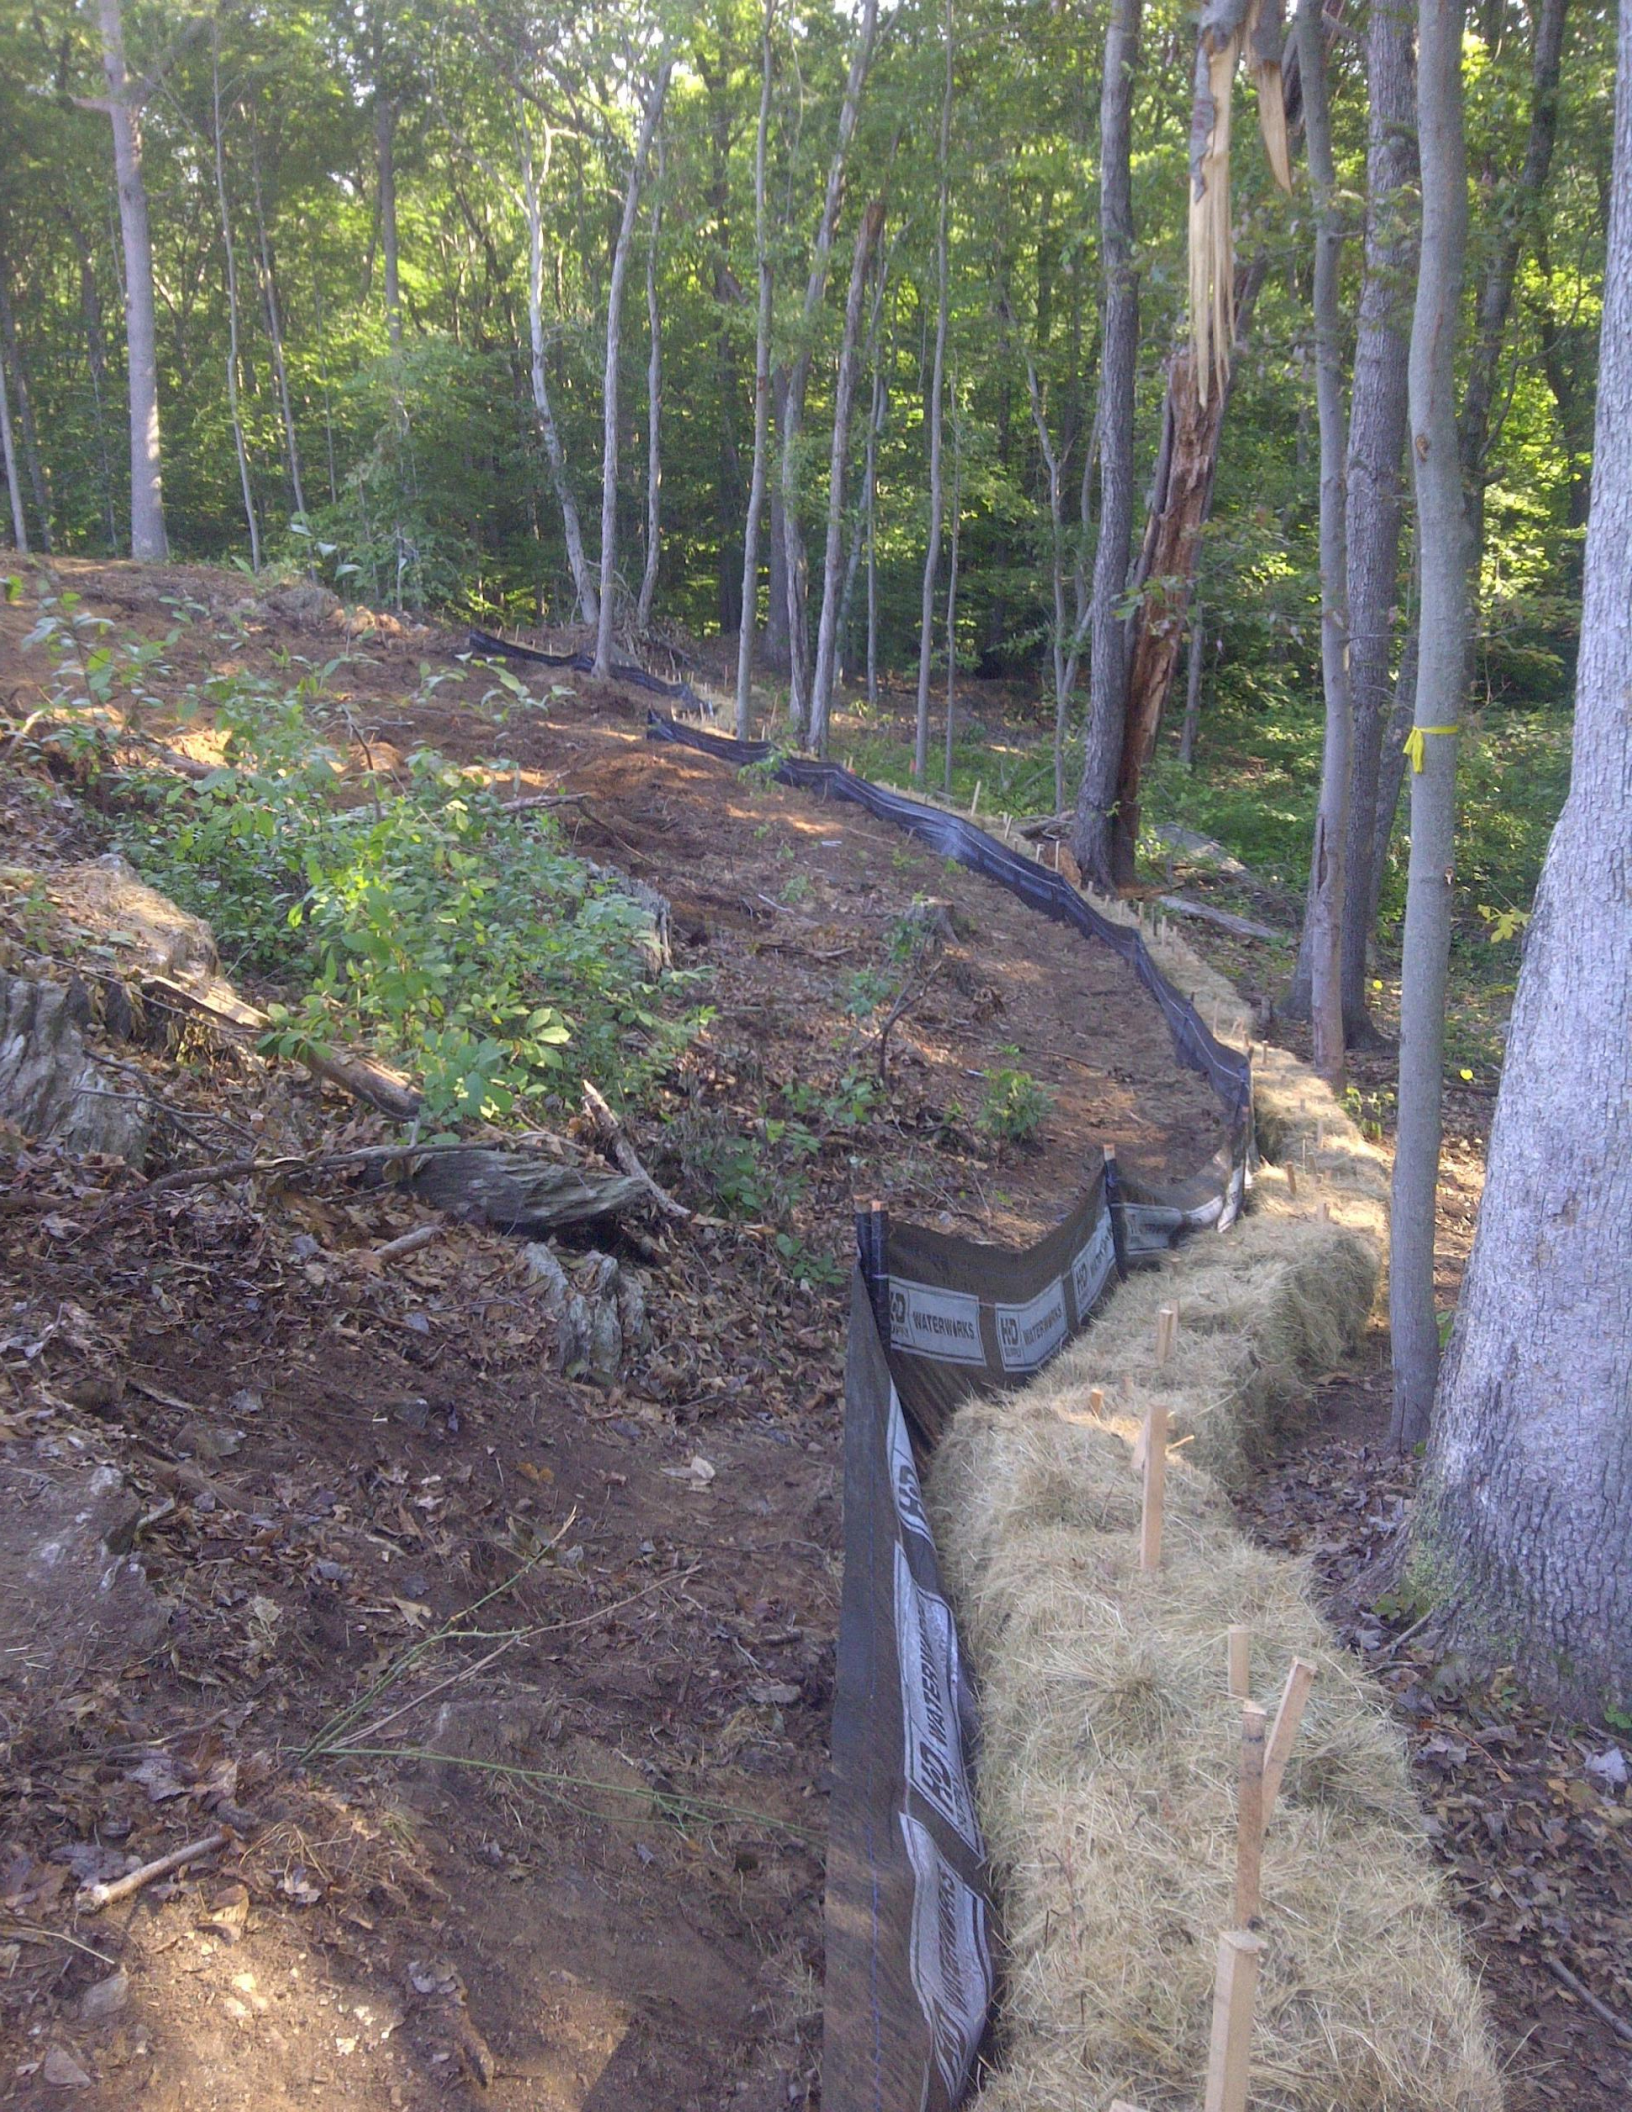
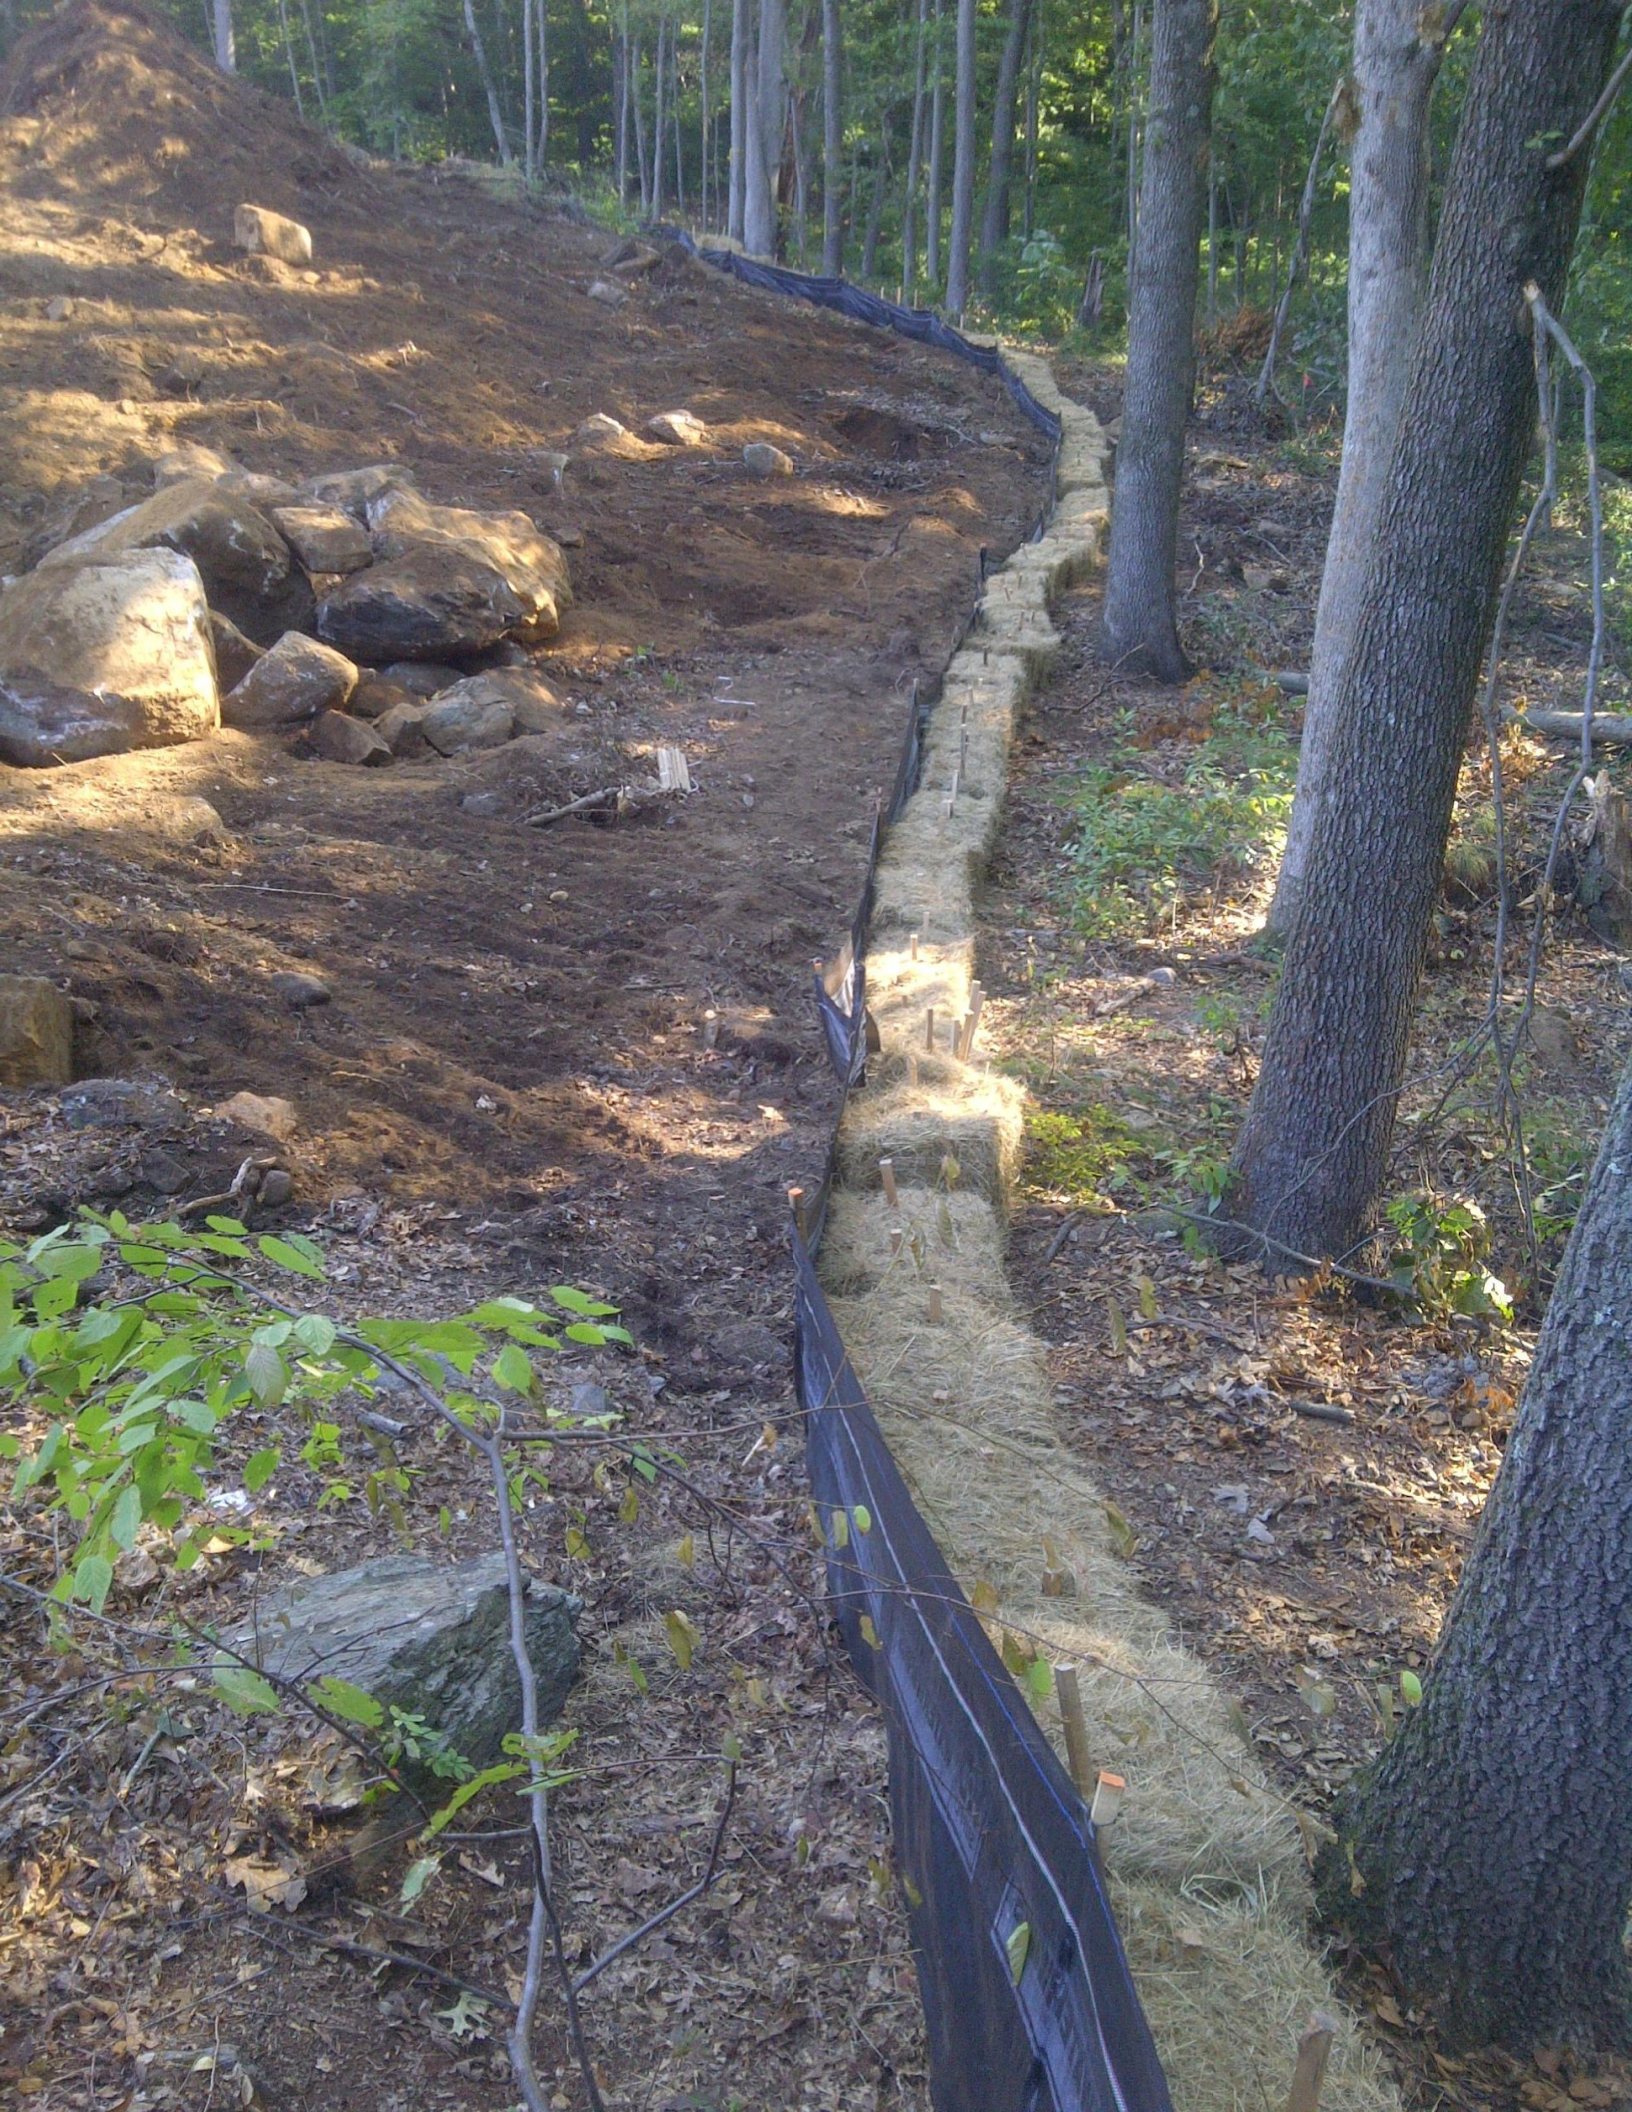
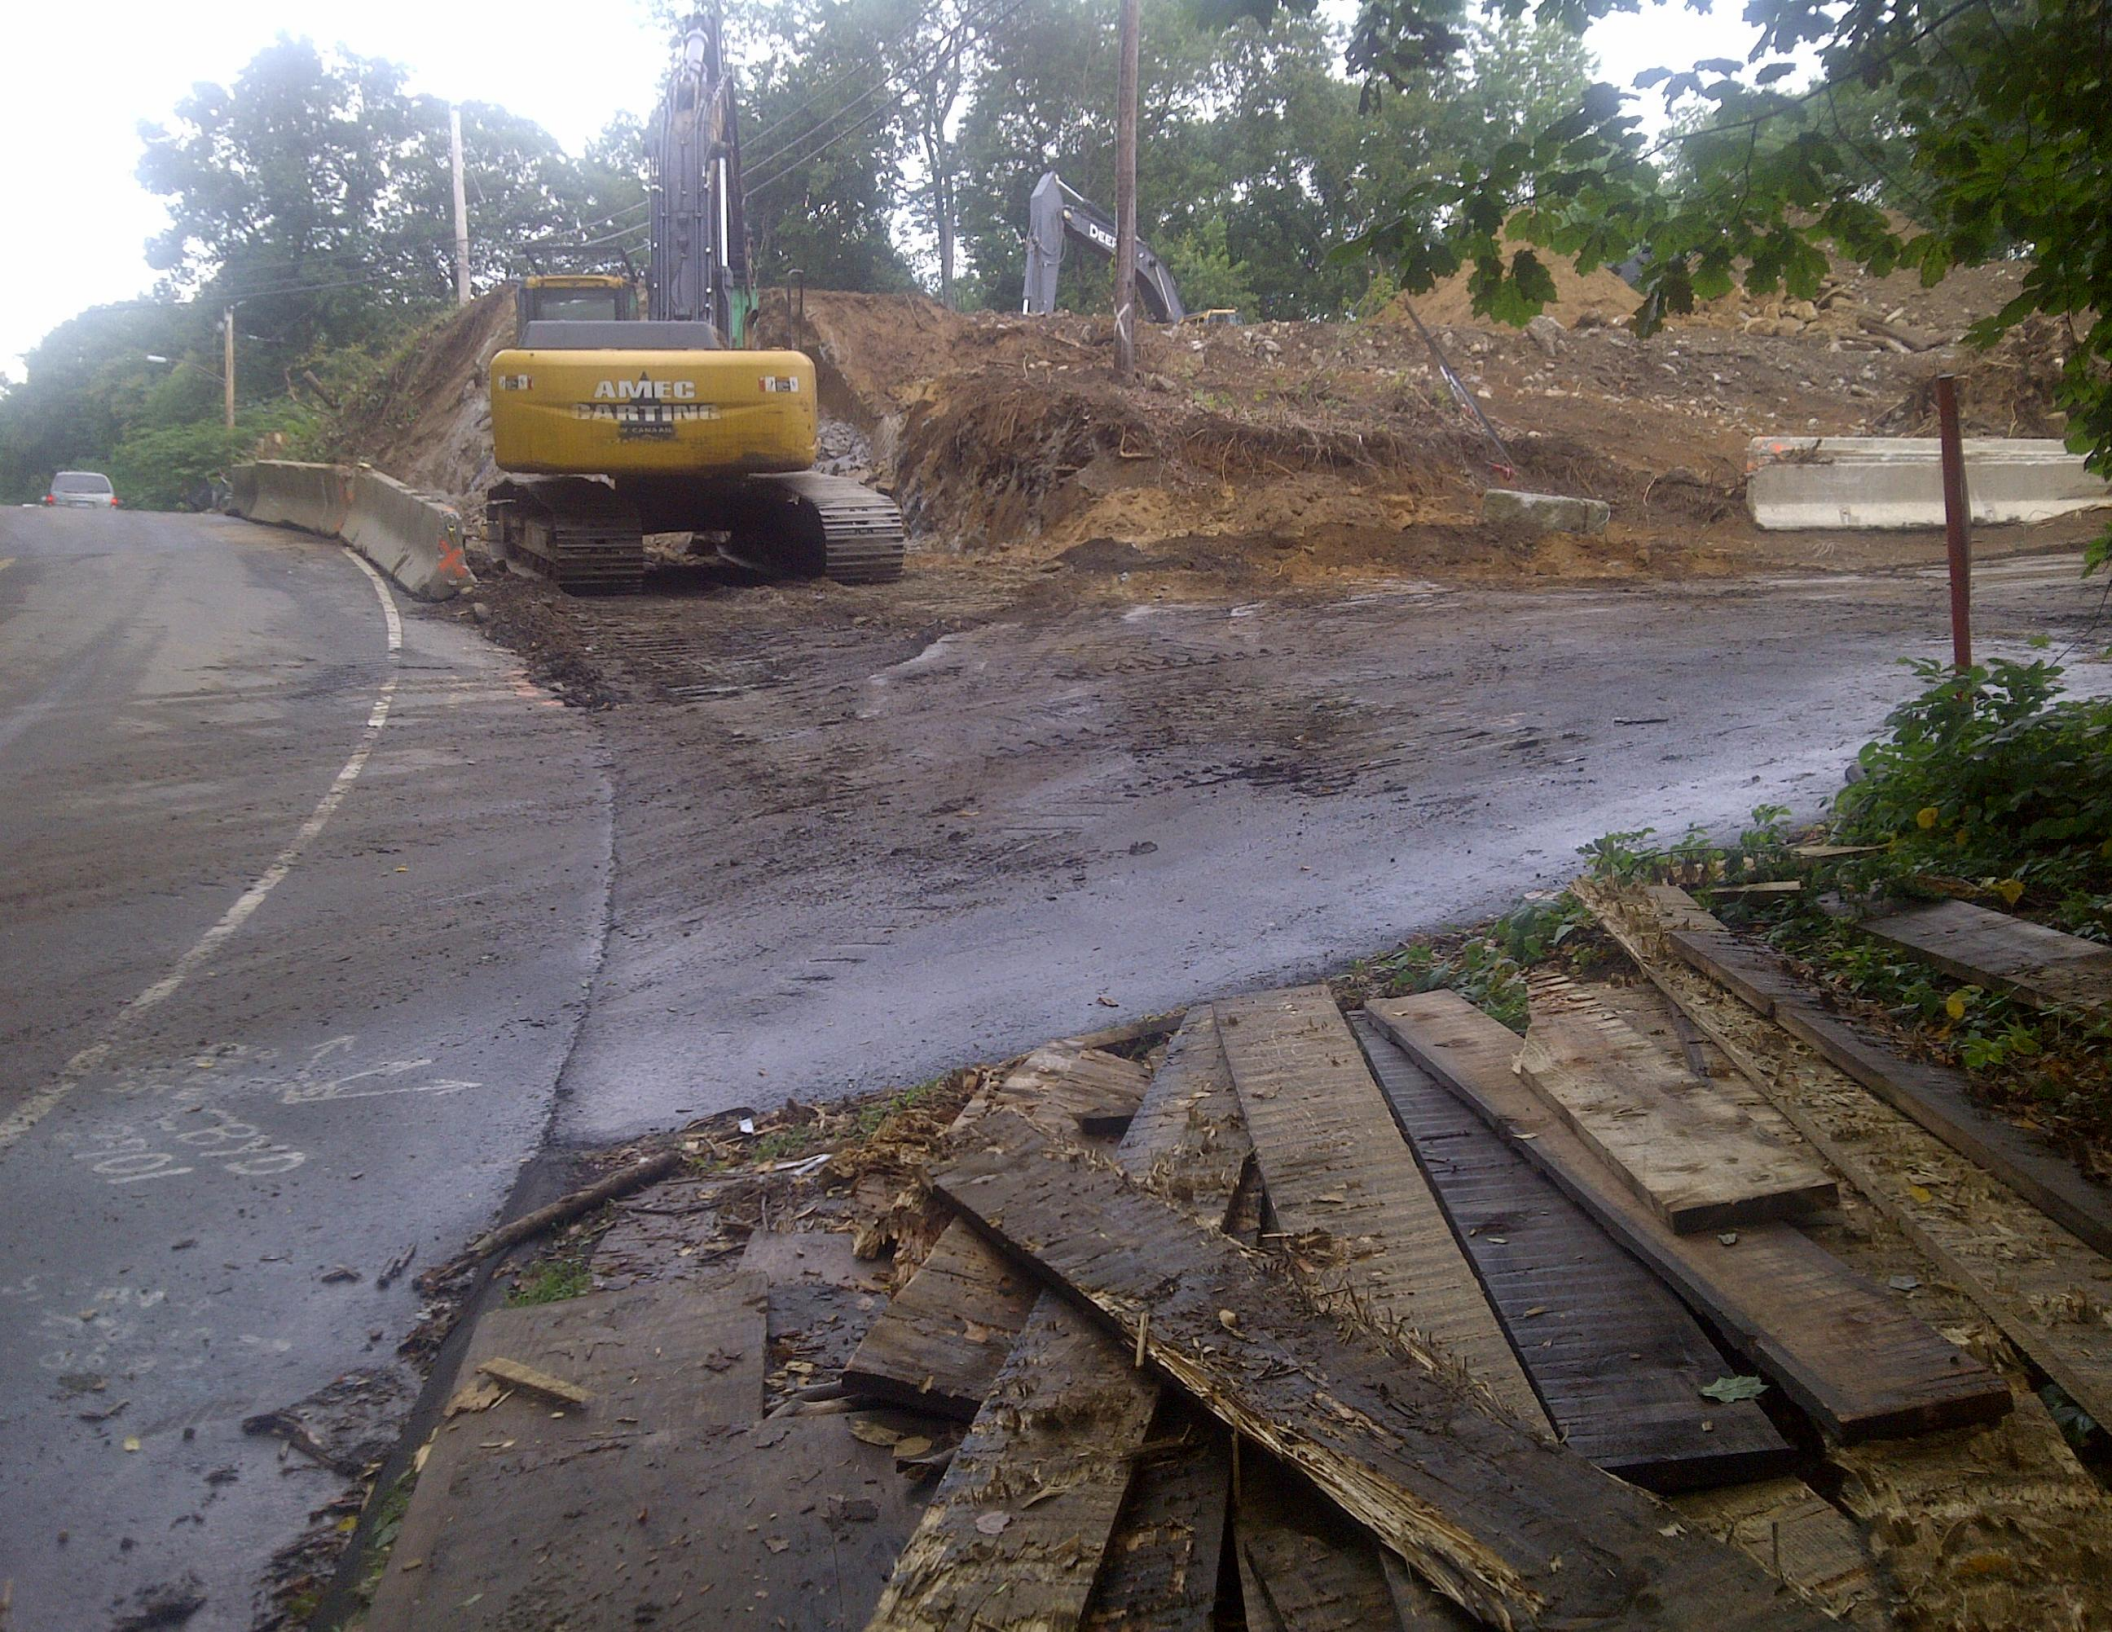
Stump removal and hammering is ongoing. Silt fence is installed around perimeter, with hay bales installed behind silt fence along conservation easement.
Short rainstorm this morning (approximately 0.4 inches). No erosion or discharge evident. Installed silt fence in good condition.
Some sediment accumulating at construction entrance. Contractor schedule to have sweeper onsite August 23 to clean construction entrance.

Sediment being tracked into construction entrance. Sweeper scheduled for August 23 to clean.

Three photos showing construction entrance and silt fence with hay bales attached.
