# WEEKLY EROSION CONTROL INSPECTION

PROJECT:	Avalon Bay Stratford, CT	DATE:	March 6, 2014
CONTRACTOR:	AMEC	PROJECT NO.:	86 16038
PREPARED BY:	Ken Kohlbrenner, PE	REPORT NO.:	25
SIGNATURE:		PERMIT NO.:	IWWA #2001-9(M)

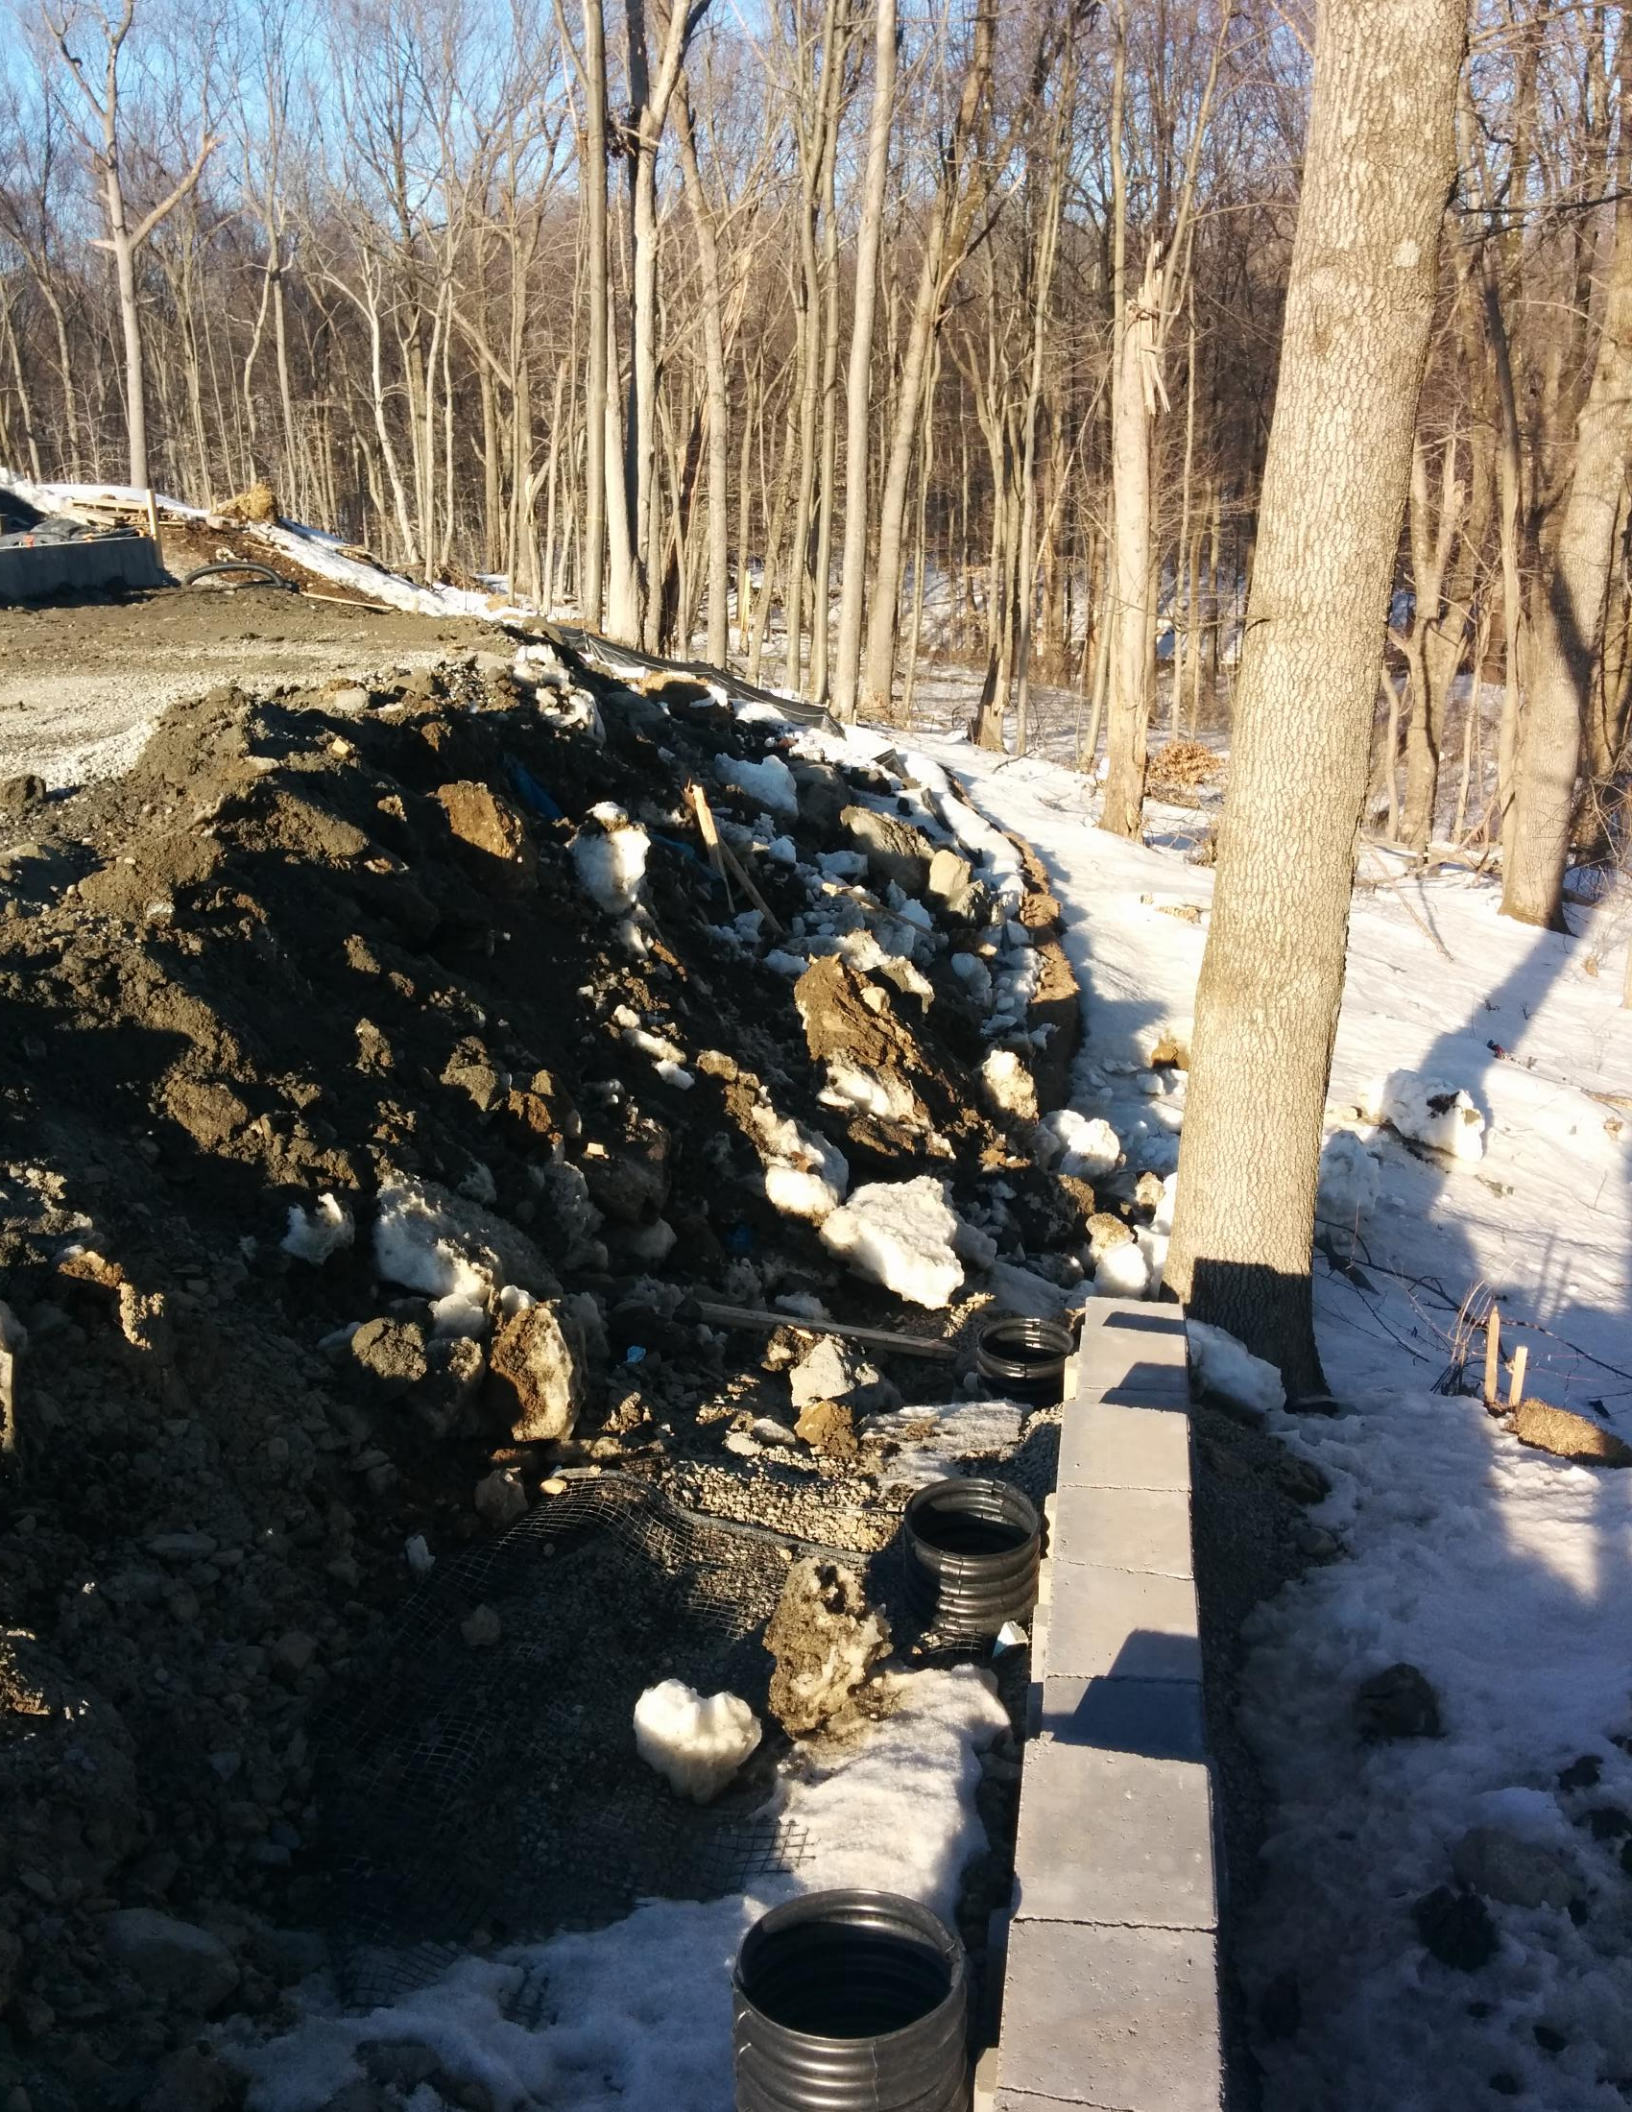
Photos of areas where silt fence repair needed.

1. South of Building 4
2. South of Building 3
3. South of Building 1

Continued cold temperatures are reducing dust and sediment tracked offsite. Areas of silt fence will need to be repaired when warmer weather allows (examples noted in pictures).
