# WEEKLY EROSION CONTROL INSPECTION

PROJECT:	Avalon Bay Stratford, CT	DATE:	May 15, 2014
CONTRACTOR:	AMEC	PROJECT NO.:	86 16038
PREPARED BY:	Ken Kohlbrenner, PE	REPORT NO.:	33
SIGNATURE:	ty the	PERMIT NO.:	IWWA #2001-9(M)

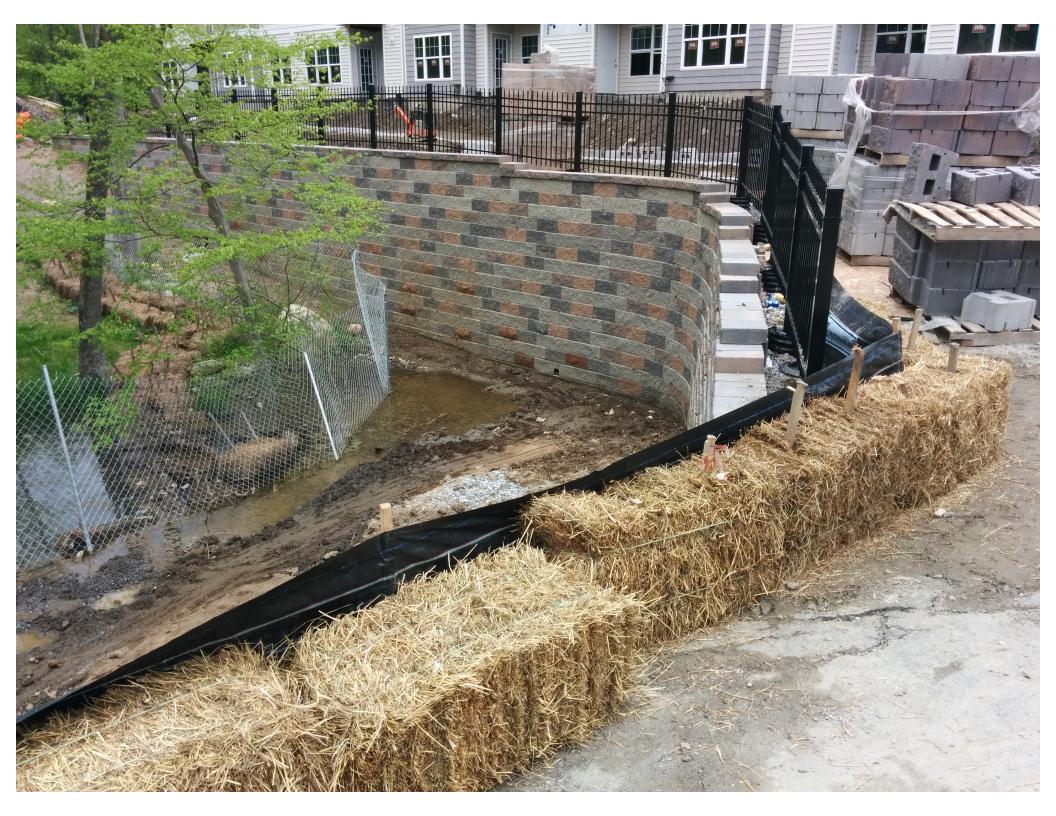
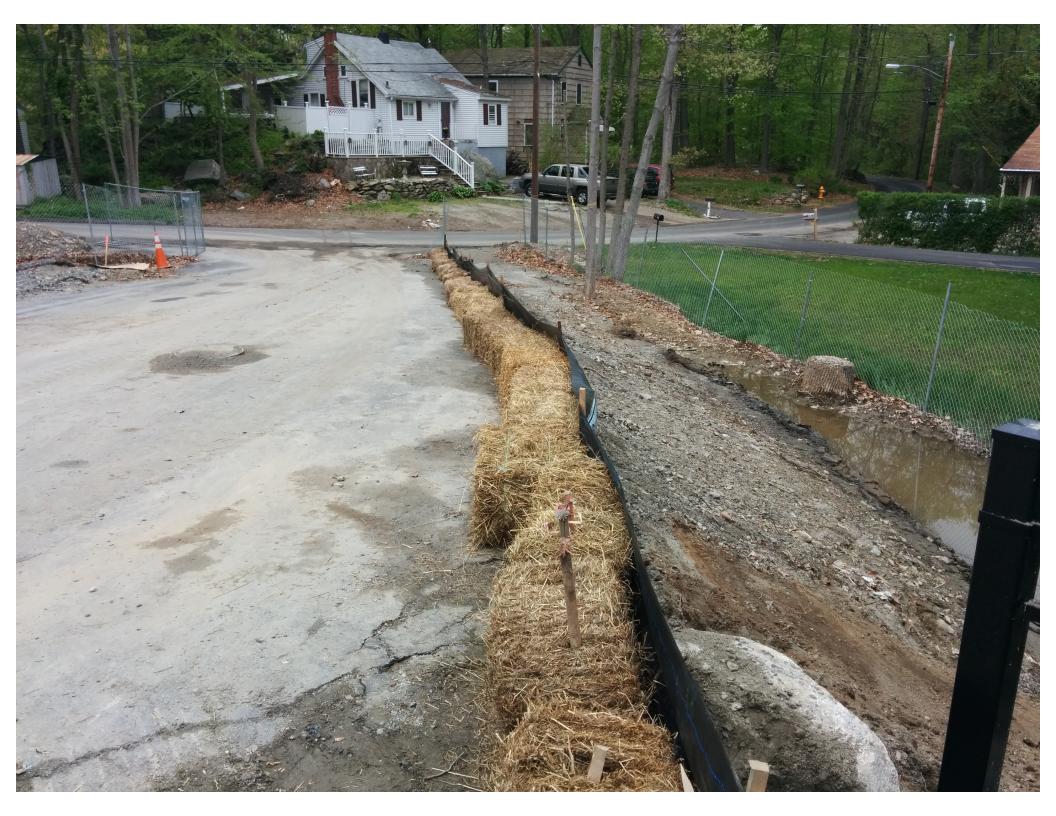
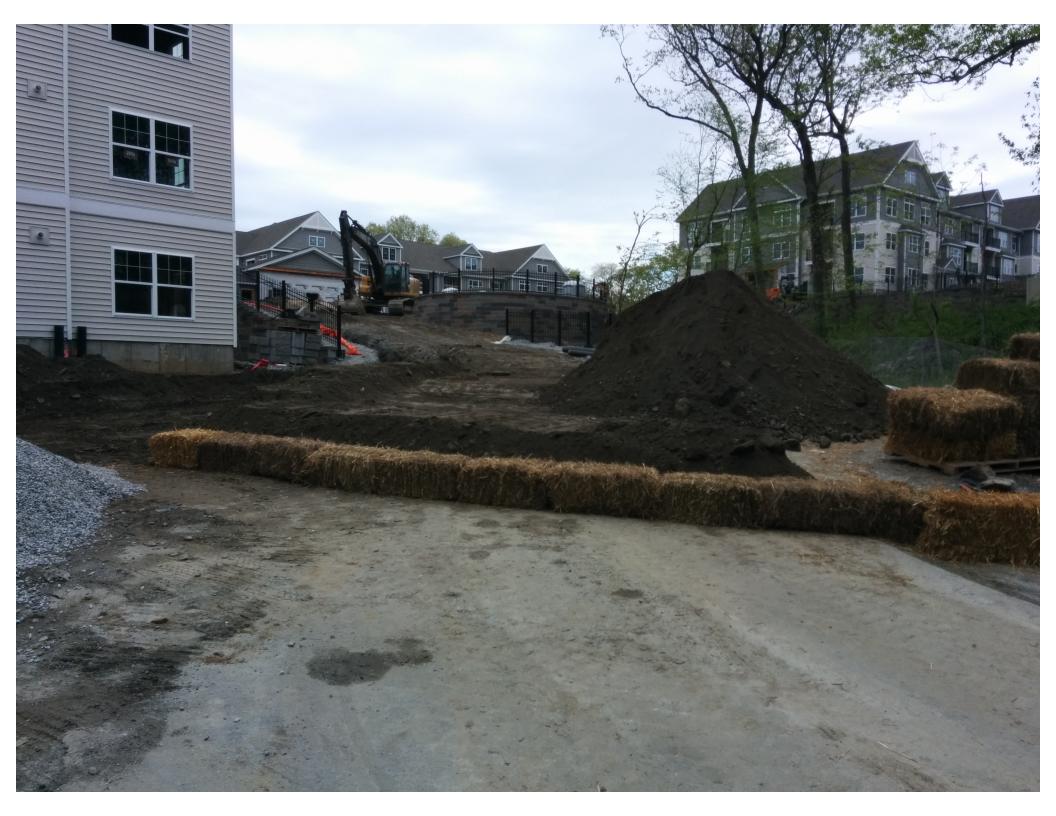
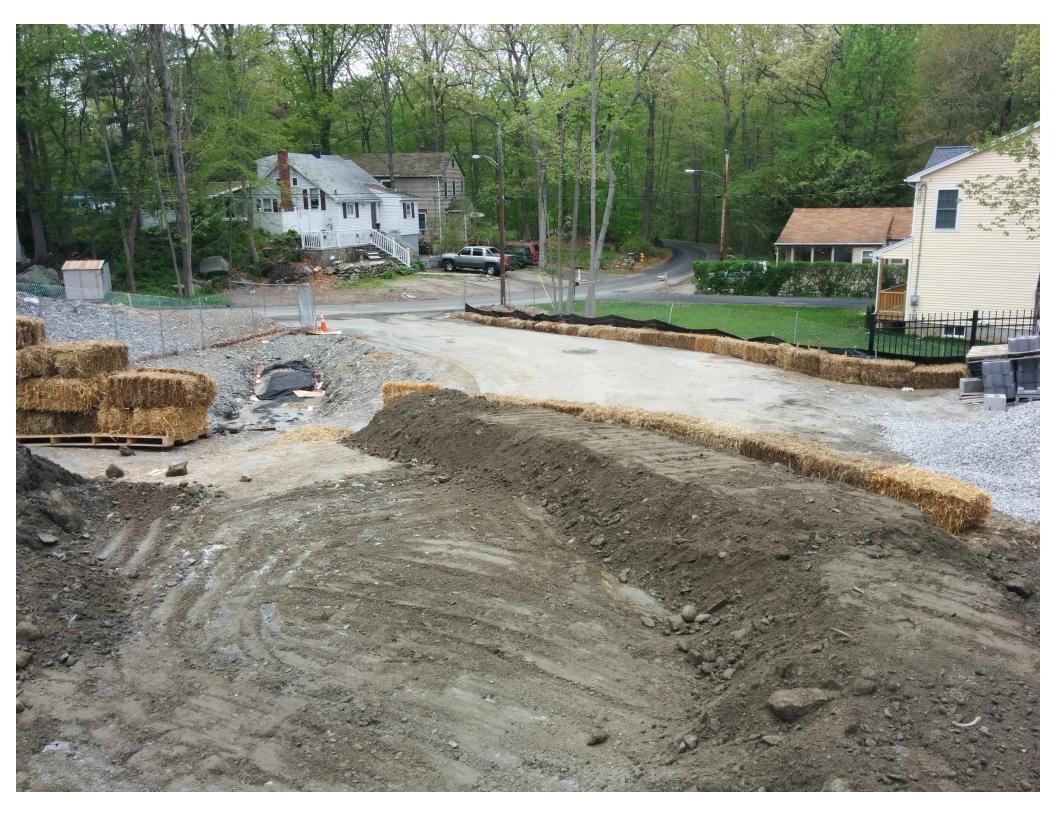
Photos of interim diversion berm and hay bales for 152 Circle Drive

Meeting was held with Brian Carey (Stratford), Aaron Levy and Todd Nicotra (AvalonBay) and Ken Kohlbrenner (GHD) on May 14<sup>th</sup> to review runoff toward 152 Circle Drive. Agreed that, as an immediate fix, the ponding area will be cleaned out, the slope regraded, and hay bales installed to divert runoff toward the detention basin, rather than the low area. As an interim fix, a curb will be installed to divert runoff until the permanent trench drain can be installed. The Circle Drive access road is no longer to be used as a construction entrance.
